Late 1940's,
Early 1950's

F.T. Events/Accidents

Note on the structural failure of
Handley Page 88 (E6/48) VX.330

The Handley Page 88 prototype (E6/48) crashed at Stansted airfield on 26/6/51 following structural failure in the air. The pilot was killed.

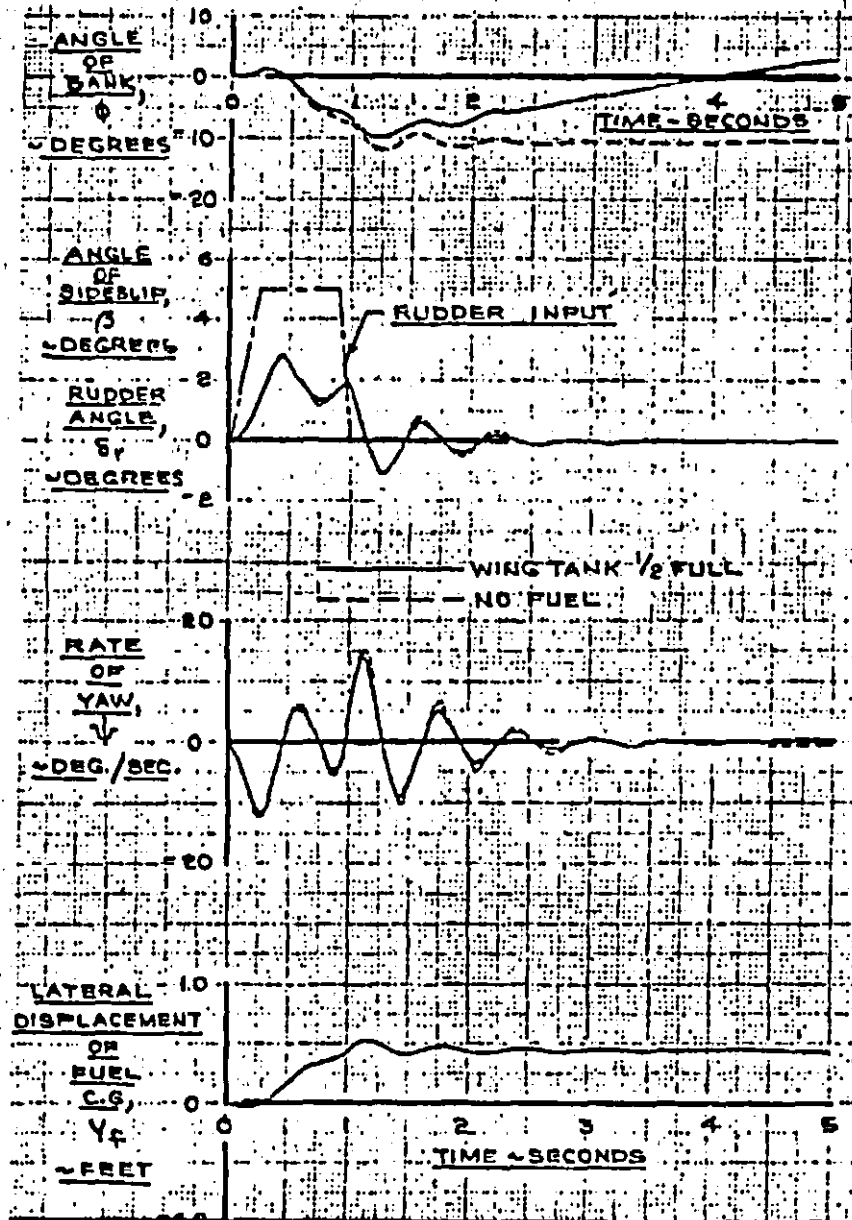
A4D wing fuel shift shows up as spiral instability, which can be easily corrected by the ailerons (Figure 14.3). However, the early A4D airplanes had a single, or nonredundant, aileron hydraulic system. When aileron hydraulics malfunctioned at a high Mach number during an early test flight, the airplane and pilot James Verdin were lost. The painful lesson was learned. Production A4D (now A-4) airplanes retain the single integral wing fuel tank, but dual, independent aileron power systems now guard against loss in lateral control due to fuel shift.

Figure 14.3 Calculated effect of fuel shift in the Douglas A4 Skyhawk's wing tip-to-wing tip wing tank. With half wing fuel, a rudder kick shifts the fuel, giving apparent spiral instability. The bank angle increases slowly with time. (From Abzug, Douglas Rept. ES 29551, 1959.)

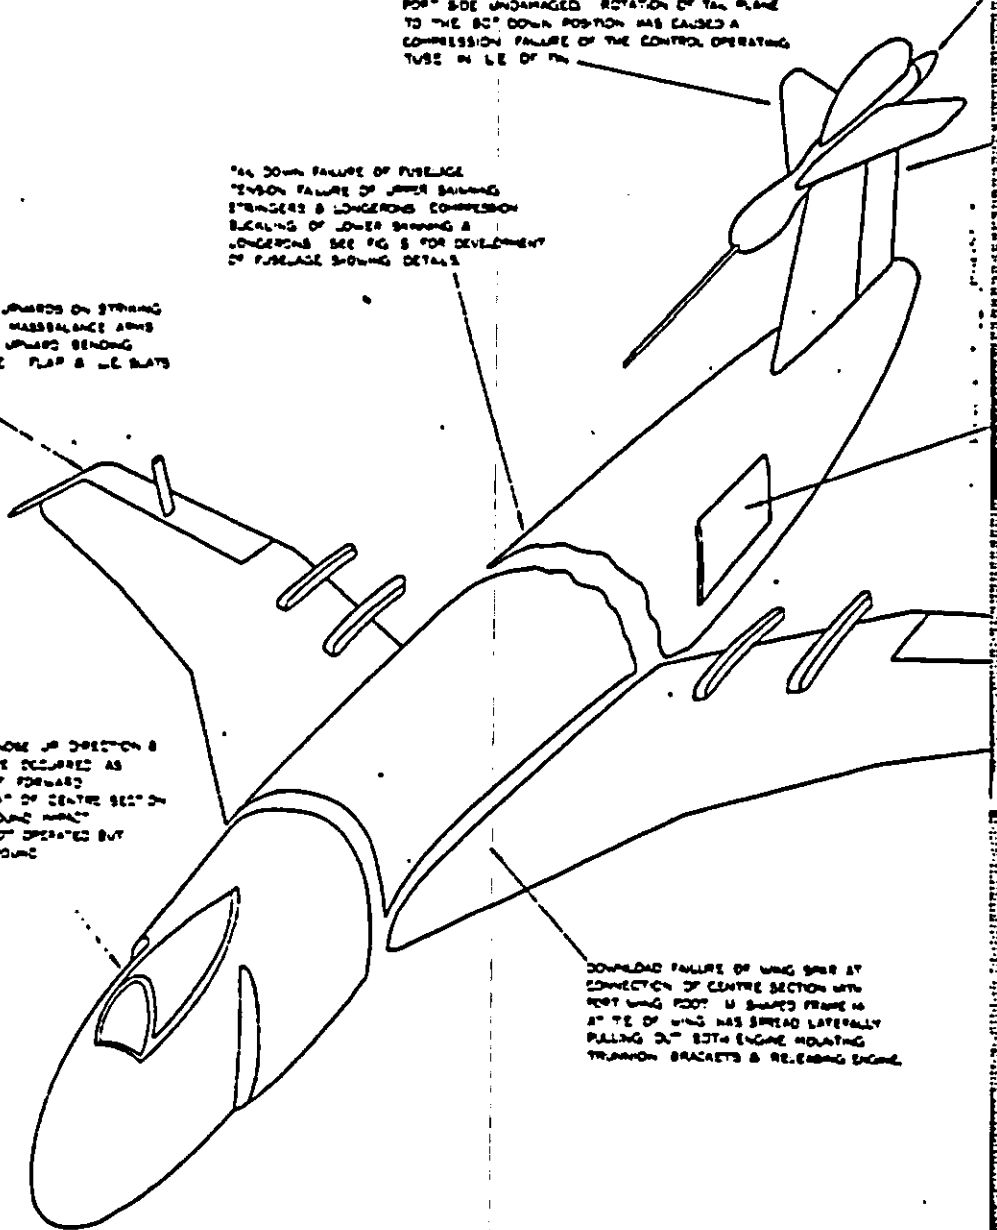
FIG.2. HANDLEY PAGE 88. VX 33
MAJOR AIRFRAME FAILURES.

An examination of the wreckage made at the R.A.E. leads to the conclusion that primary failure occurred in the fuselage. This failure was probably due to pitching oscillations.

6.1 The main features observed in the examination of the wreckage are described on the sketch in Fig.2.

FRONT FUSELAGE DETACHED IN NONE OF DIRECTION &
PROBABLY BEFORE A NG FAILURE OCCURRED AS
THERE IS NO DEFORMATION OF FORWARD
FUSELAGE COMPARABLE TO THAT OF CENTRE SECTION
EXCEPT DEFORMATION IN GROUND IMPACT
PLANE SECTION WAS NOT OPERATED BUT
WAS IN STRIKING THE GROUND

COMPLETE FAILURE OF WING SPAR AT
CONNECTION OF CENTRE SECTION WITH
PORT WING FOOT IN SHARP FRAME 16
A FEET OF WING WAS SHRED LATERALLY
FALLING IN BOTH ENGINE MOUNTING
TRUSSON BRACKETS & RELEASING ENGINE

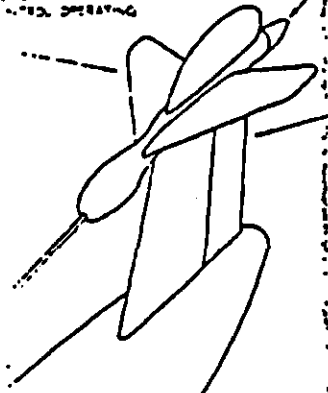
TAIL PARACHUTE STREAMED & JETTISONED
NO EVIDENCE OF HEAVY LOADING ON WEA
LINK UPPER SHEAR PIN OR ON SHACALE
OR JETTISON GEAR

RUDDER WAS ROTATED HARD TO PORT FALLING
IN COMPRESSION THE OPERATING LINK &
SUBSEQUENTLY ROTATING HARD TO STARBOARD &
TOWLING THE SHROUL

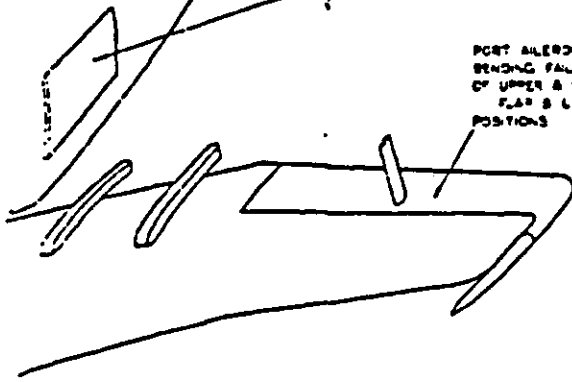
PORT AIR BRAKE EXTENDED WHEN THE REAR
FUSELAGE STRUCK THE GROUND FAILURE
OF OPERATING STRUT IN COMPRESSION
STARBOARD AIR BRAKE DETACHED ON
STRUCK THE GROUND. EVIDENCE INDICATES
THAT IT WAS EXTENDED & BROKEN OFF AT
THE HINGE IN A DOWNWARD DIRECTION

PORT AILERON INTACT EXCEPT FOR
BENDING FAILURES IN AN INBOARD DIRECTION
OF UPPER & LOWER MASSBALANCE ARMS
FLAP & LE SLATS IN RETRACTED
POSITIONS

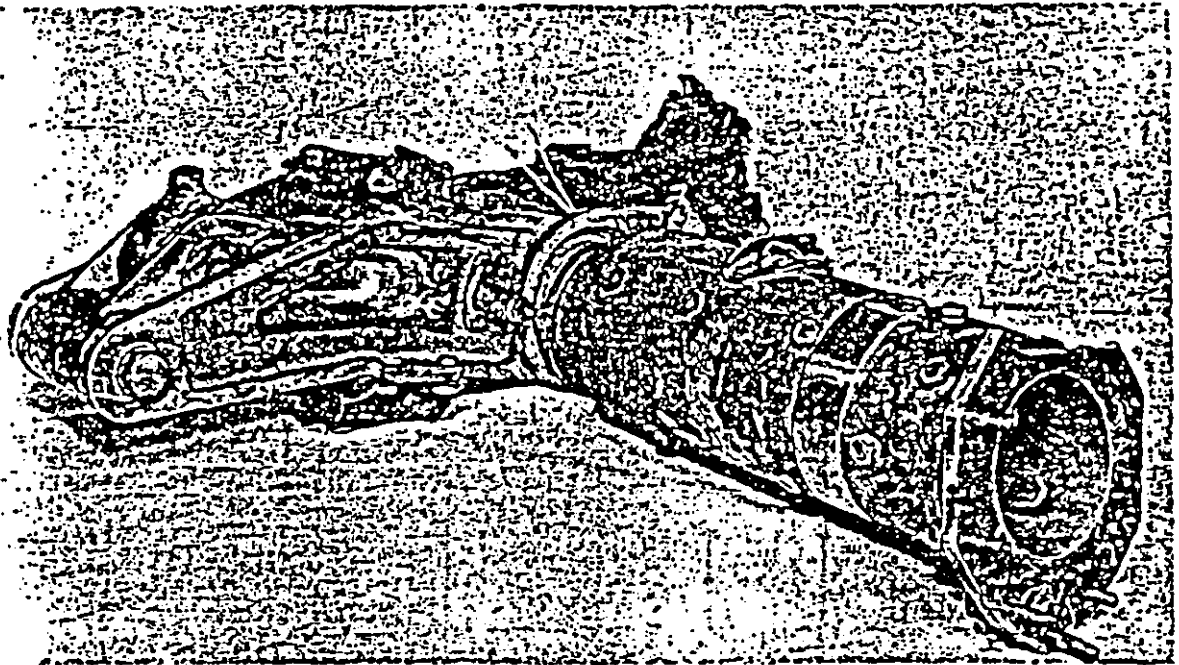
FIG.9. PORT. ELEVON TORQUE SHAFT SHOWING BROKEN FLANGE

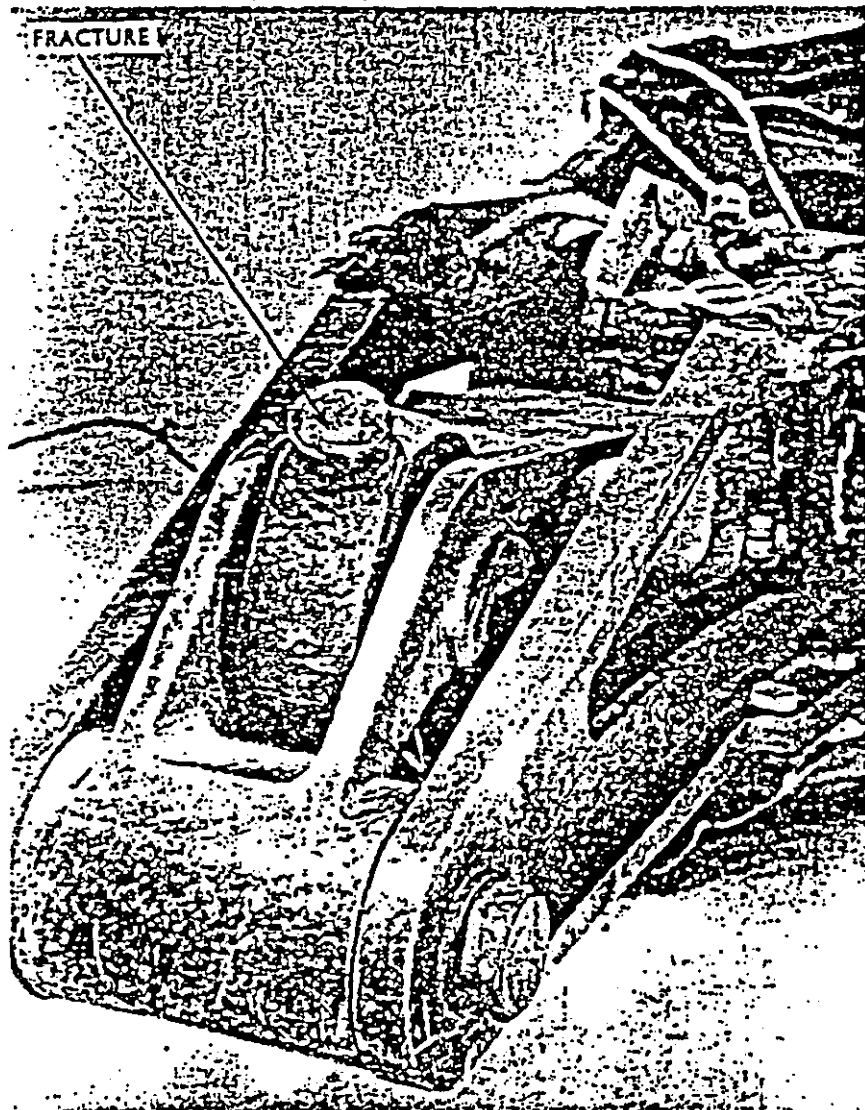
FIG.10. FAILURE OF THE OPERATING LEVER TO THE PORT ELEVON TORQUE SHAFT

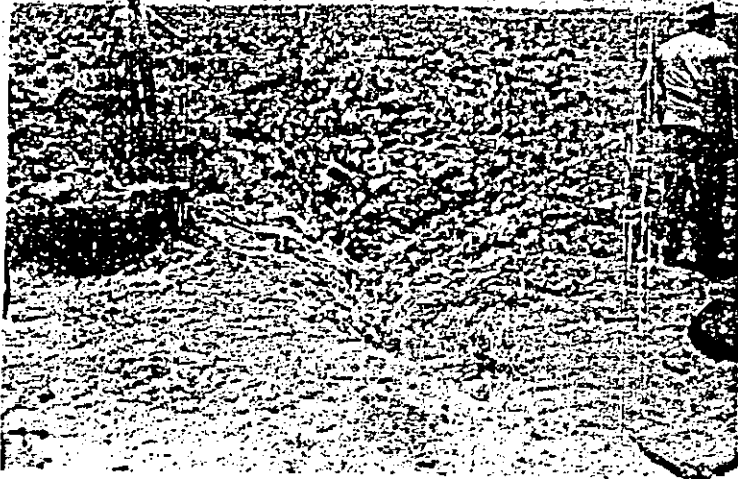
#1 IMPACT CRATER
