Canedair ~~CL~~CL44 Modified  
"Guppy" ✓

+++++  
+ DATA REPORT CANADAIR - CL44  
+ EVENTS | PHASES: AIRFRAME FAILURE | AERIAL WORK

## 377MGT-1 Accident

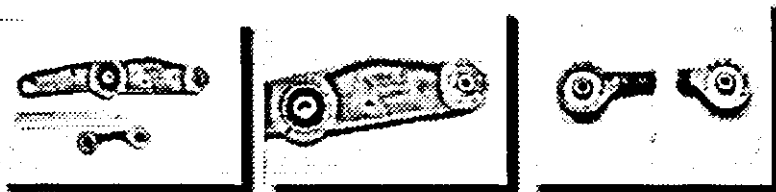
Examination of the Rudder System revealed the the Rudder Bell Crank Arm Assembly, Boeing P/N 15-23765 and the Rudder Boost Control Link Assembly, Boeing P/N 6-38900 were broken. The broken assemblies were removed and forwarded to the NTSB Metallurgist for fracture analysis. The fractures were typical of bending overload breaks.

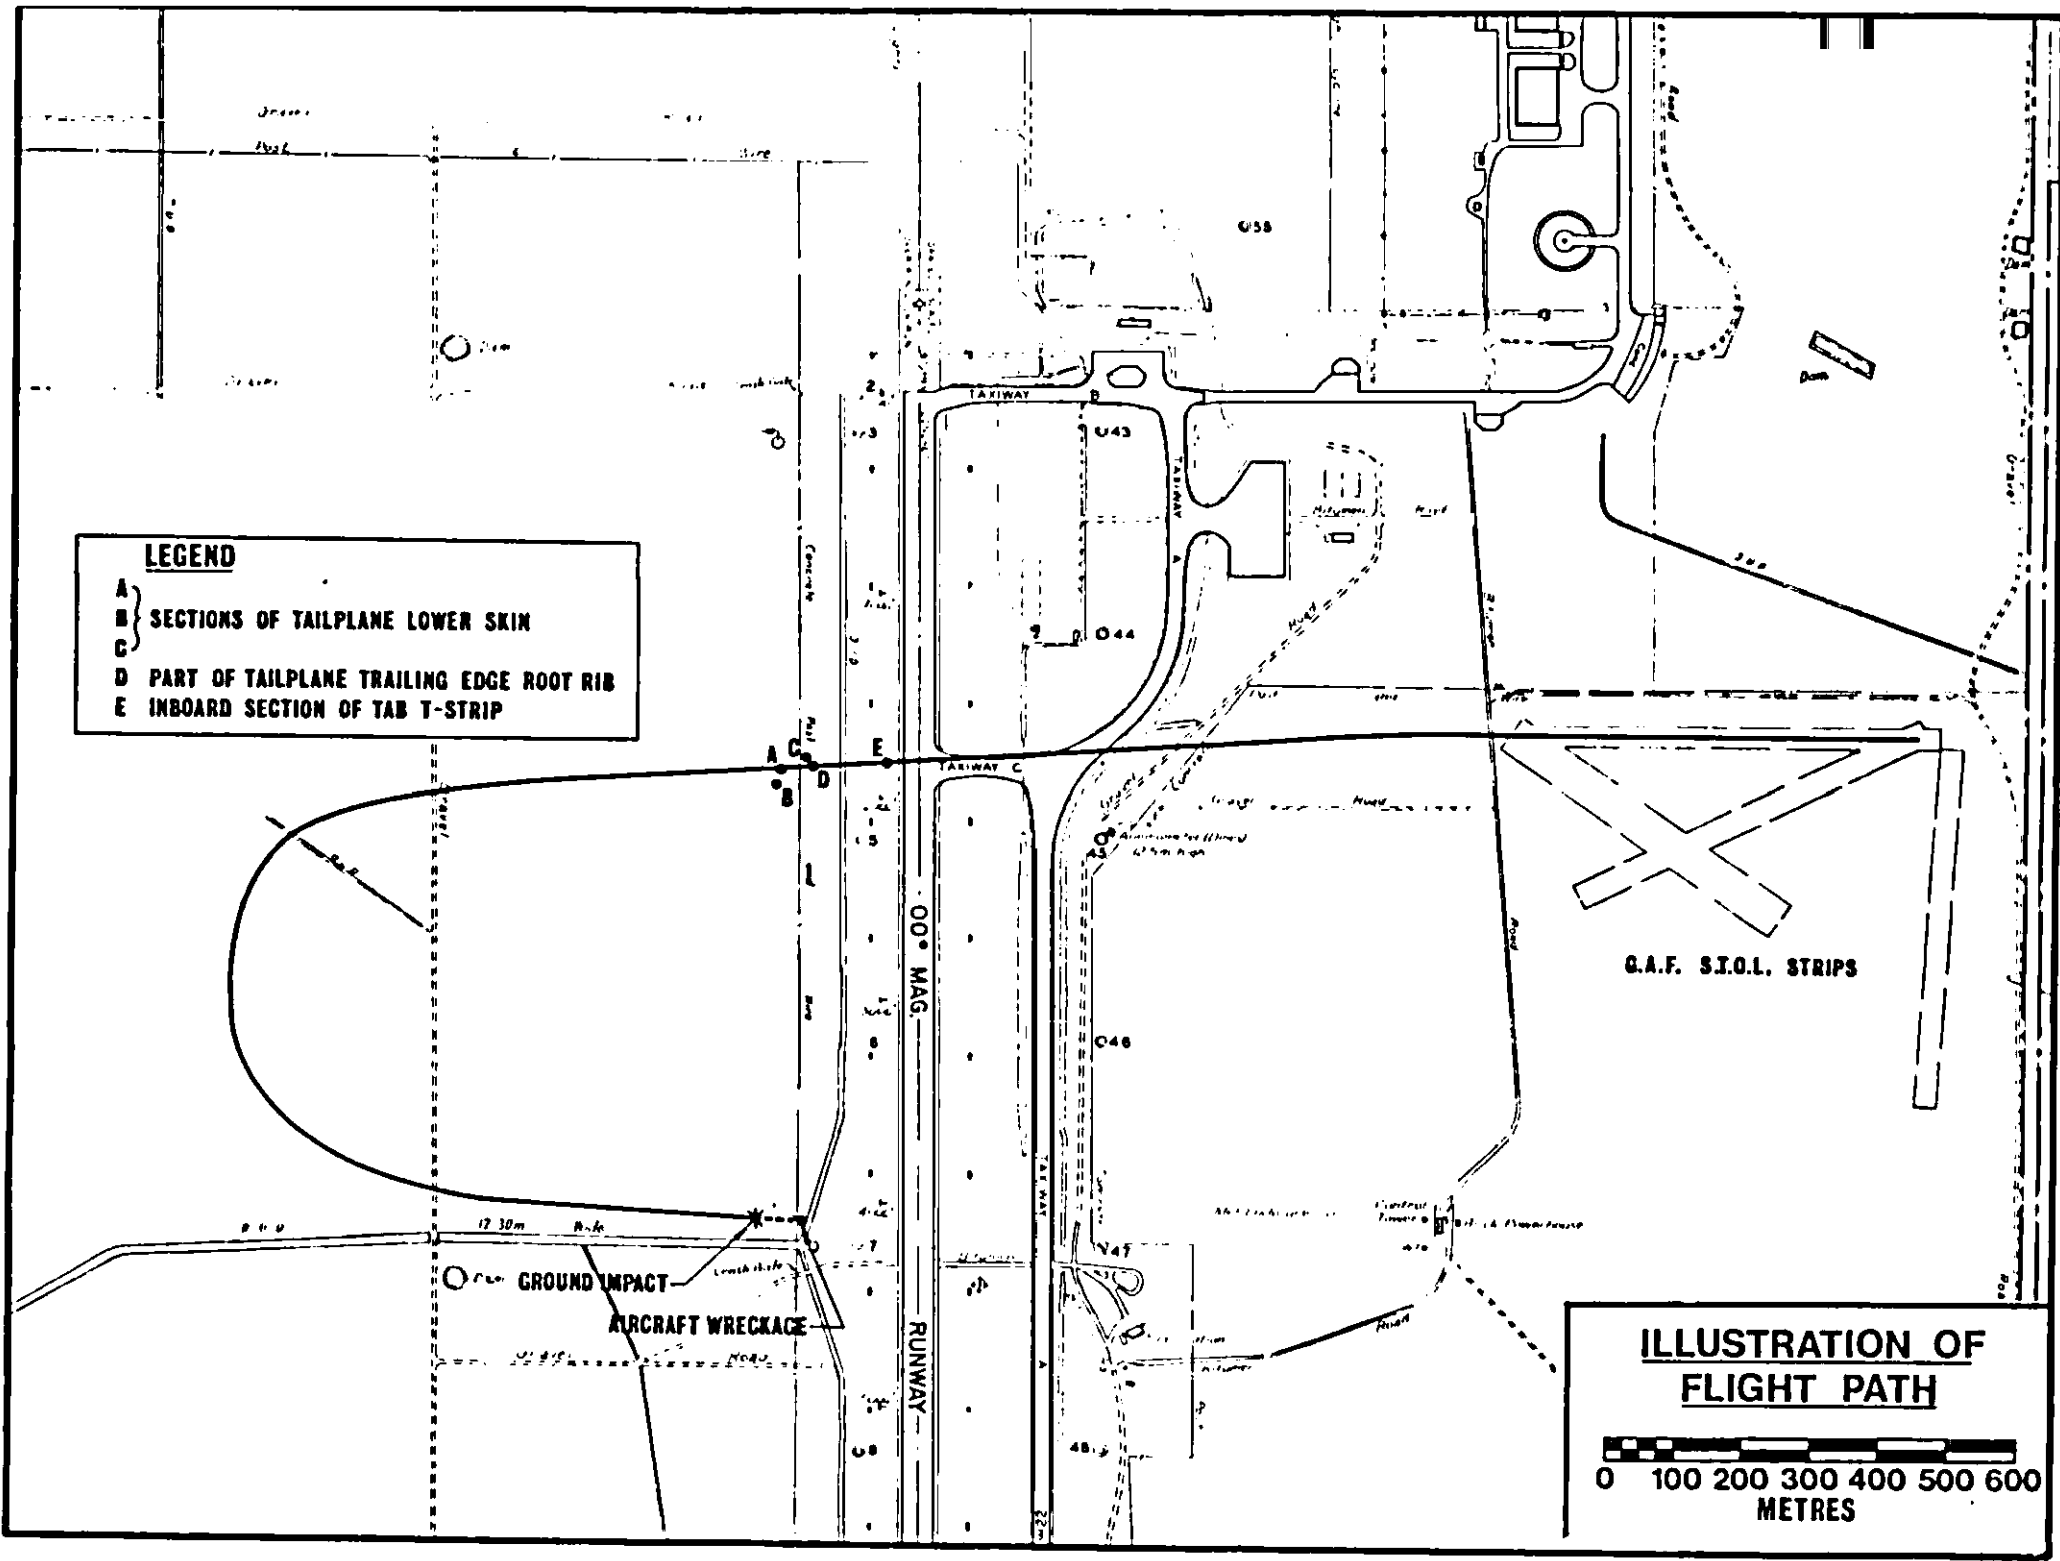
**LEGEND**

- A } SECTIONS OF TAILPLANE LOWER SKIN
- B } SECTIONS OF TAILPLANE LOWER SKIN
- C } SECTIONS OF TAILPLANE LOWER SKIN
- D PART OF TAILPLANE TRAILING EDGE ROOT RIB
- E INBOARD SECTION OF TAB T-STRIP

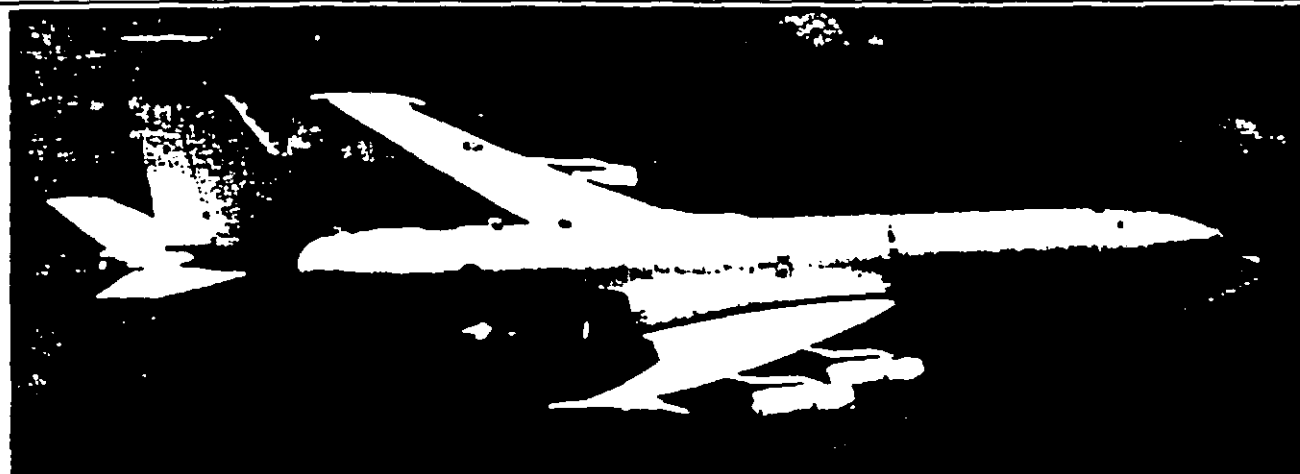
The Navy and Boeing Aerospace have agreed to delay delivery of the E-6A Tacamo submarine communications aircraft until there is a better understanding of why about a third of the tail surfaces broke off during flutter testing in February (AW&ST Mar. 6, p. 23). Delivery of the first aircraft was to have taken place on Apr. 28.
