SJ30-2 SN002 Flight 211 4-26-03

SSAC SJ30-2 Flight 231: Post Flight Briefing

On April 26, 2003 at approximately 1005 CDT, a Sino Swearingen SJ30-2, N138BF, was destroyed when it impacted terrain north of Del Rio, Texas. The certificated airline transport pilot was fatally injured. Visual meteorological conditions prevailed and an instrument flight rules flight plan was filed. The experimental test flight was conducted under 14 CFR Part 91. The accident airplane and the accompanying T-38 chase plane (shown in Figure 1) departed San Antonio International Airport (SAT), San Antonio, Texas, at approximately 0911 to conduct high speed flight flutter testing north of Del Rio, Texas.

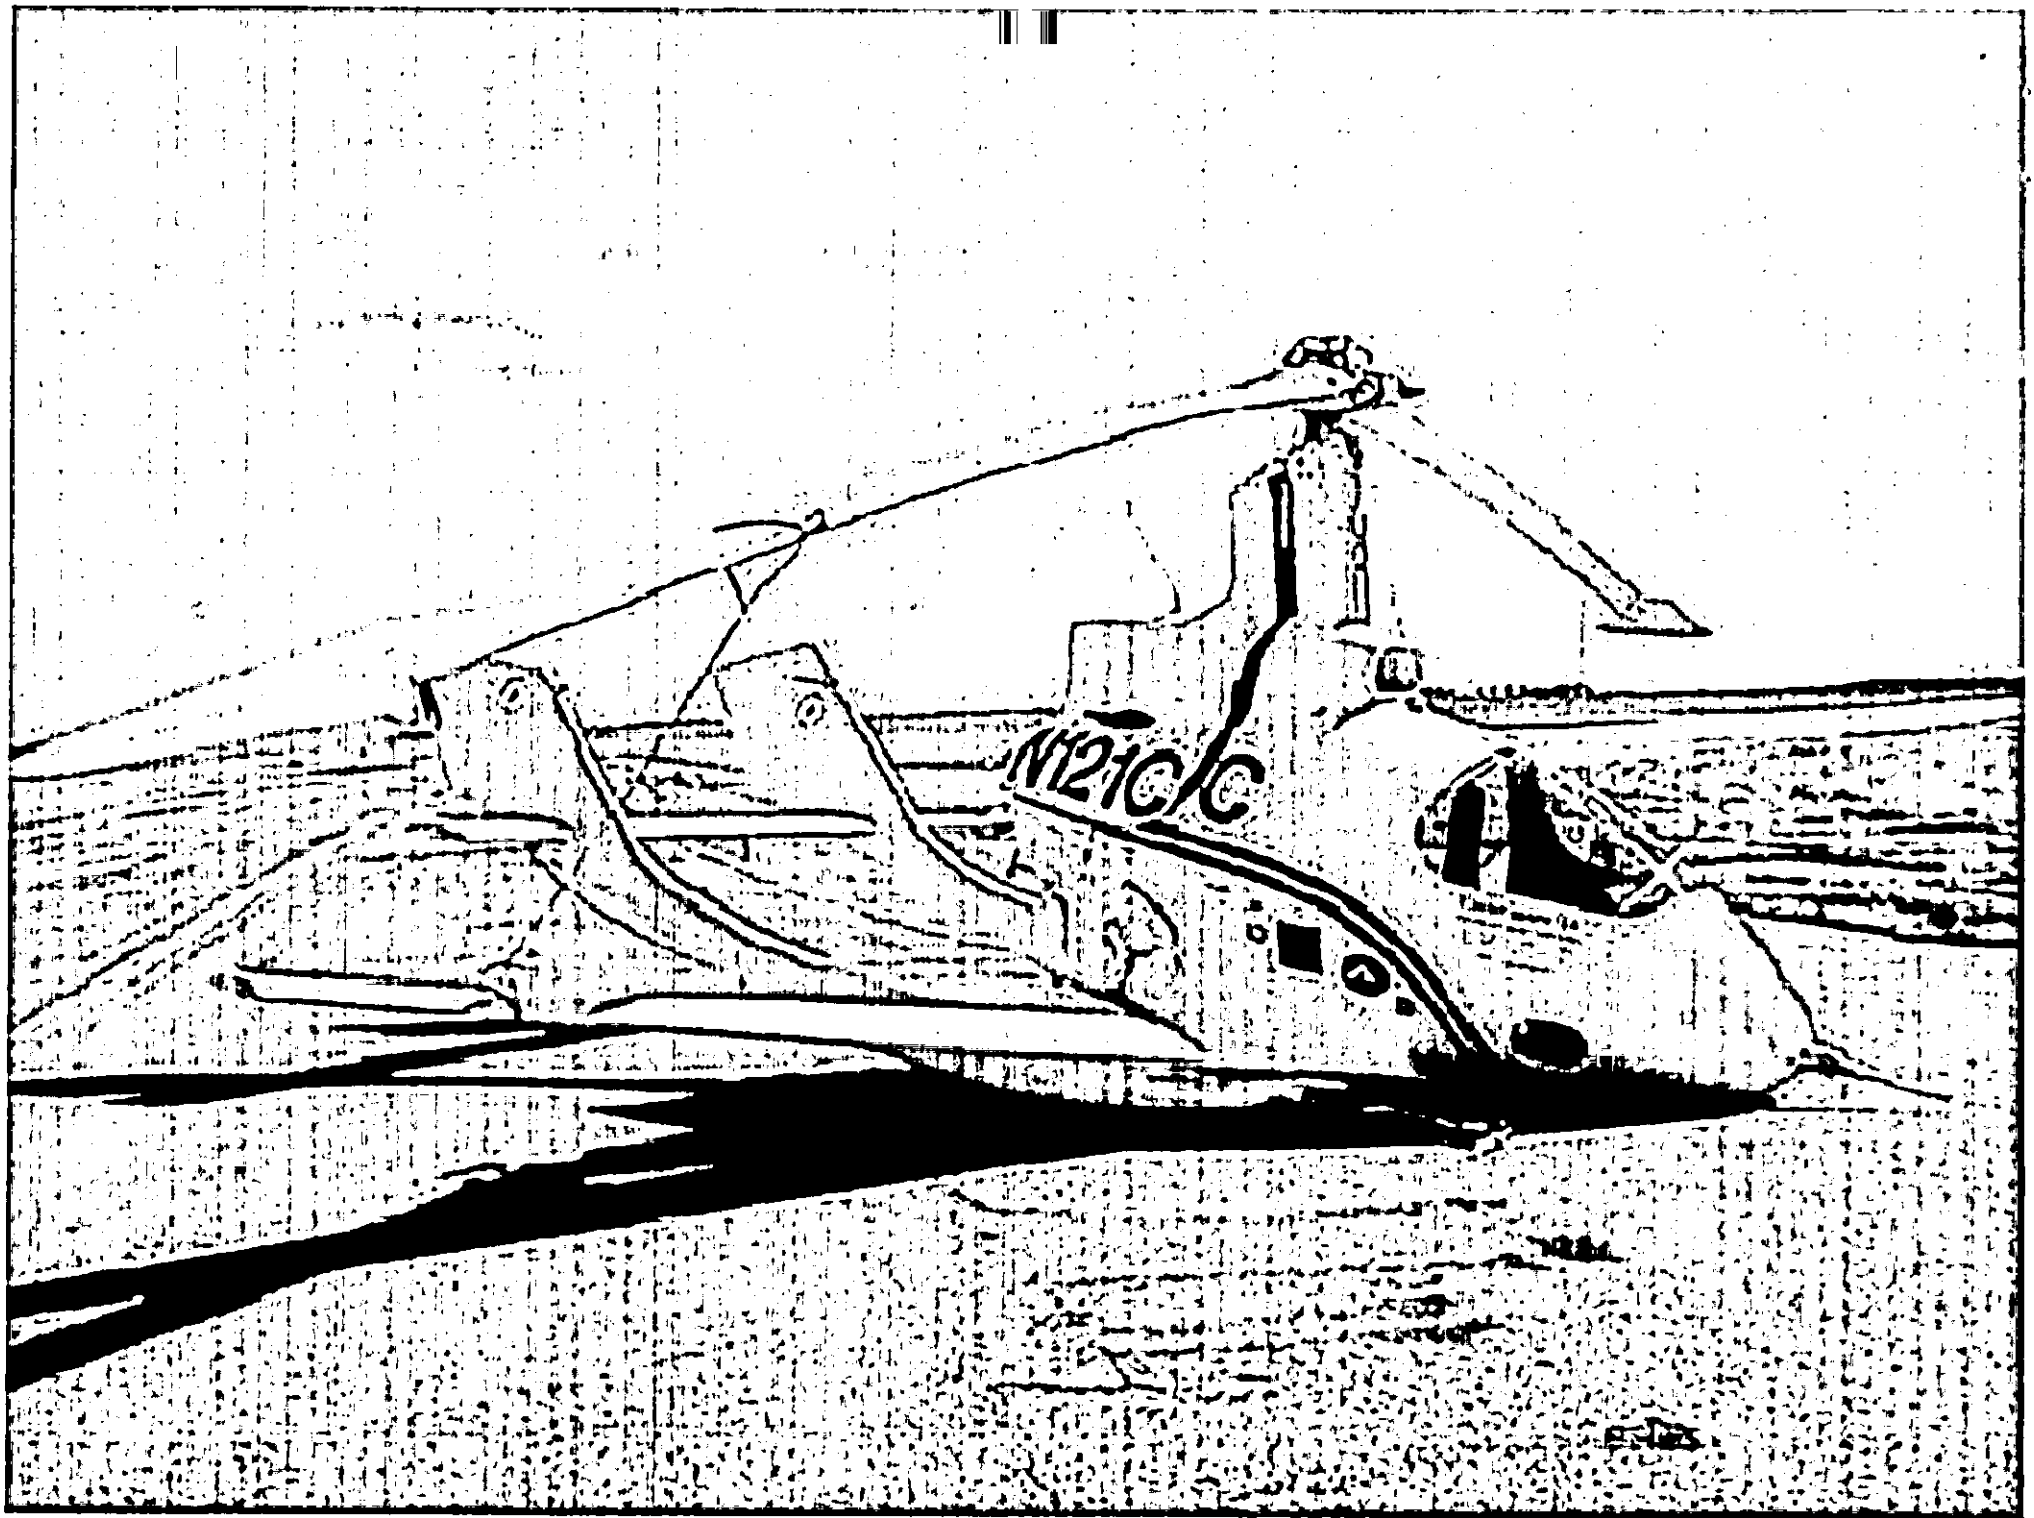
Photo. General view of the gyrocraft's fuselage damage.

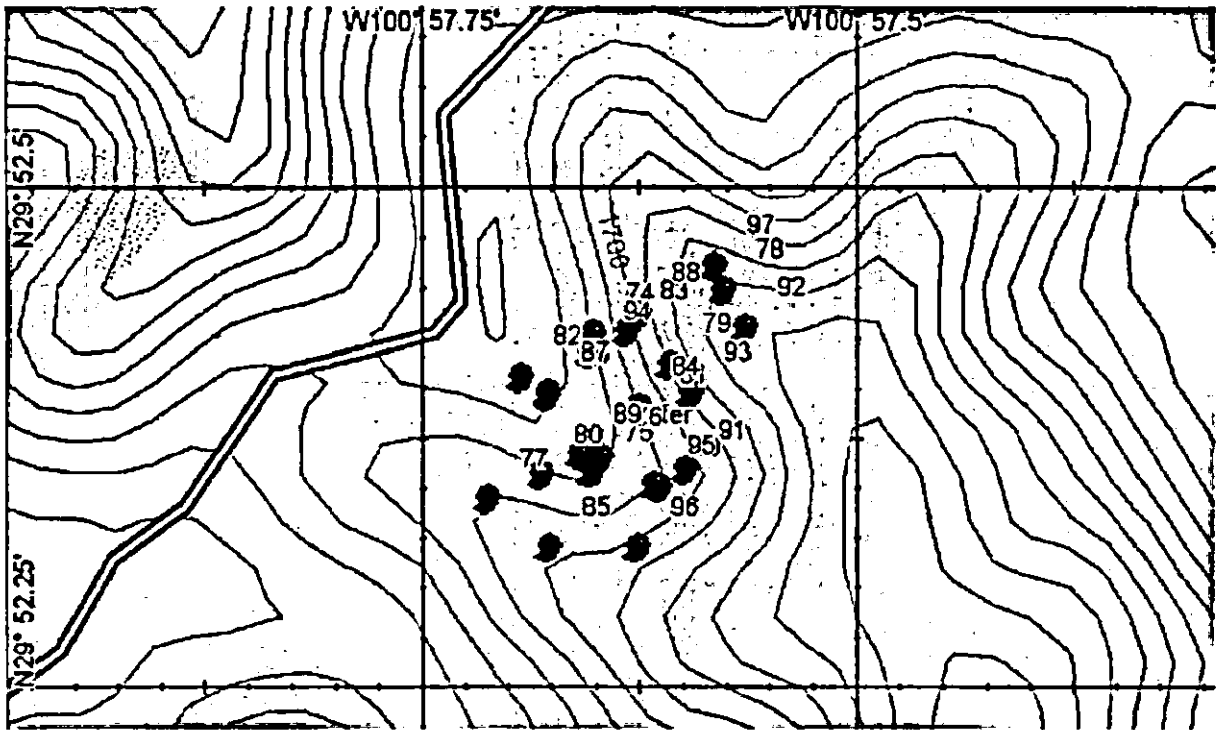
Figure 2: Location of main portions of wreckage distribution. See the Structures Group Chairman's Factual Report, Attachment A for identifier definitions.

Distribution of the wreckage around the crater did not show any obvious direction of travel or horizontal velocity, although there appeared to be considerably more wreckage east and north of the crater than south and west. Witnesses in the T-38 chase plane stated that the airplane maintained approximately the same ground track from initiation of the event to impact with terrain.
