EMBRAER -120 Brasilia Simulated Ice Shapes Incident

Flight Test Safety Workshop
Seattle May/2012

This presentation intends to cover some technical aspects of an EMB-120 Brasilia incident which happened during one of the last test flights of Inter-cycle Ice Evaluation performed in the Prototype EMB-120 s/n 001 (PT-ZBA) at early 01's, and also emphasizes the organization and procedural changes and lessons learned resulting from that incident.

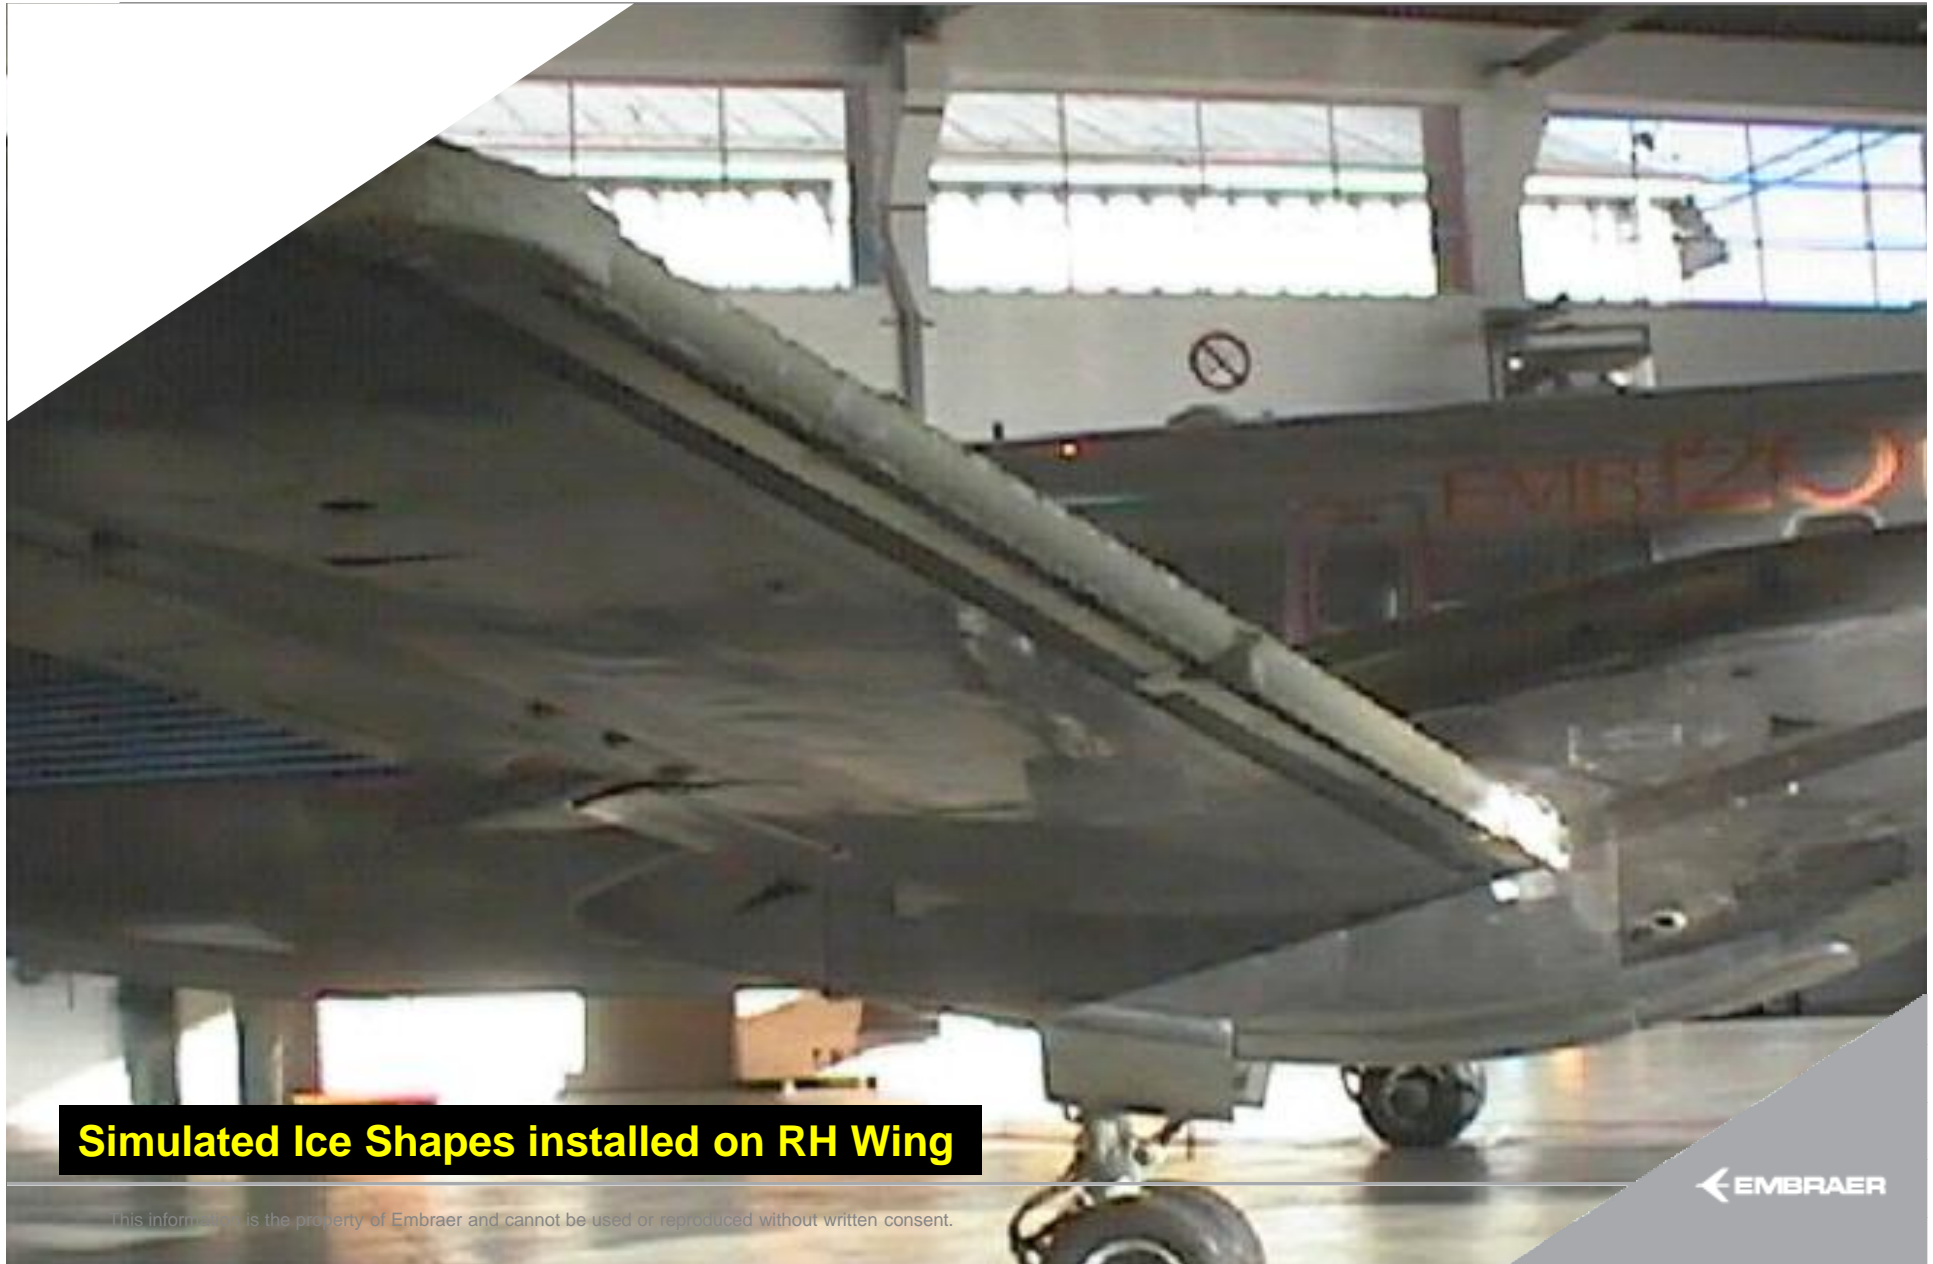
Simulated Ice Shapes installed on RH Wing

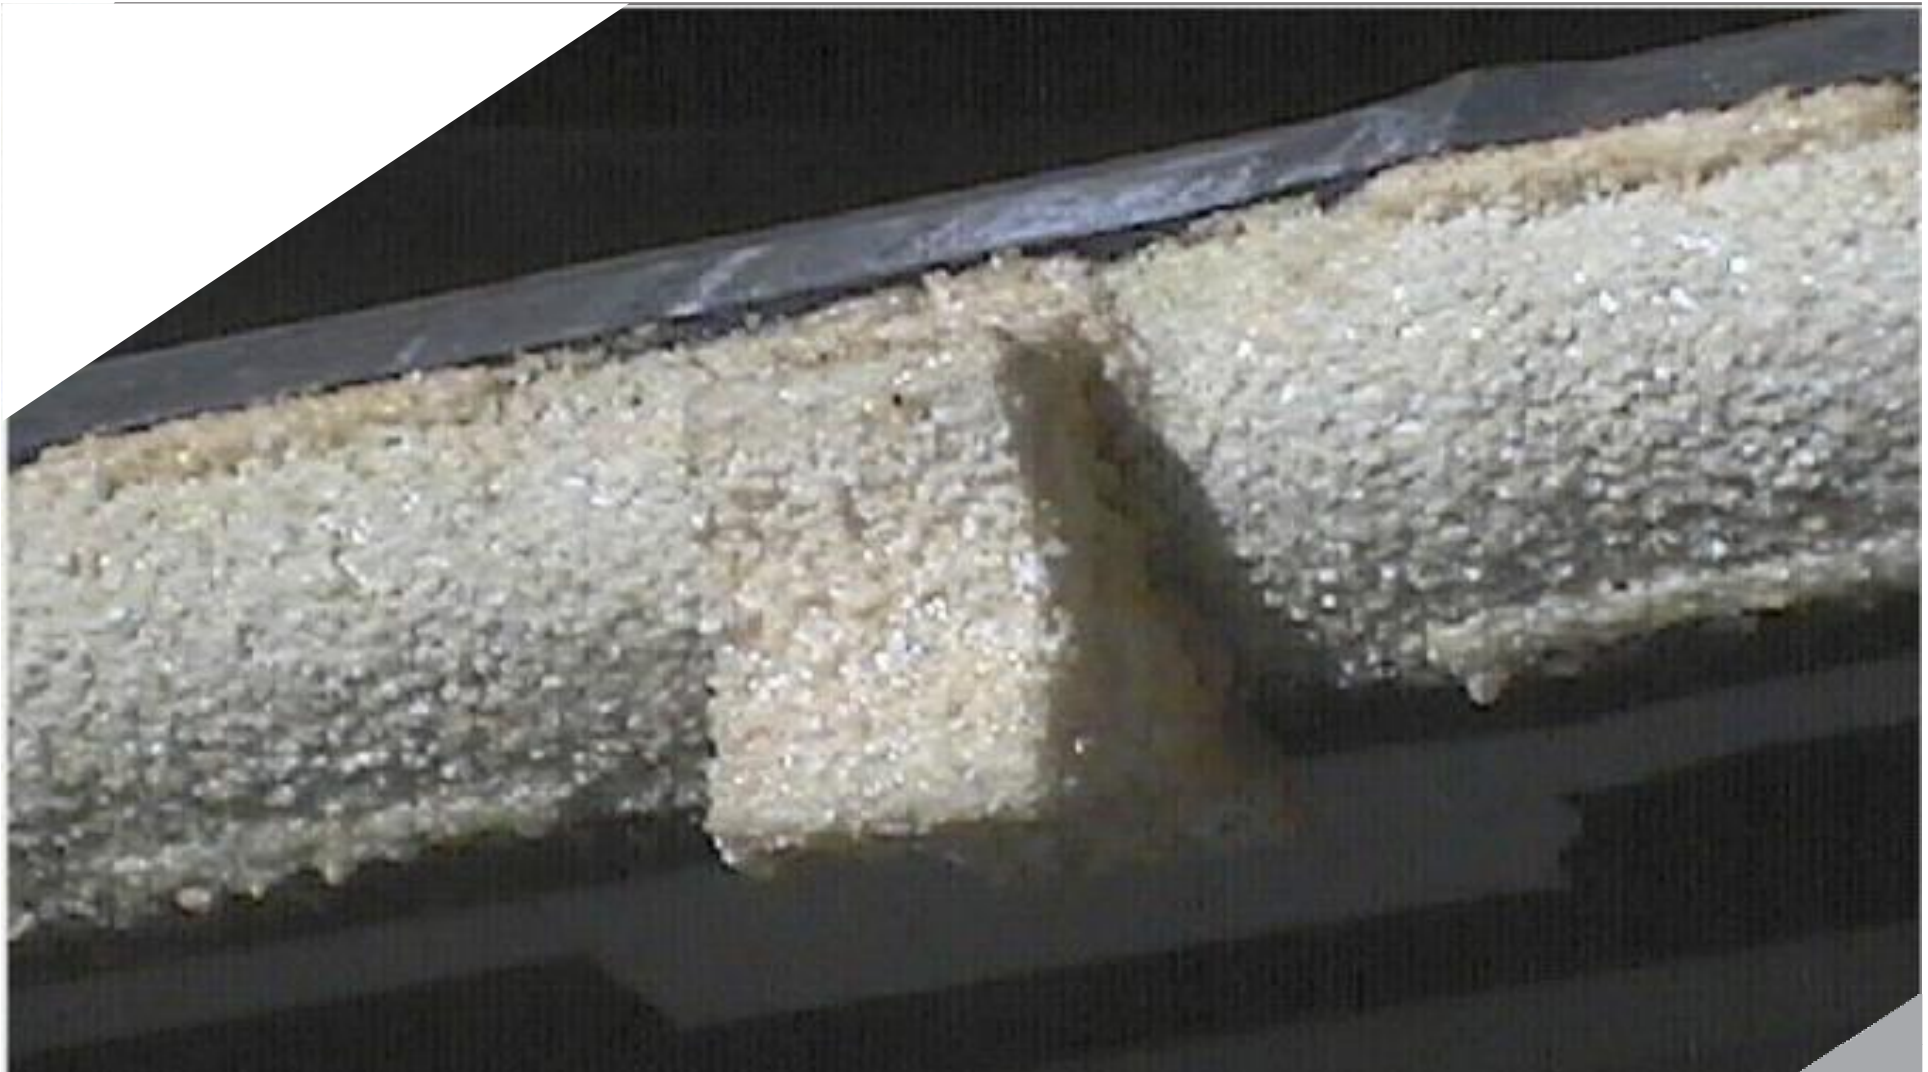
Inter-Cycle Ice & Unprotected Areas Ice Shapes

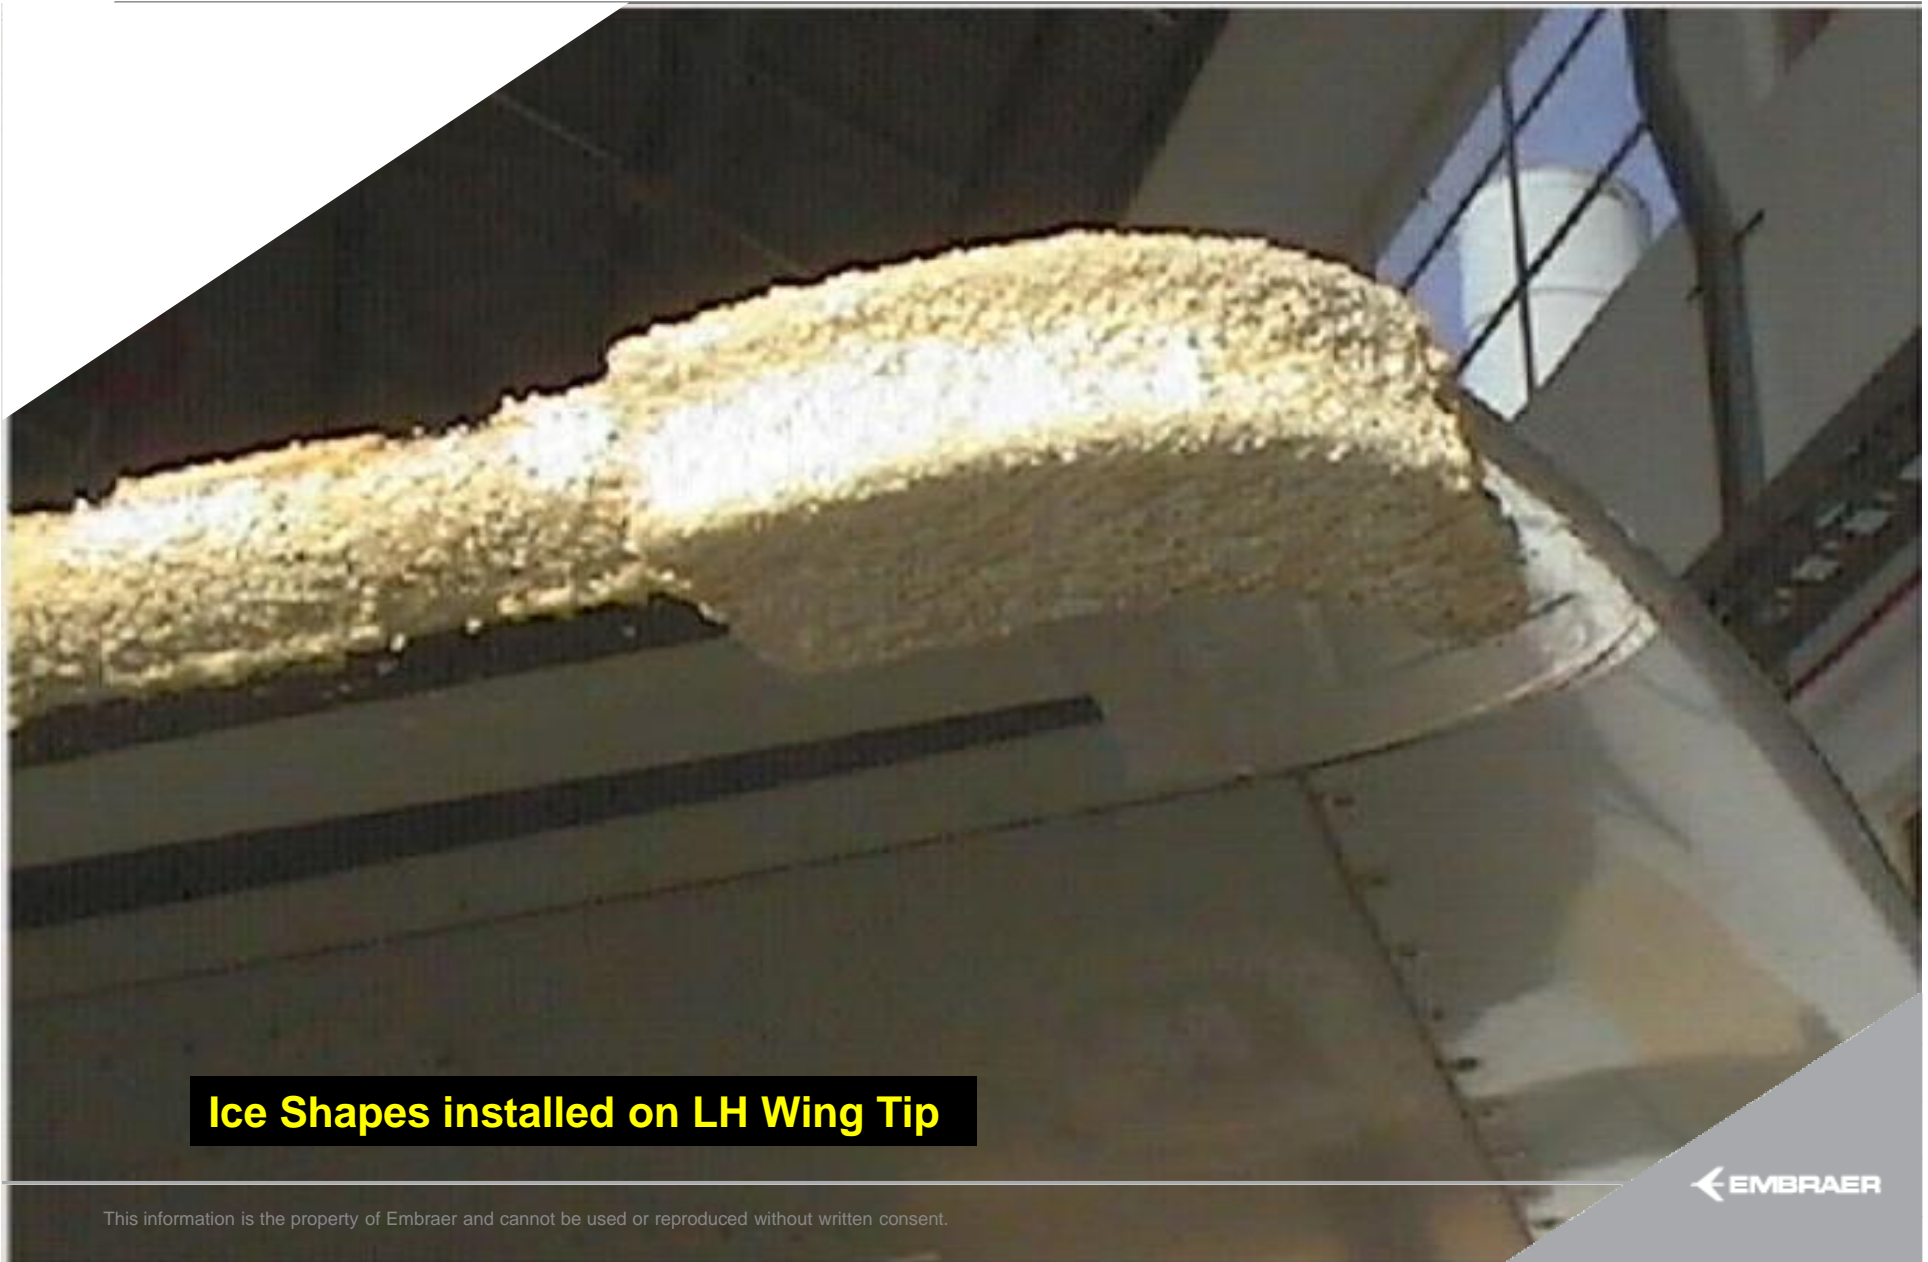
Ice Shapes installed on LH Wing Tip

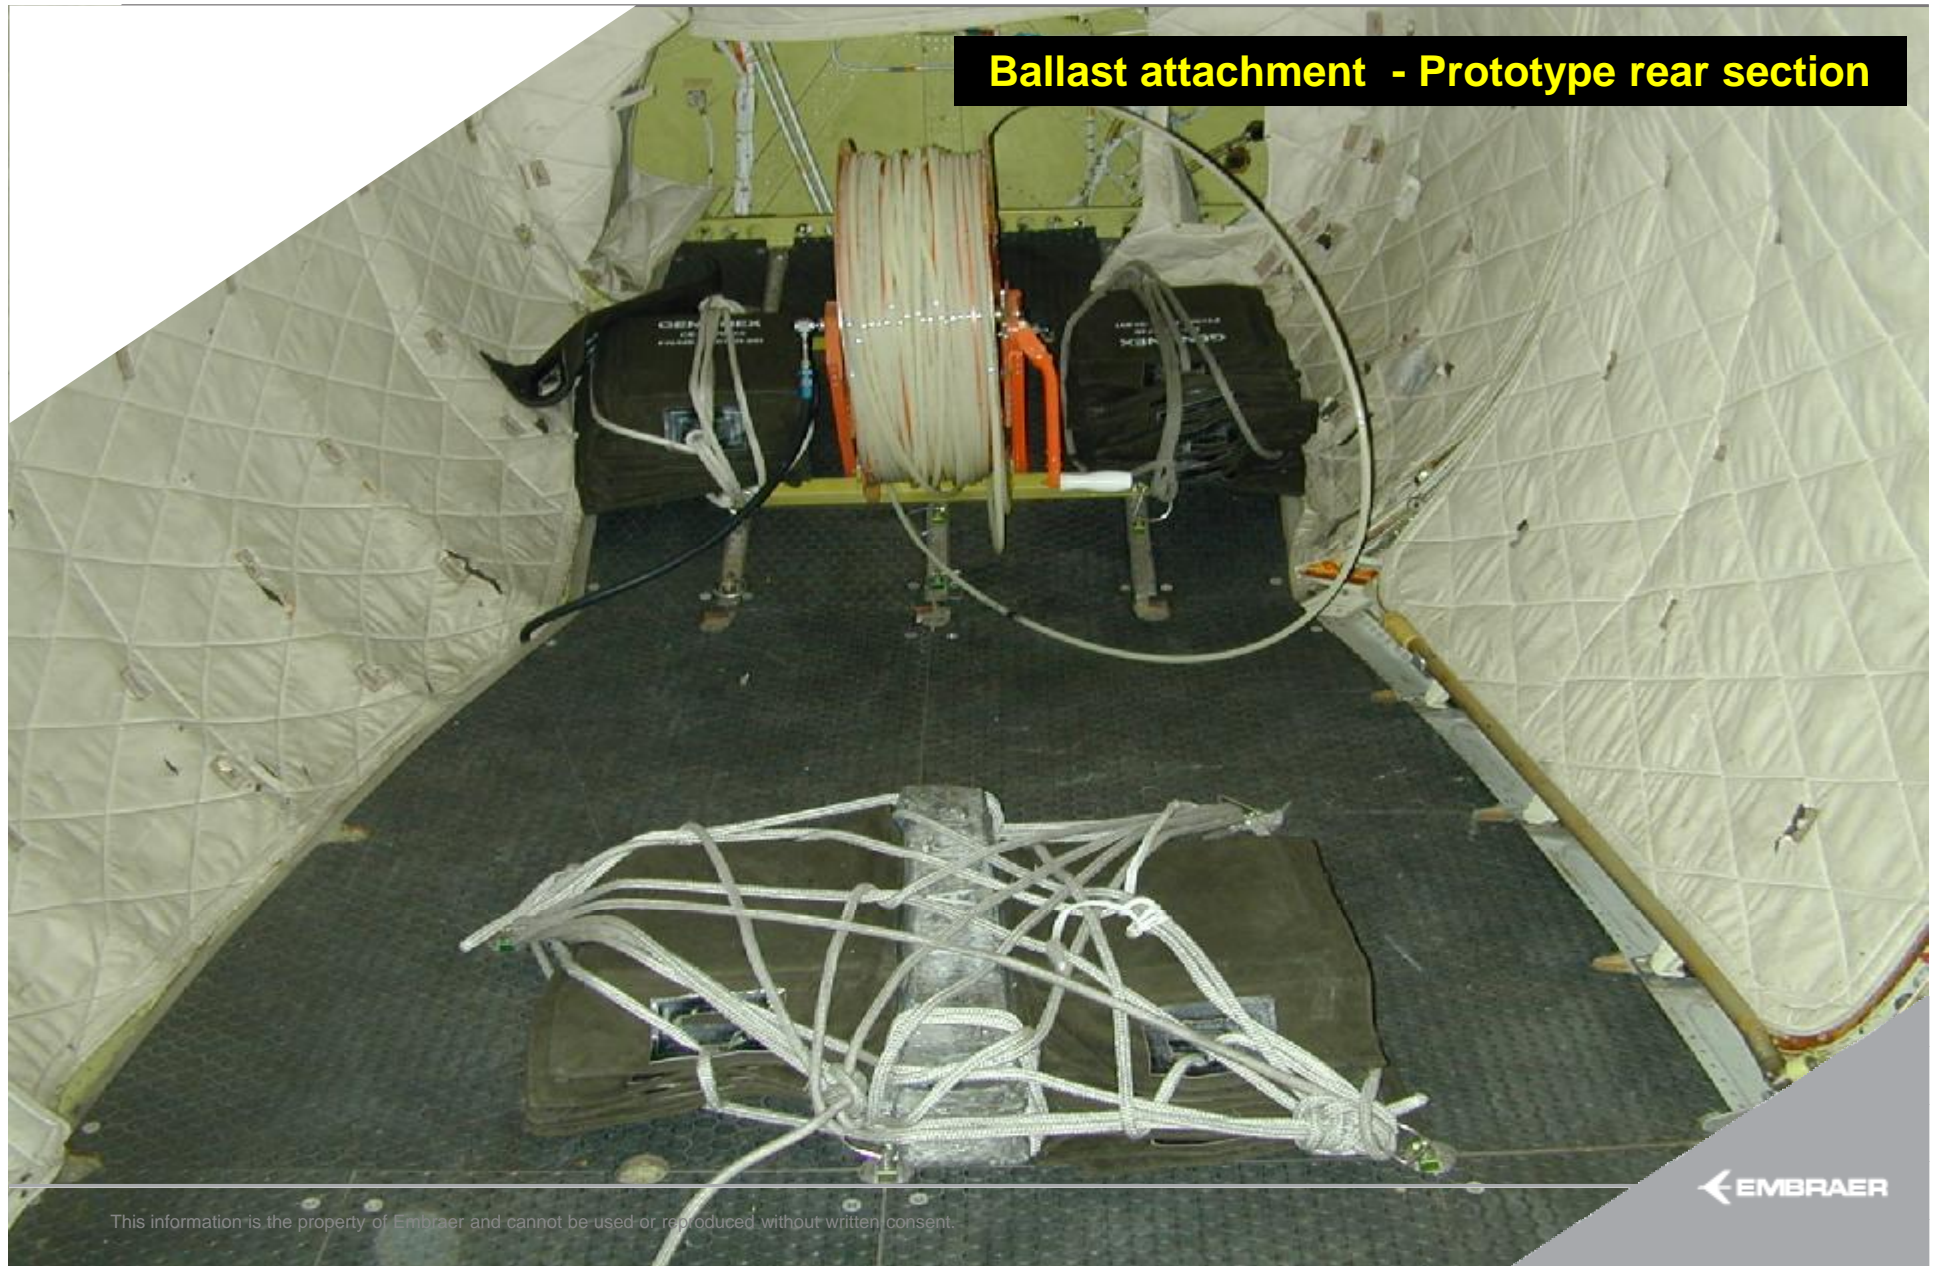
- Ø Prototype not fully representative from series aircraft and difficult to maintain
- Ø Lack of good Configuration Control and Tech Publications
- Ø Aircraft was parked outside Hangar for a long time
- Ø Lack of inspections on the Ice shapes (Horizontal Stabilizer)
- Ø Poor plumb ballast attachment
- Ø No FDR installation, only FTI data

Ballast attachment - Prototype rear section

- Ø Complete redesign of all ballast attachment devices
- Ø New Artificial Ice Shapes Adhesives / Resins and Materials are now employed
- Ø For longer Flight Test Campaigns, any “special equipment/device” installed shall have a dedicated appreciation regarding its “expiration time”
- Ø Ongoing Research Project for new Artificial Ice Shapes materials and gluing processes

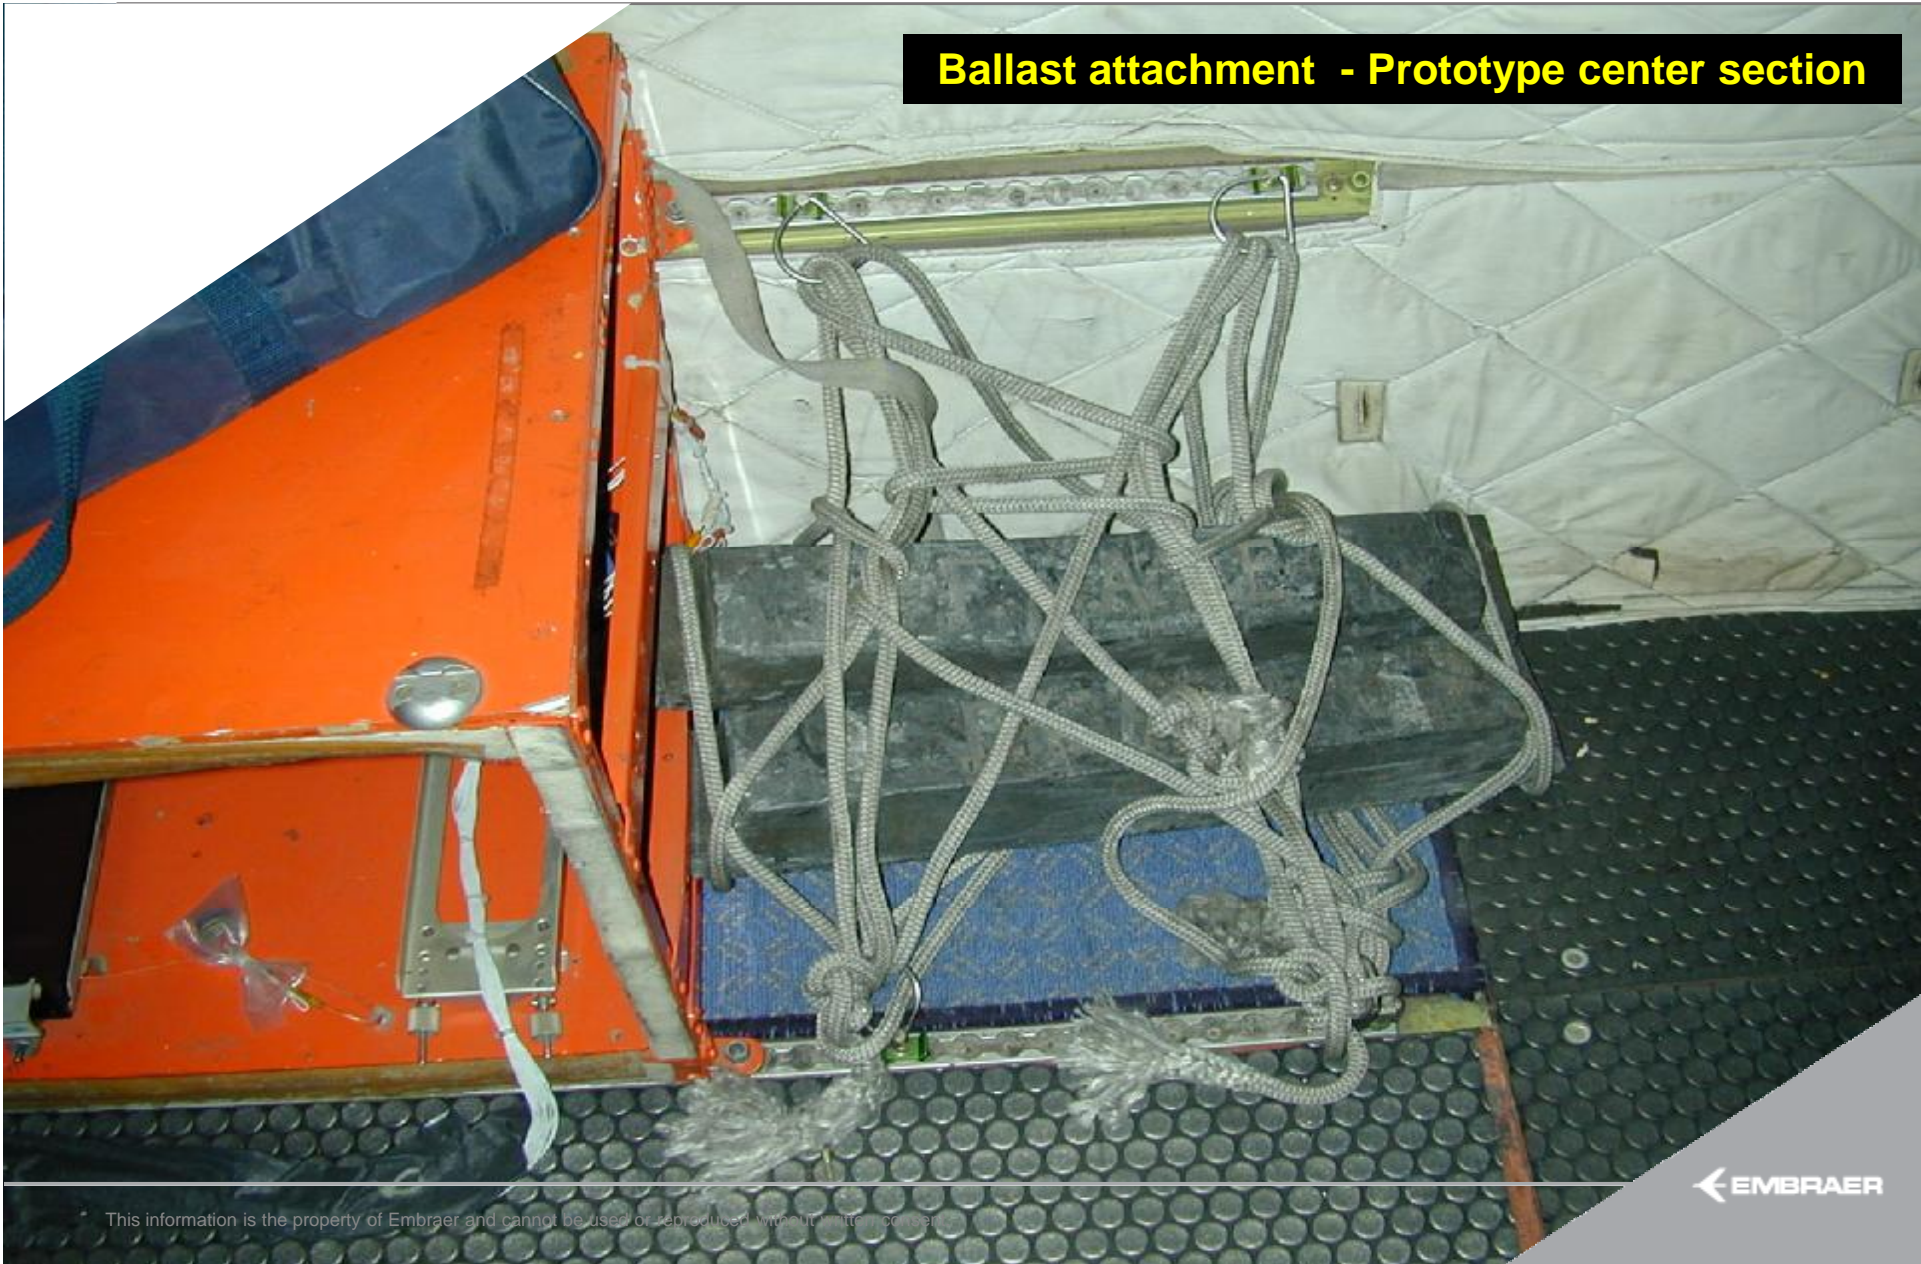
Ballast attachment - Prototype center section

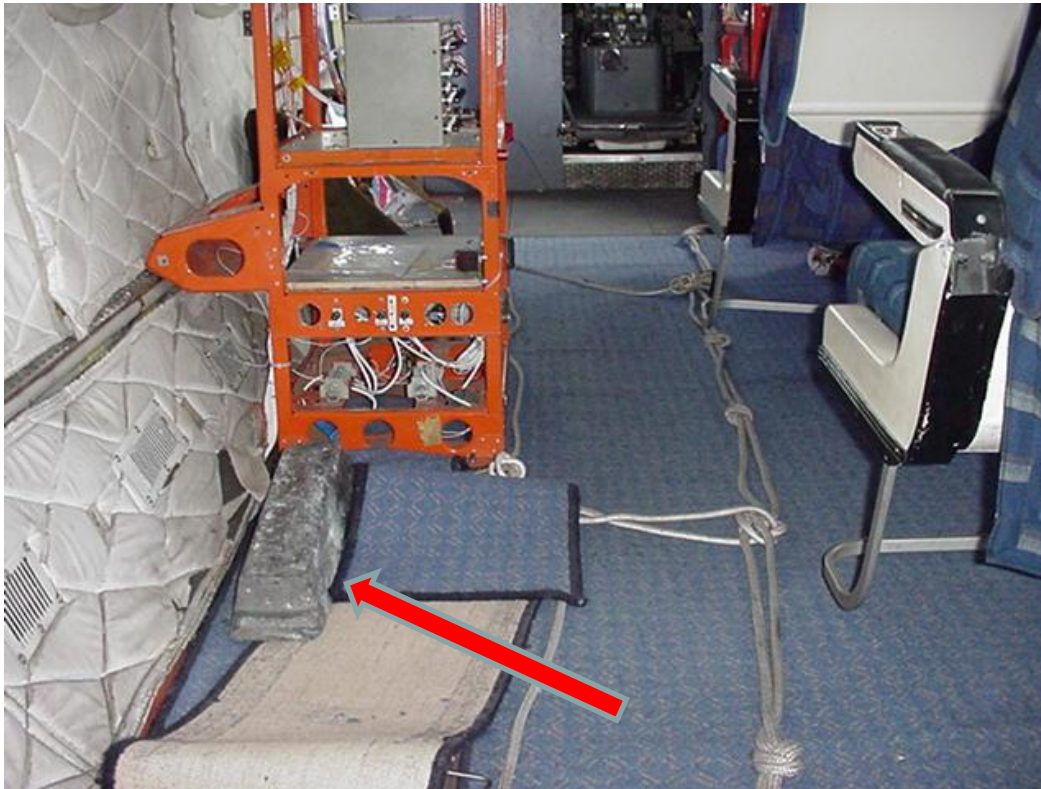
- Ø Several Ice shapes installed on the leading edges were damaged
- Ø Two plumb ballasts got loose during the nose down upset and damaged the aircraft superior fuselage and floor

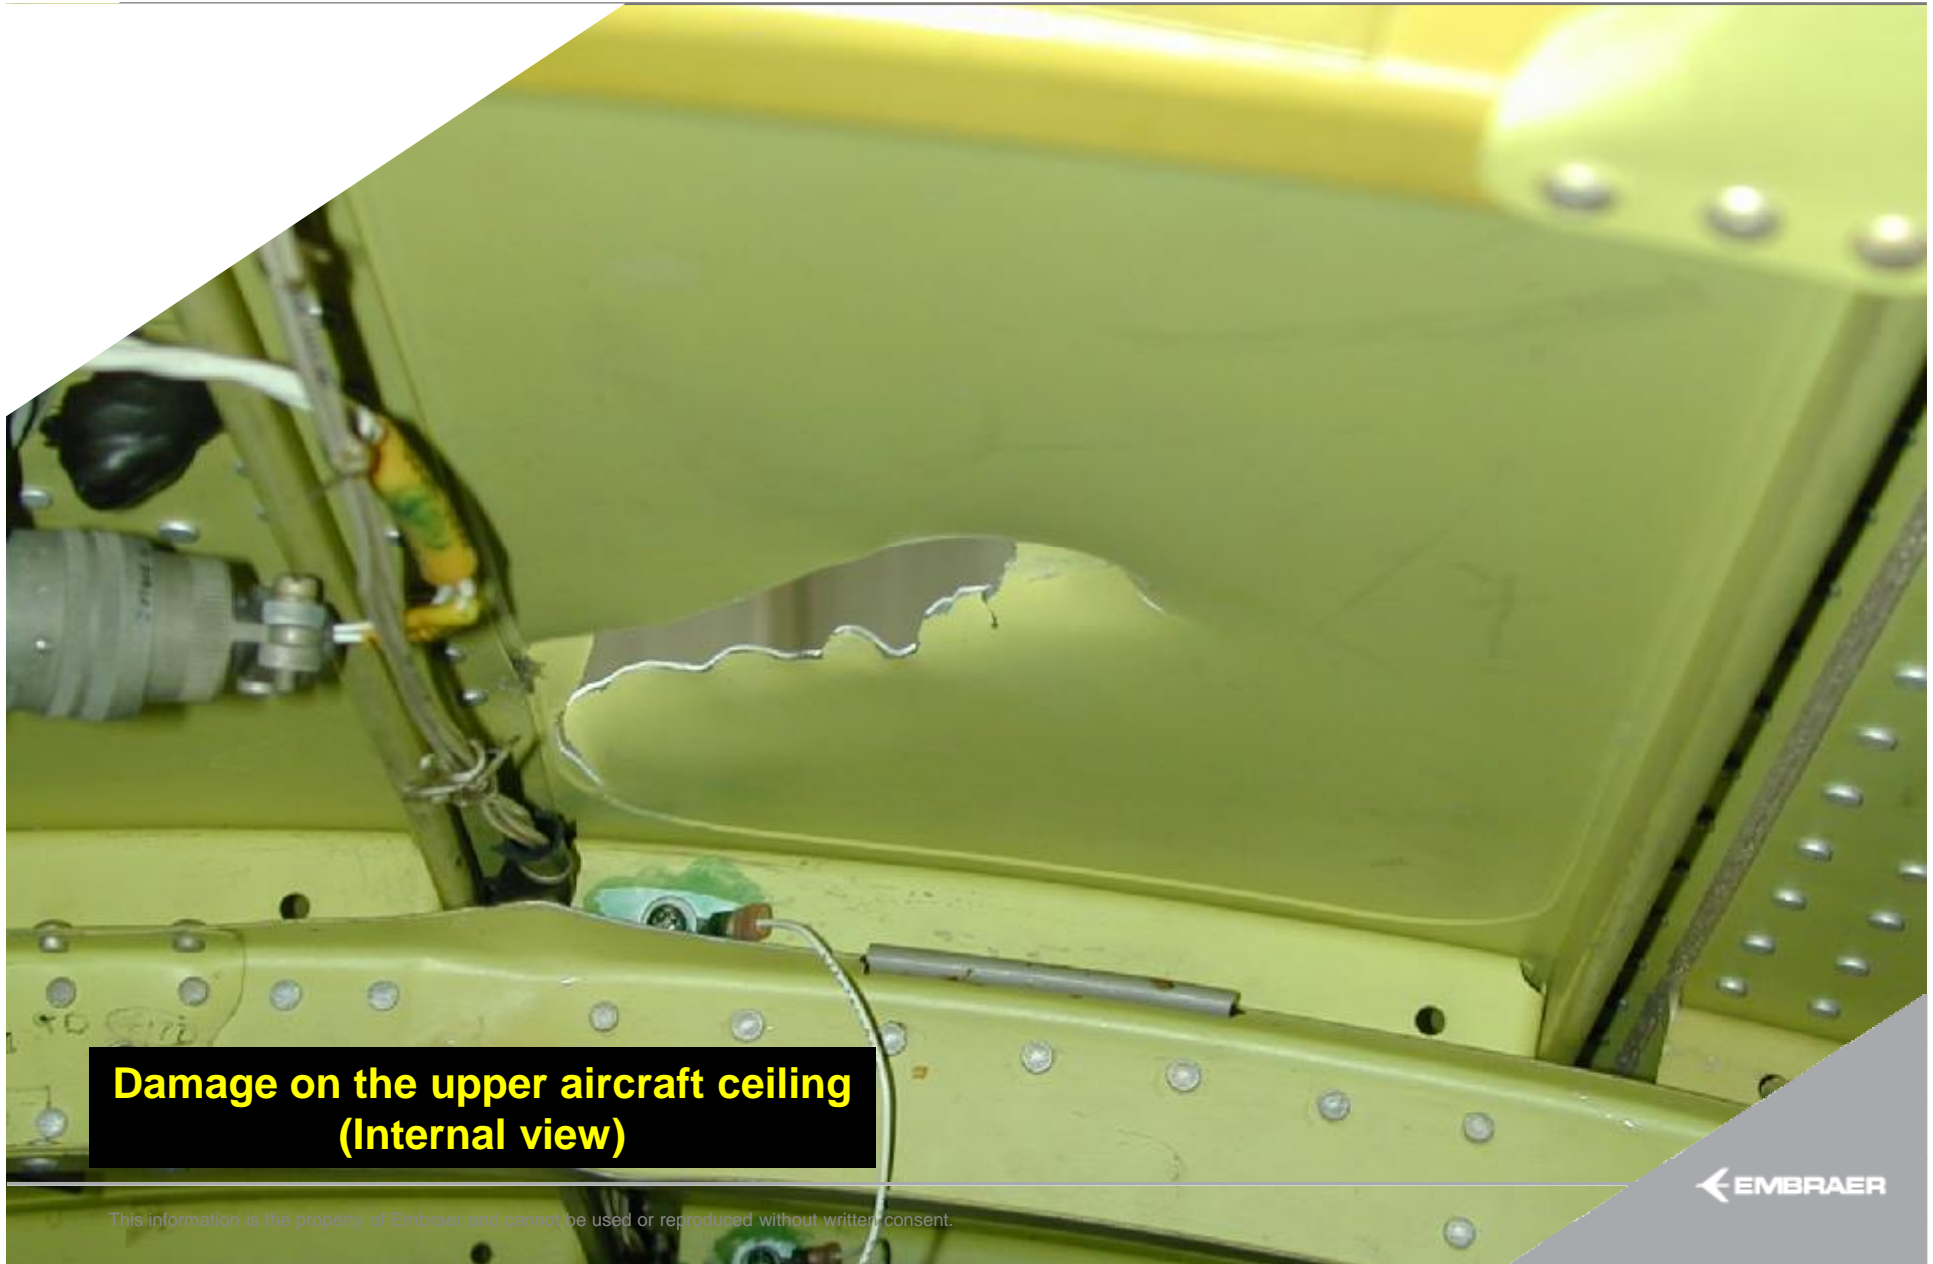
**Damage on the upper aircraft ceiling
(Internal view)**

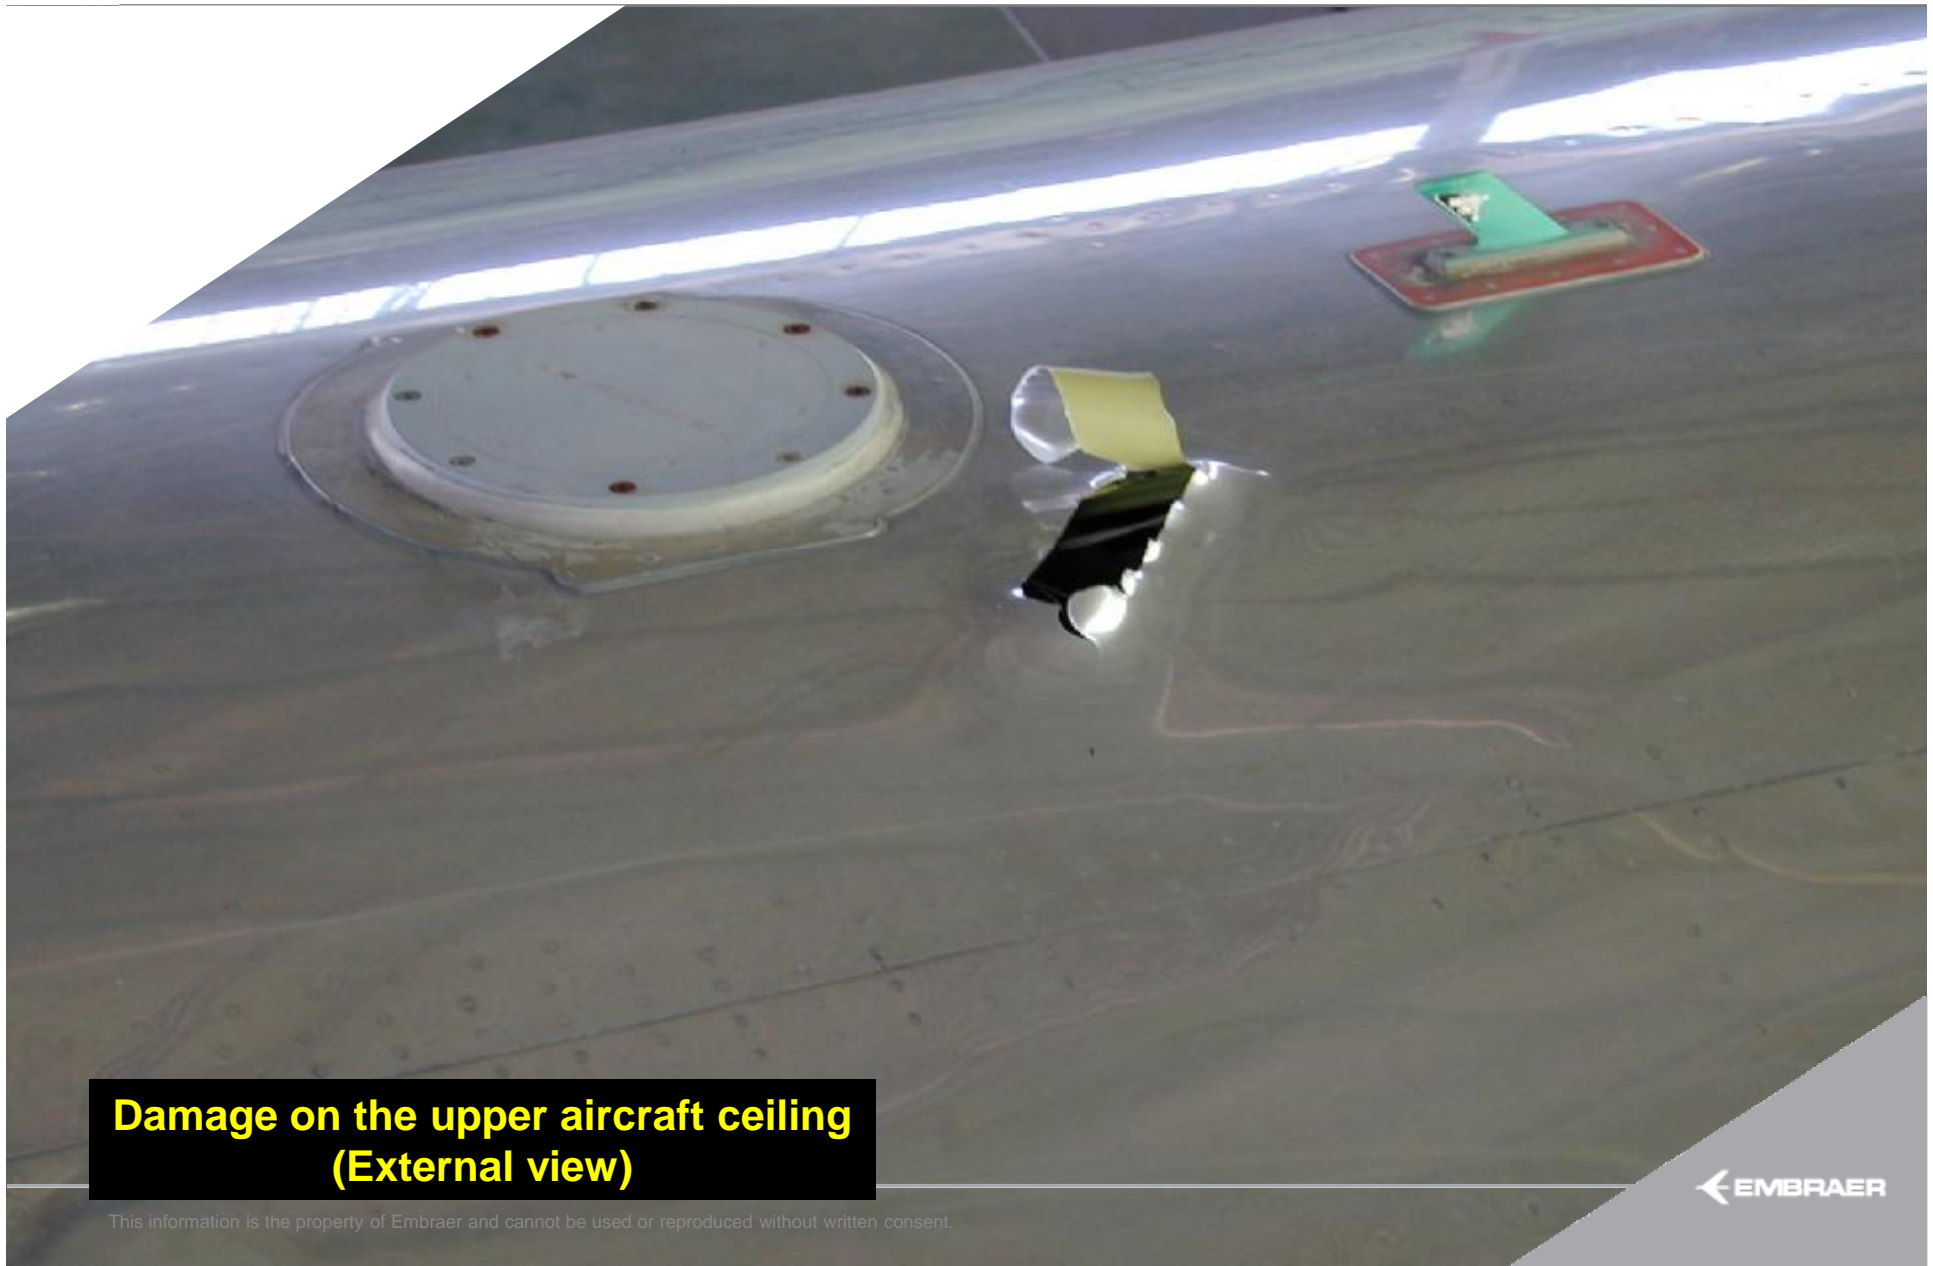
**Damage on the upper aircraft ceiling
(External view)**

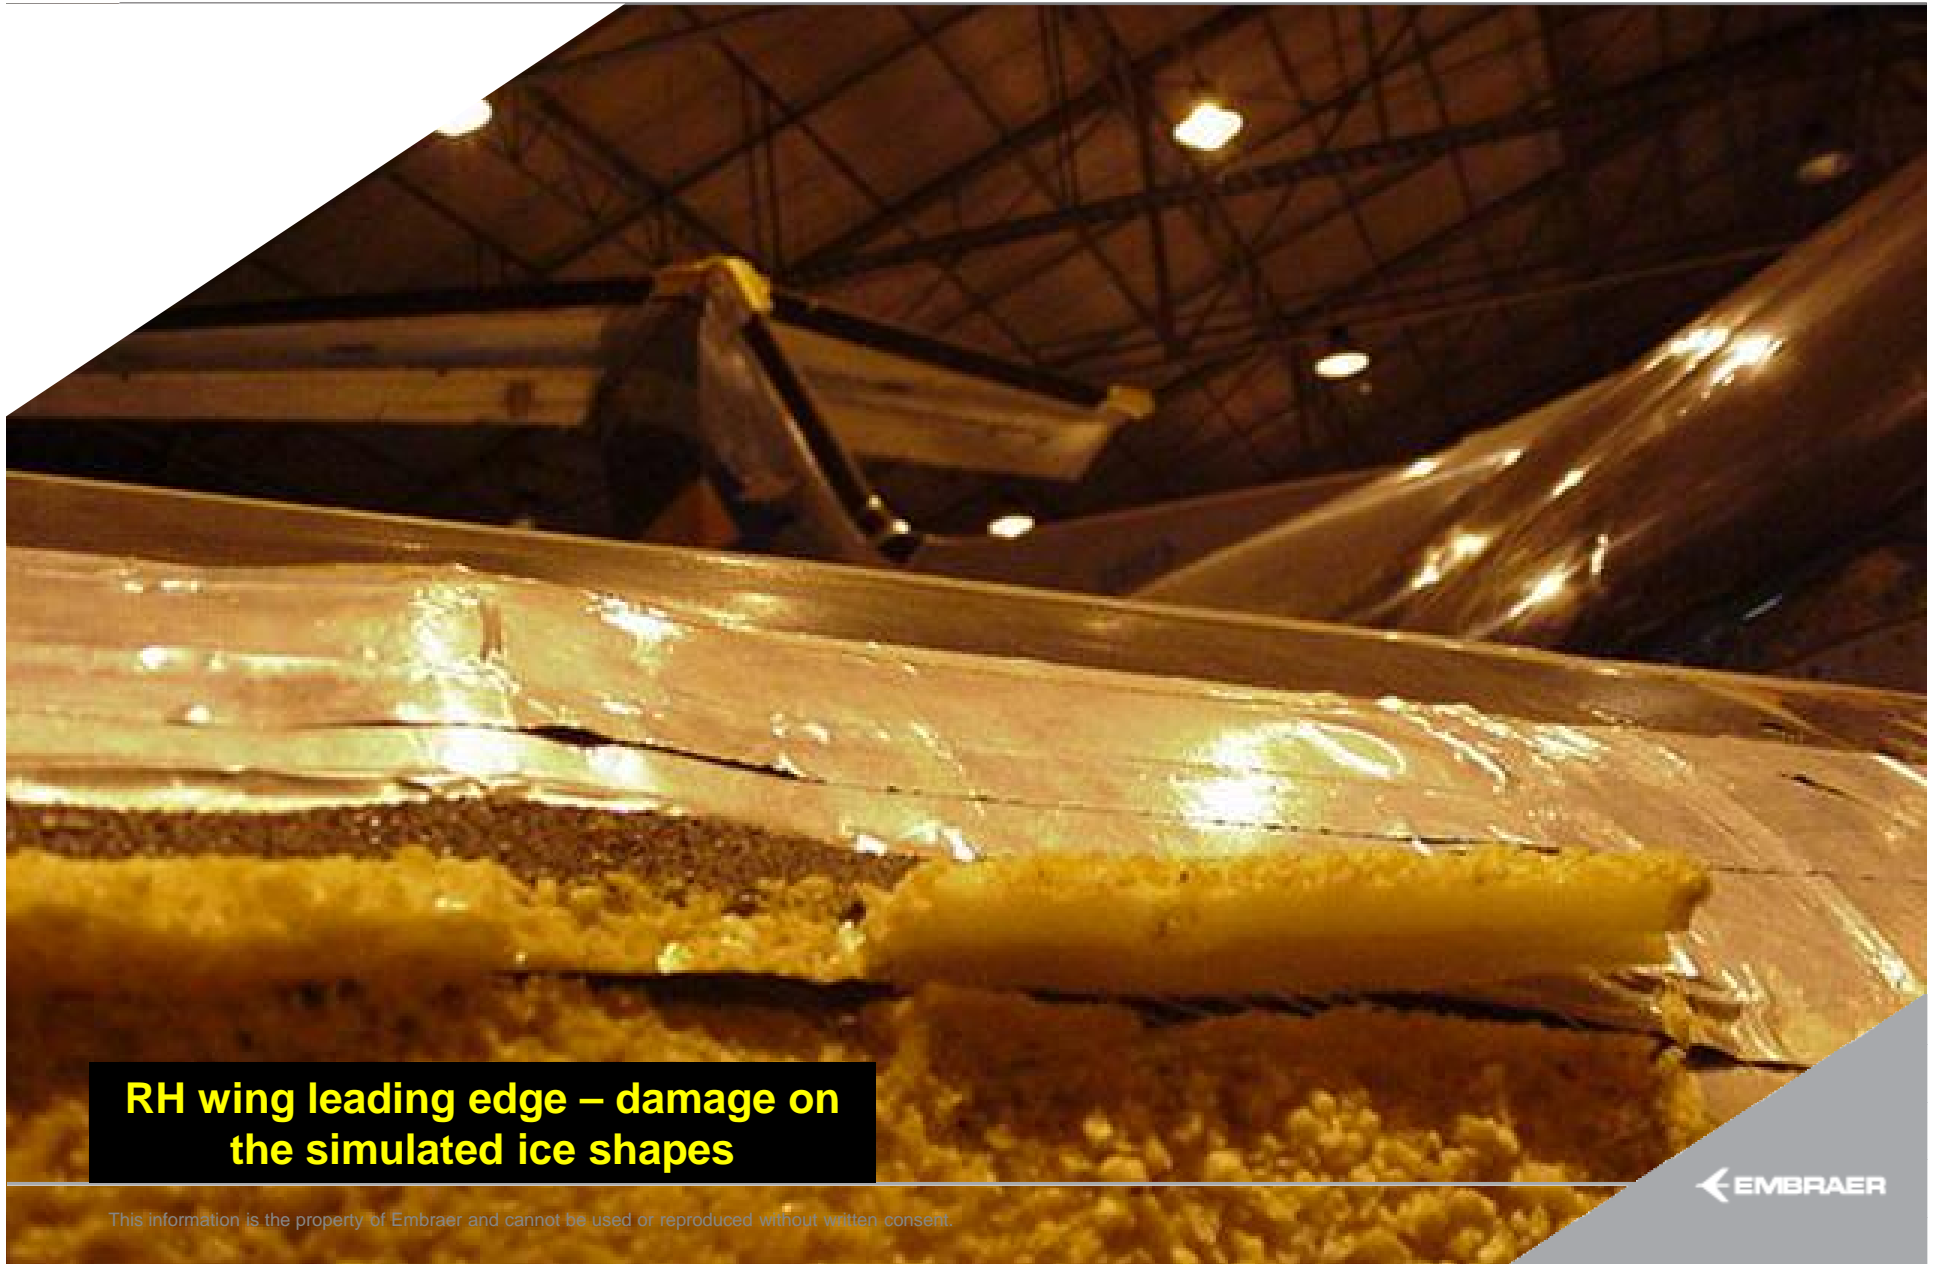
RH wing leading edge – damage on the simulated ice shapes

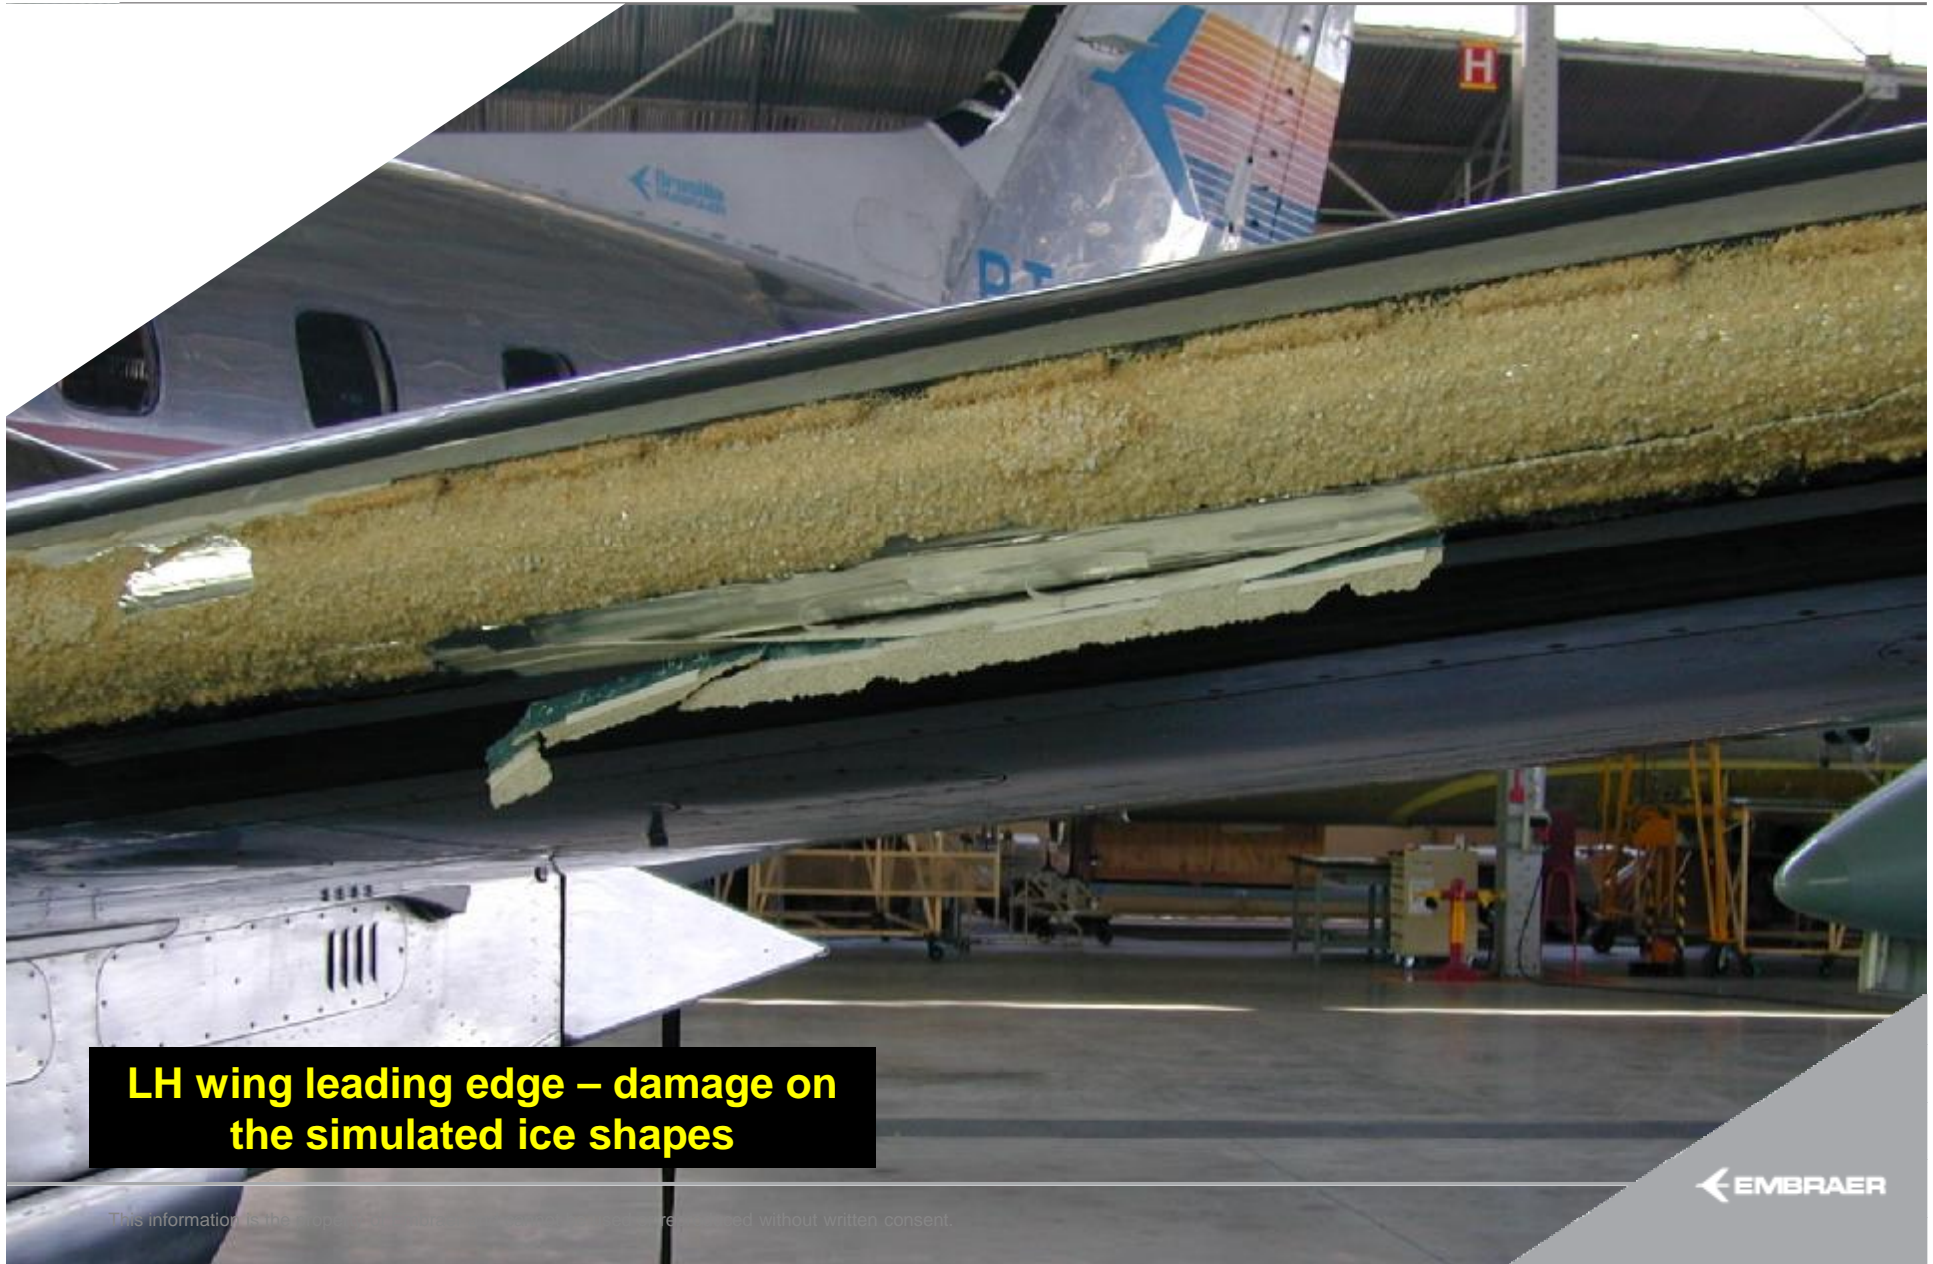
LH wing leading edge – damage on the simulated ice shapes
