EMBRAER -120 Brasilia Simulated Ice Shapes Incident

Flight Test Safety Workshop
Seattle May/2012

This presentation intends to cover some technical aspects of an EMB-120 Brasilia incident which happened during one of the last test flights of Inter-cycle Ice Evaluation performed in the Prototype EMB-120 s/n 001 (PT-ZBA) at early 01's, and also emphasizes the organization and procedural changes and lessons learned resulting from that incident.

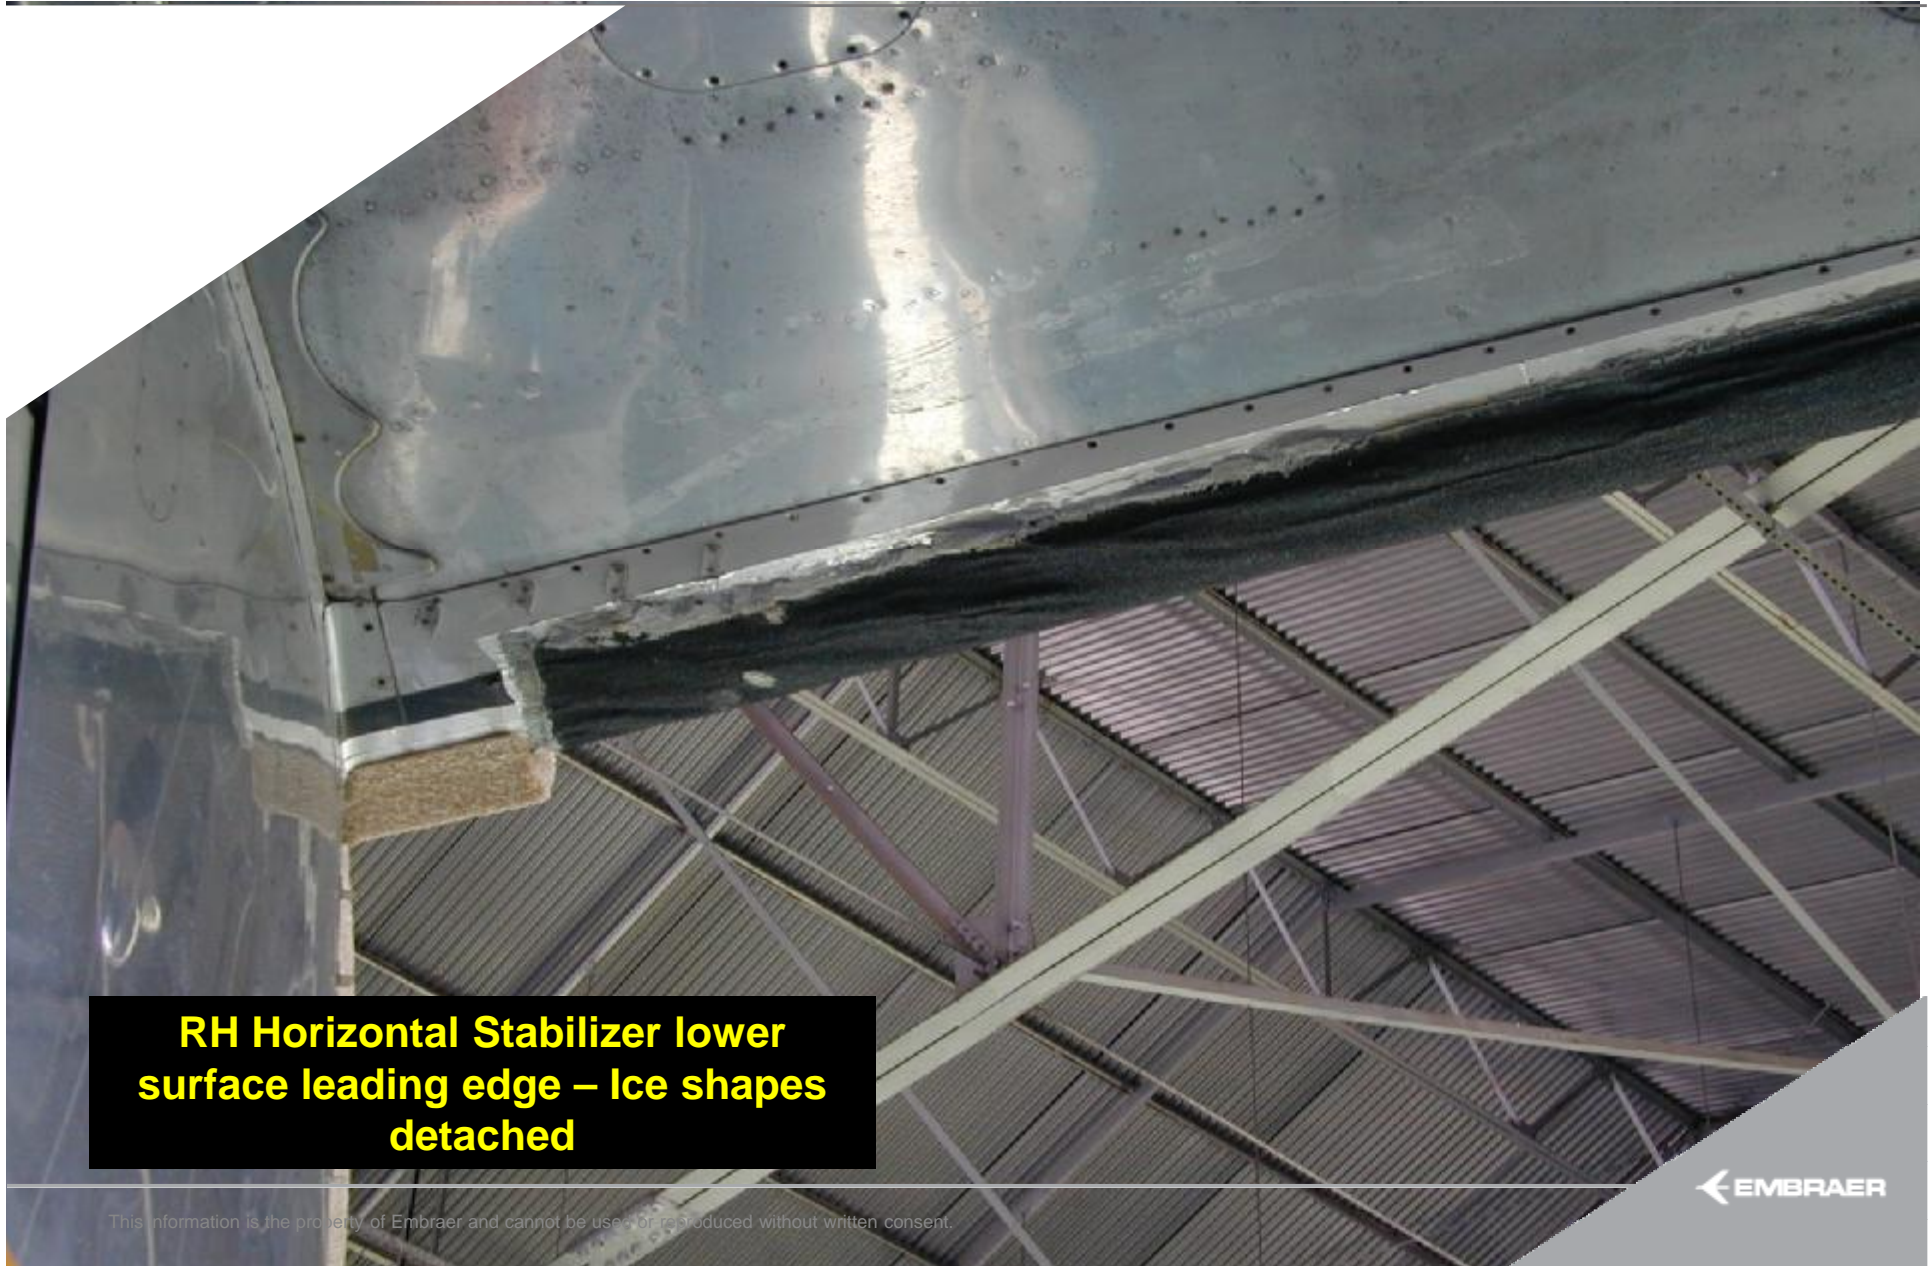
RH Horizontal Stabilizer lower surface leading edge – Ice shapes detached

- Ø Complete redesign of all ballast attachment devices
- Ø New Artificial Ice Shapes Adhesives / Resins and Materials are now employed
- Ø For longer Flight Test Campaigns, any “special equipment/device” installed shall have a dedicated appreciation regarding its “expiration time”
- Ø Ongoing Research Project for new Artificial Ice Shapes materials and gluing processes

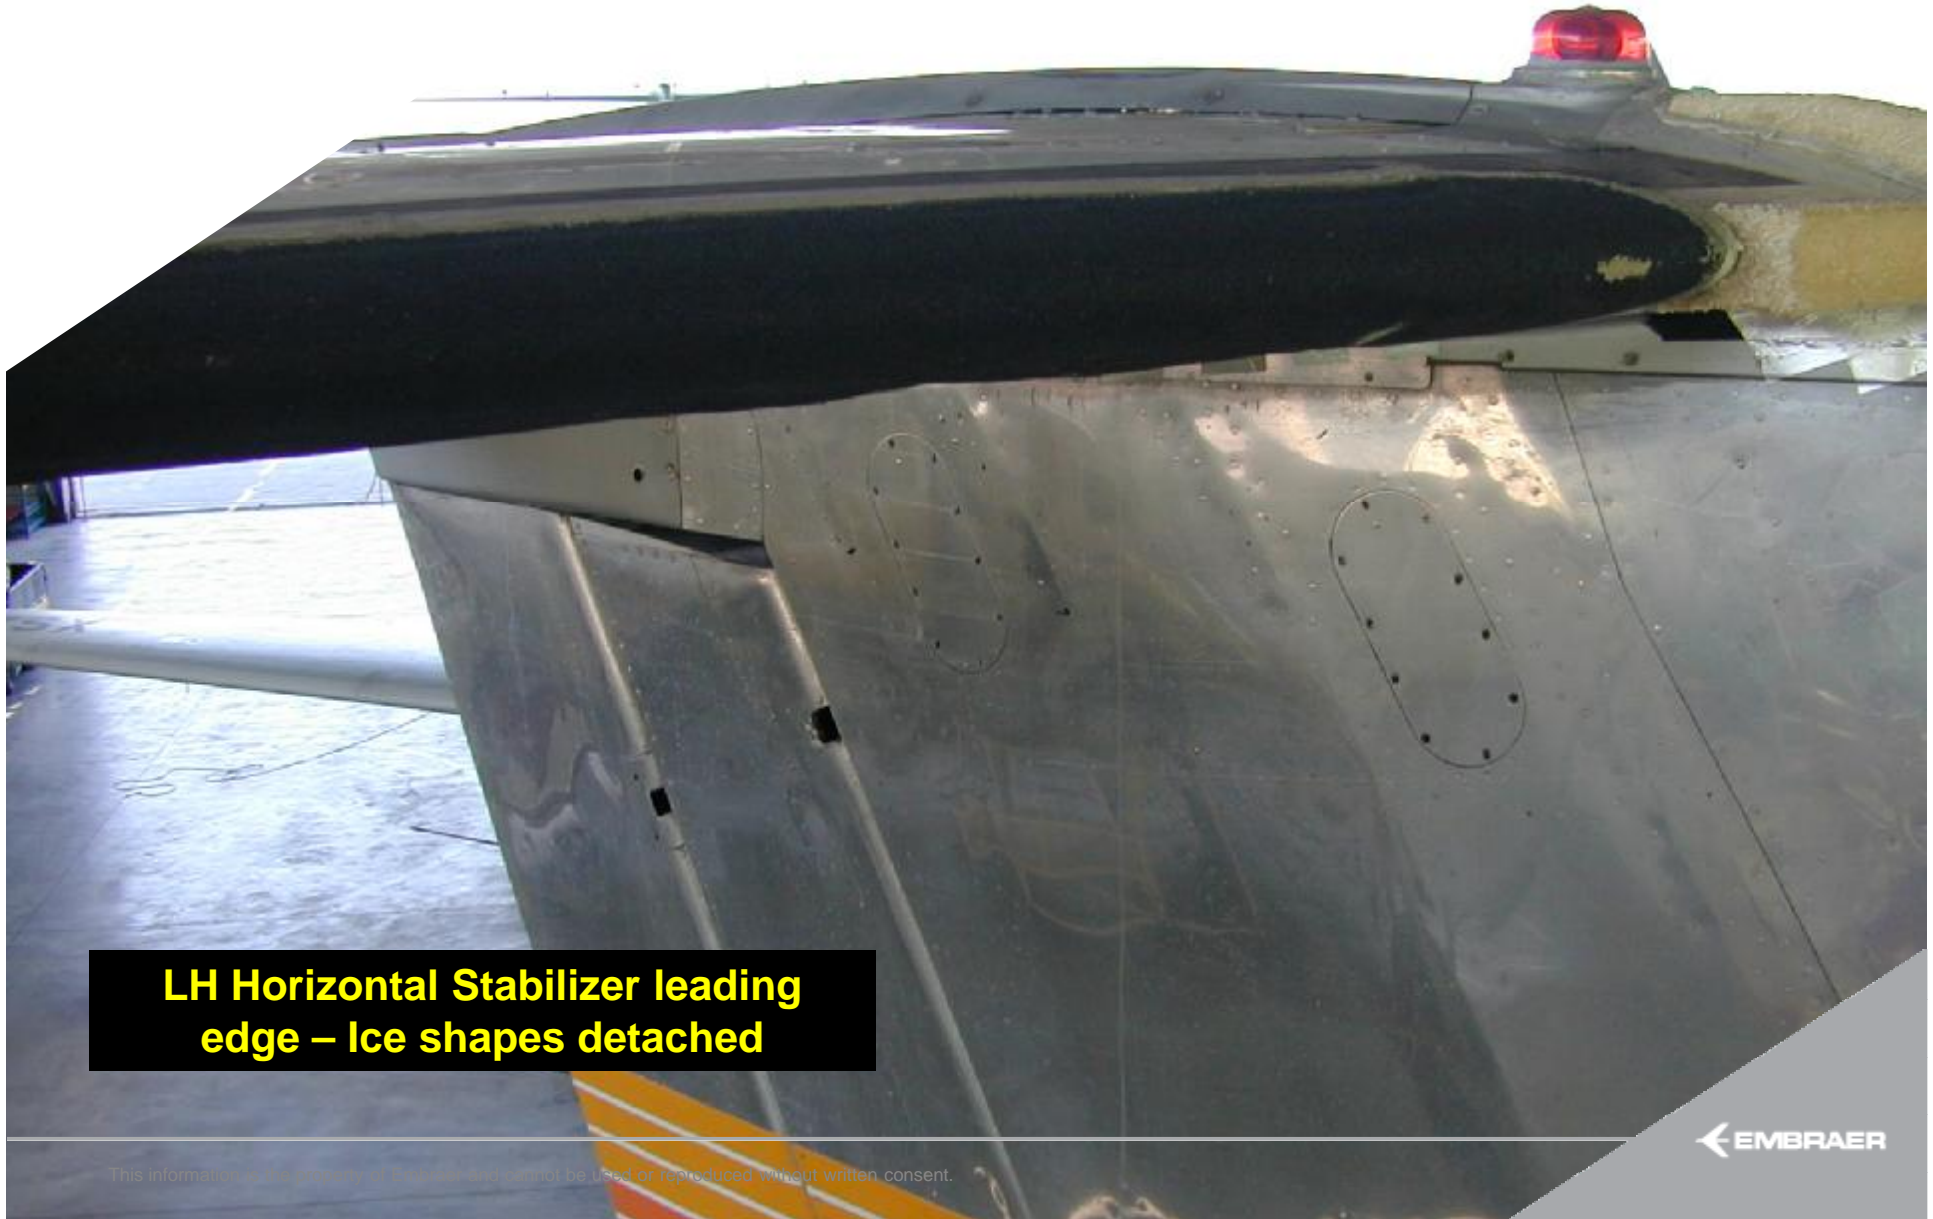
LH Horizontal Stabilizer leading edge – Ice shapes detached

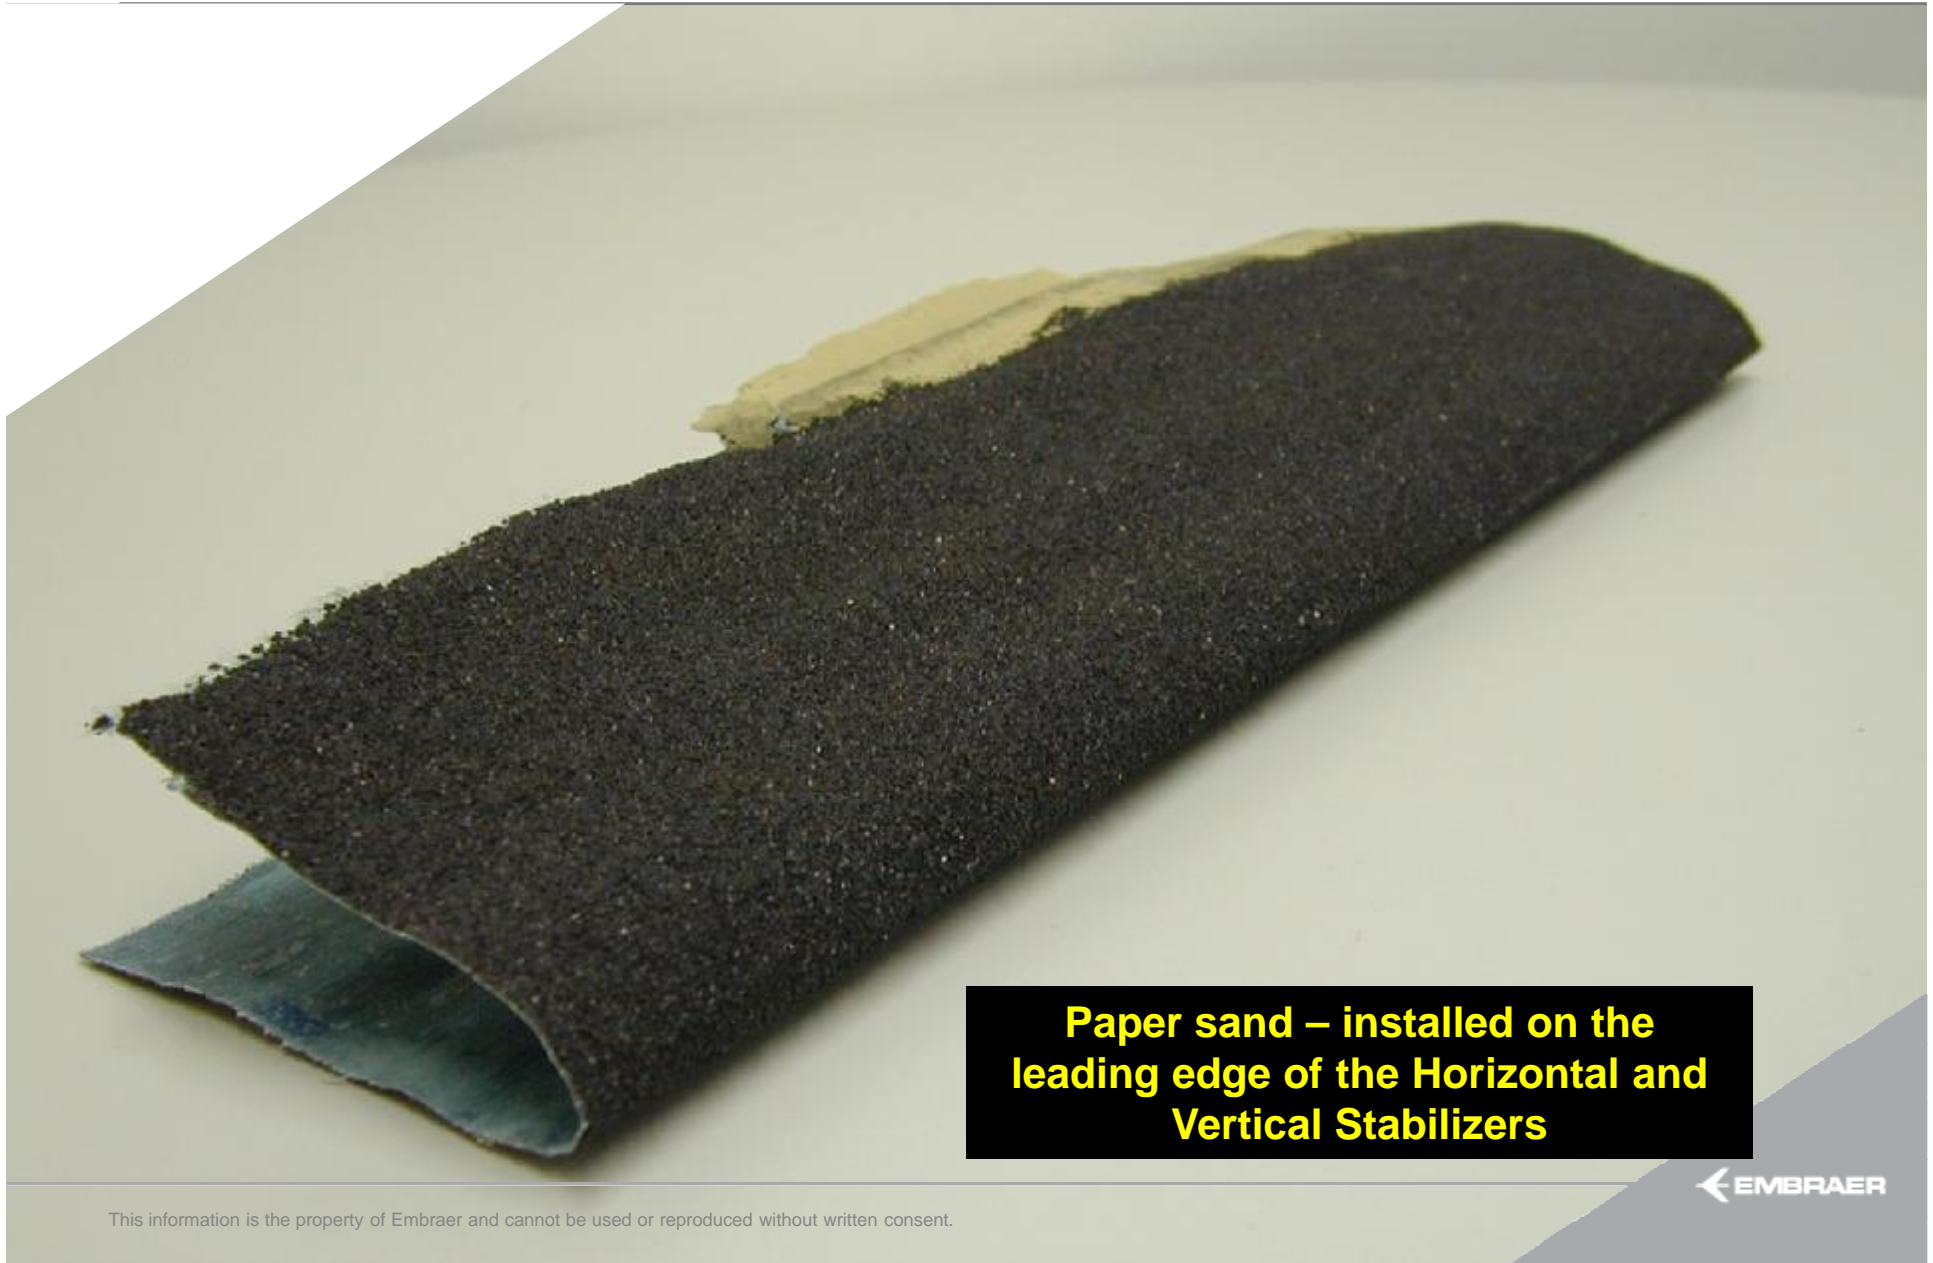
Paper sand – installed on the leading edge of the Horizontal and Vertical Stabilizers
