When Holes Line Up: The Path to a Test Safety Incident

Major Mike Barker
Aerospace Engineering Test Establishment
Canadian Air Force

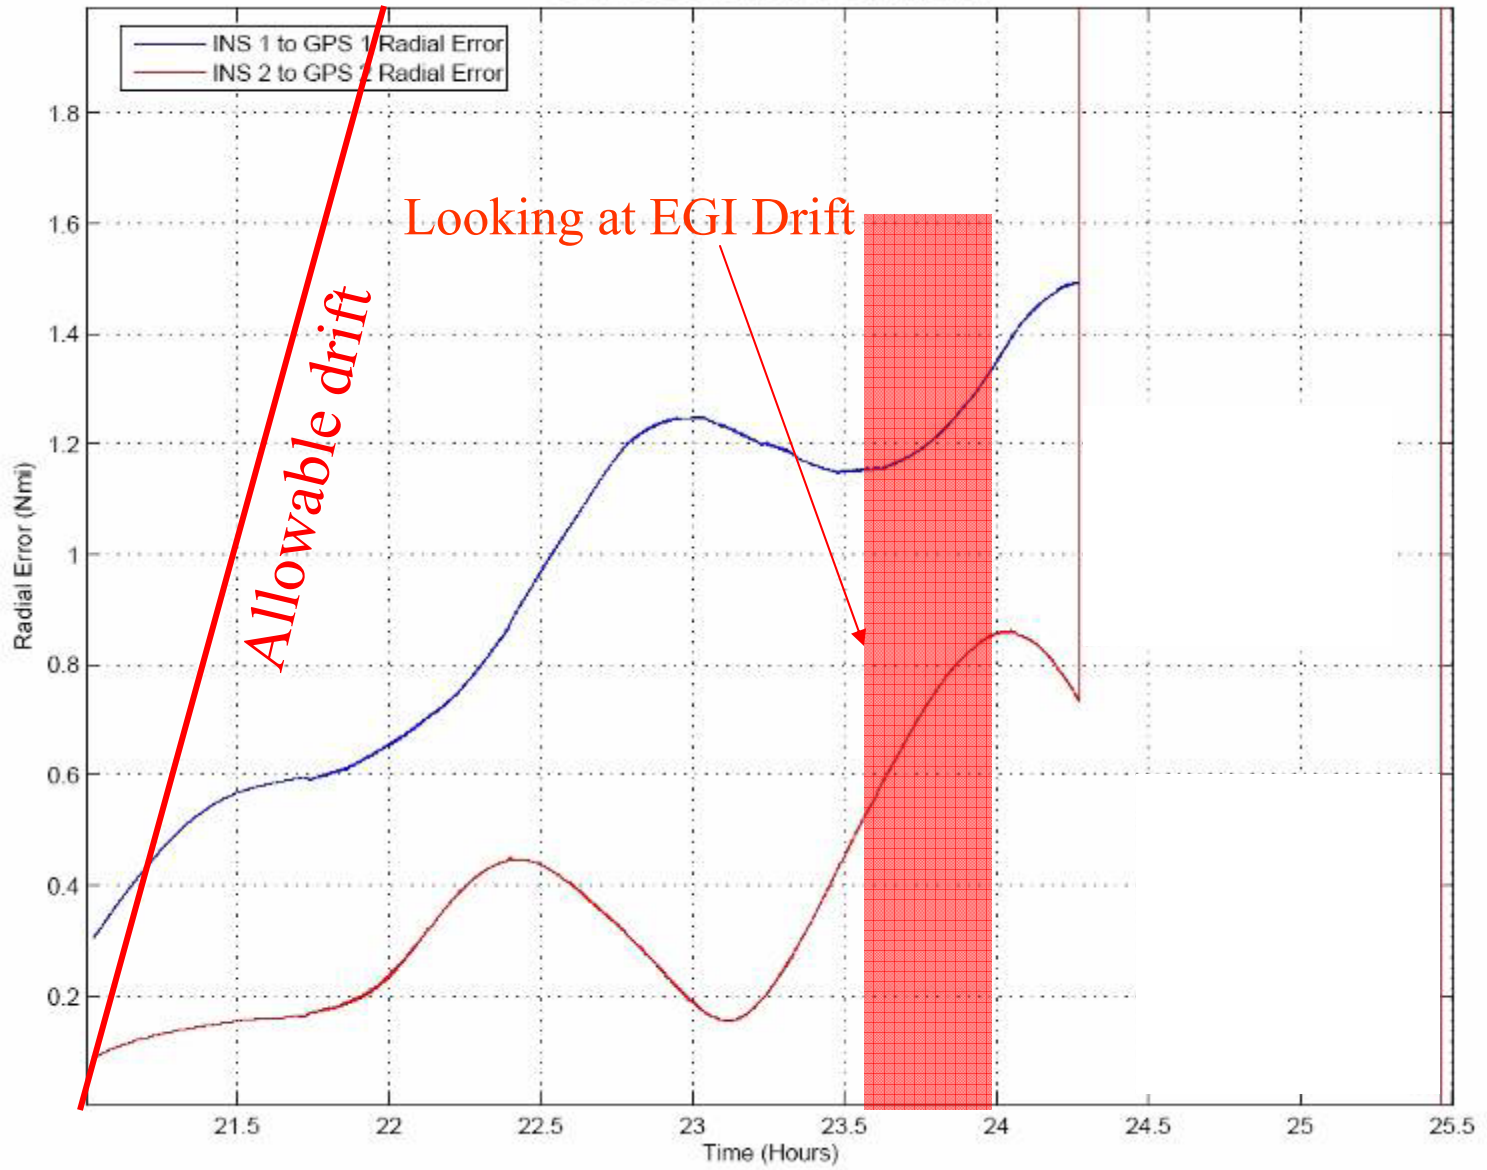
05-07-08 2101z INS to GPS Radial Error

- There was no EMI.
- Contractor engineer had recently reviewed EGI drift from last flight. Last flight had abnormally small drift, subject flight had normal drift.
- Incident happened during Schuler cycle increase.

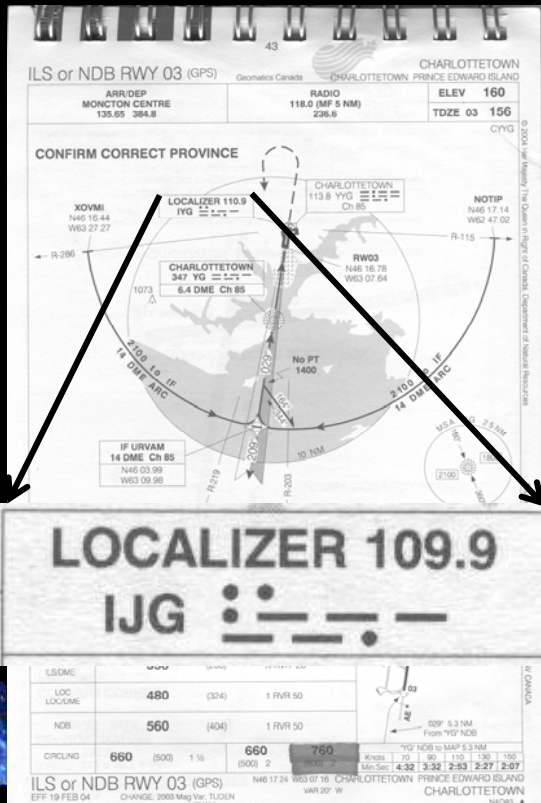
- Charlottetown and Halifax ident very close. NFP didn't check freqs or ident LOC.
