Helios High Altitude Long Endurance Mission Mishap

The Helios Mishap Root Causes

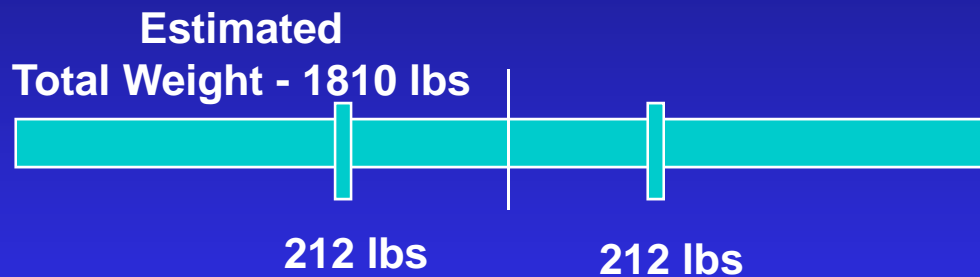
Helios Prototype (HP01)
with Planned
Regenerative Fuel Cell System

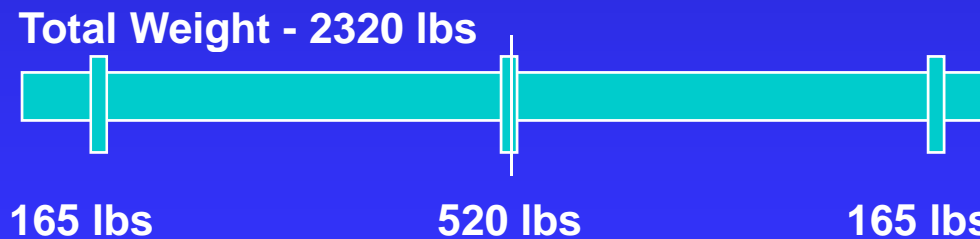
Helios Prototype (HP03)
with Hydrogen - Air
Fuel Cell System
(Three Point Masses)

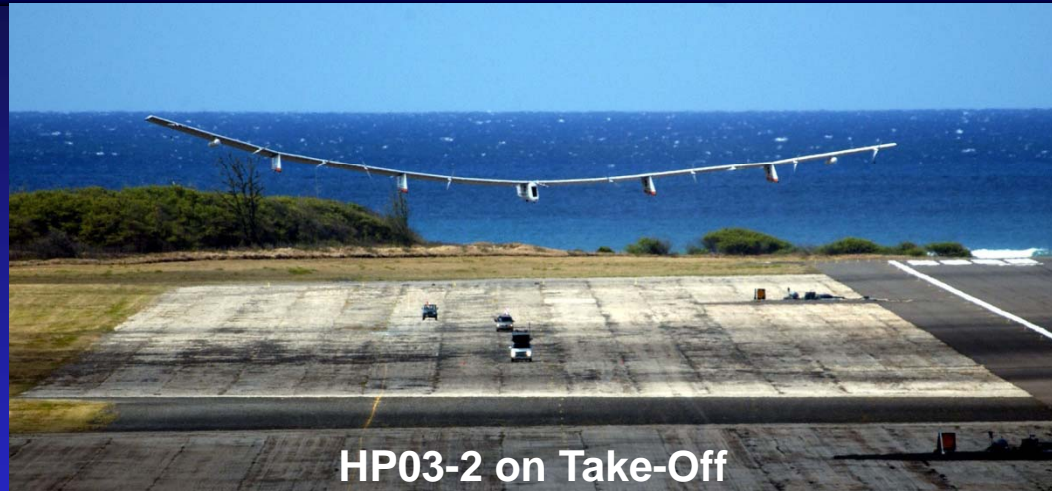
HP03-2 on Take-Off

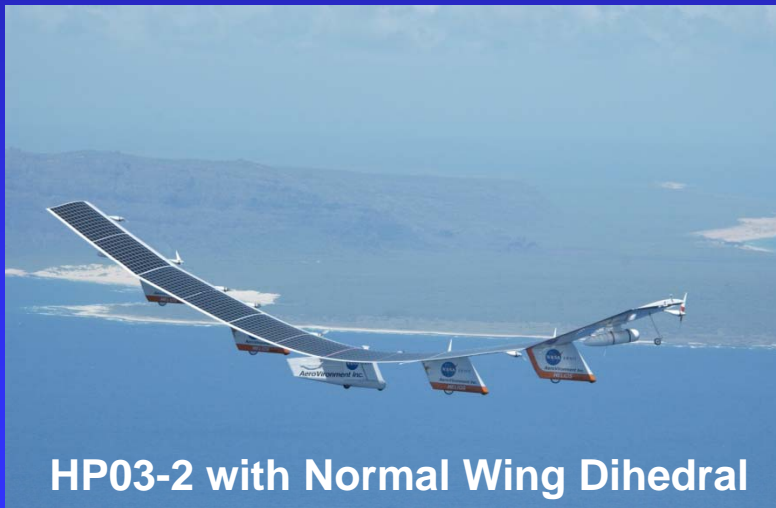
HP03-2 with Normal Wing Dihedral

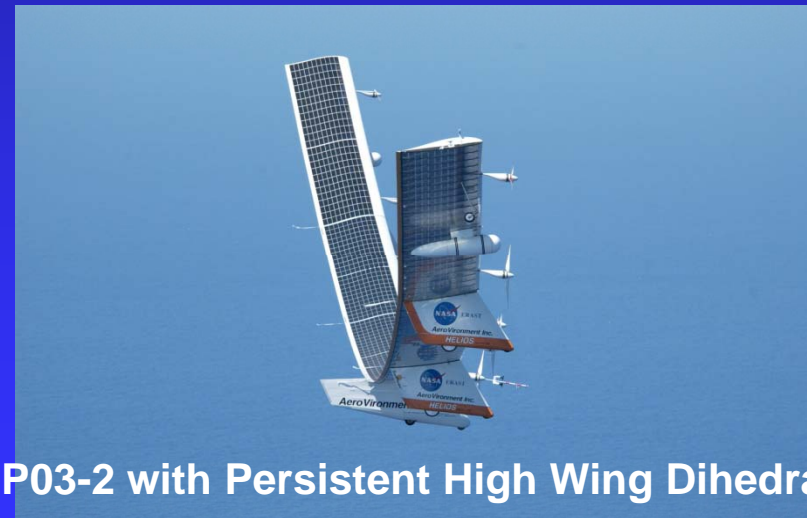
HP03-2 with Persistent High Wing Dihedral

- Lack of adequate analysis methods led to an inaccurate risk assessment of the effects of configuration changes leading to an inappropriate decision to fly an aircraft configuration highly sensitive to disturbances.
- Configuration changes to the aircraft, driven by programmatic and technological constraints, altered the aircraft from a spanloader to a highly point-loaded mass distribution on the same structure significantly reducing design robustness and margins of safety.

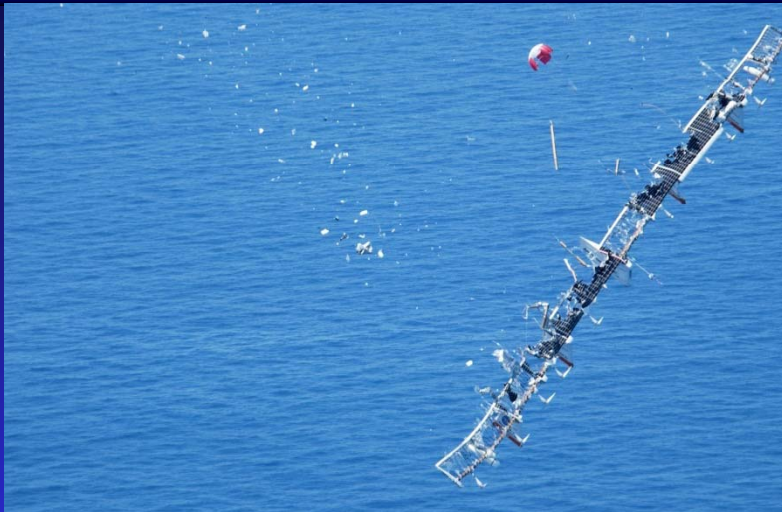
- The aircraft entered a series of severe pitch oscillations, resulting in some failure of the secondary structure, and could no longer generate lift
- The aircraft impacted the water within the confines of the Pacific Missile Range Facility, approximately 10 miles west of the island of Kauai
- Except for loss of the aircraft, no property damage, environmental hazard, or personnel injury resulted from the mishap
- Approximately 70% of the aircraft (by weight) was recovered, including the two hydrogen fuel tanks

Falling to the Pacific

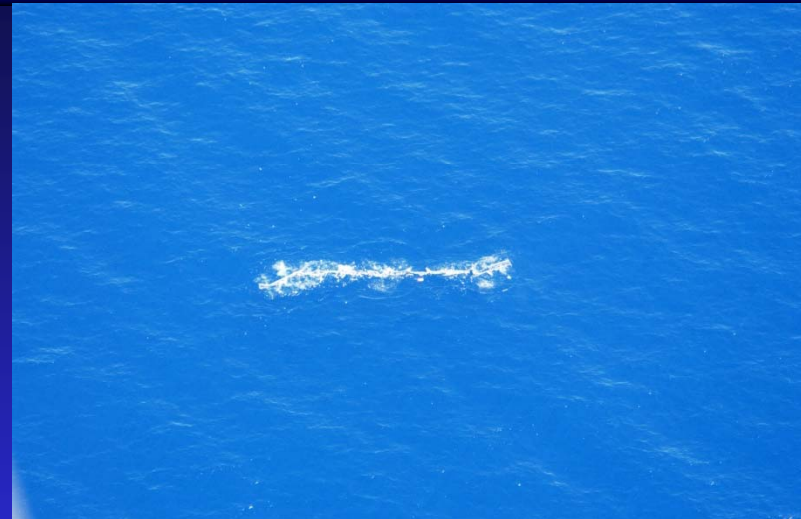
Helios Upon Impact with the Ocean

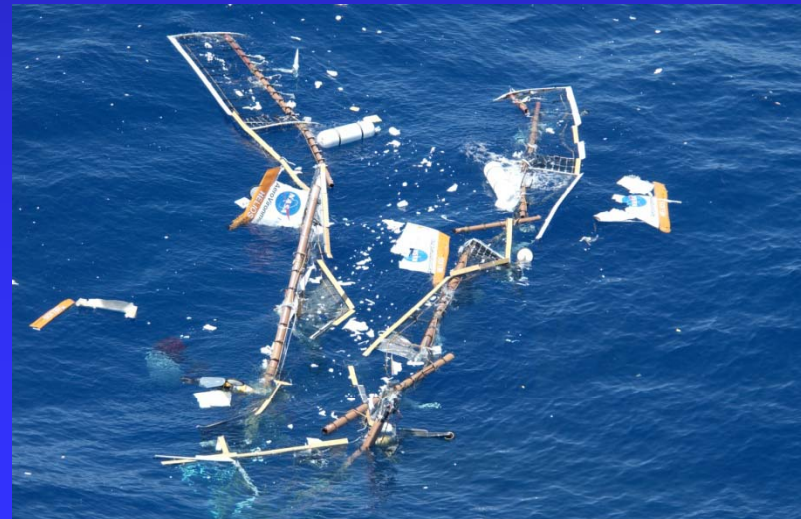
Close-Up of Floating Debris
