Can We Safely Keep it Simple?

First Flight of a Major Aircraft Upgrade

CDR James P. Borghardt, USN

Flight Test Safety Workshop

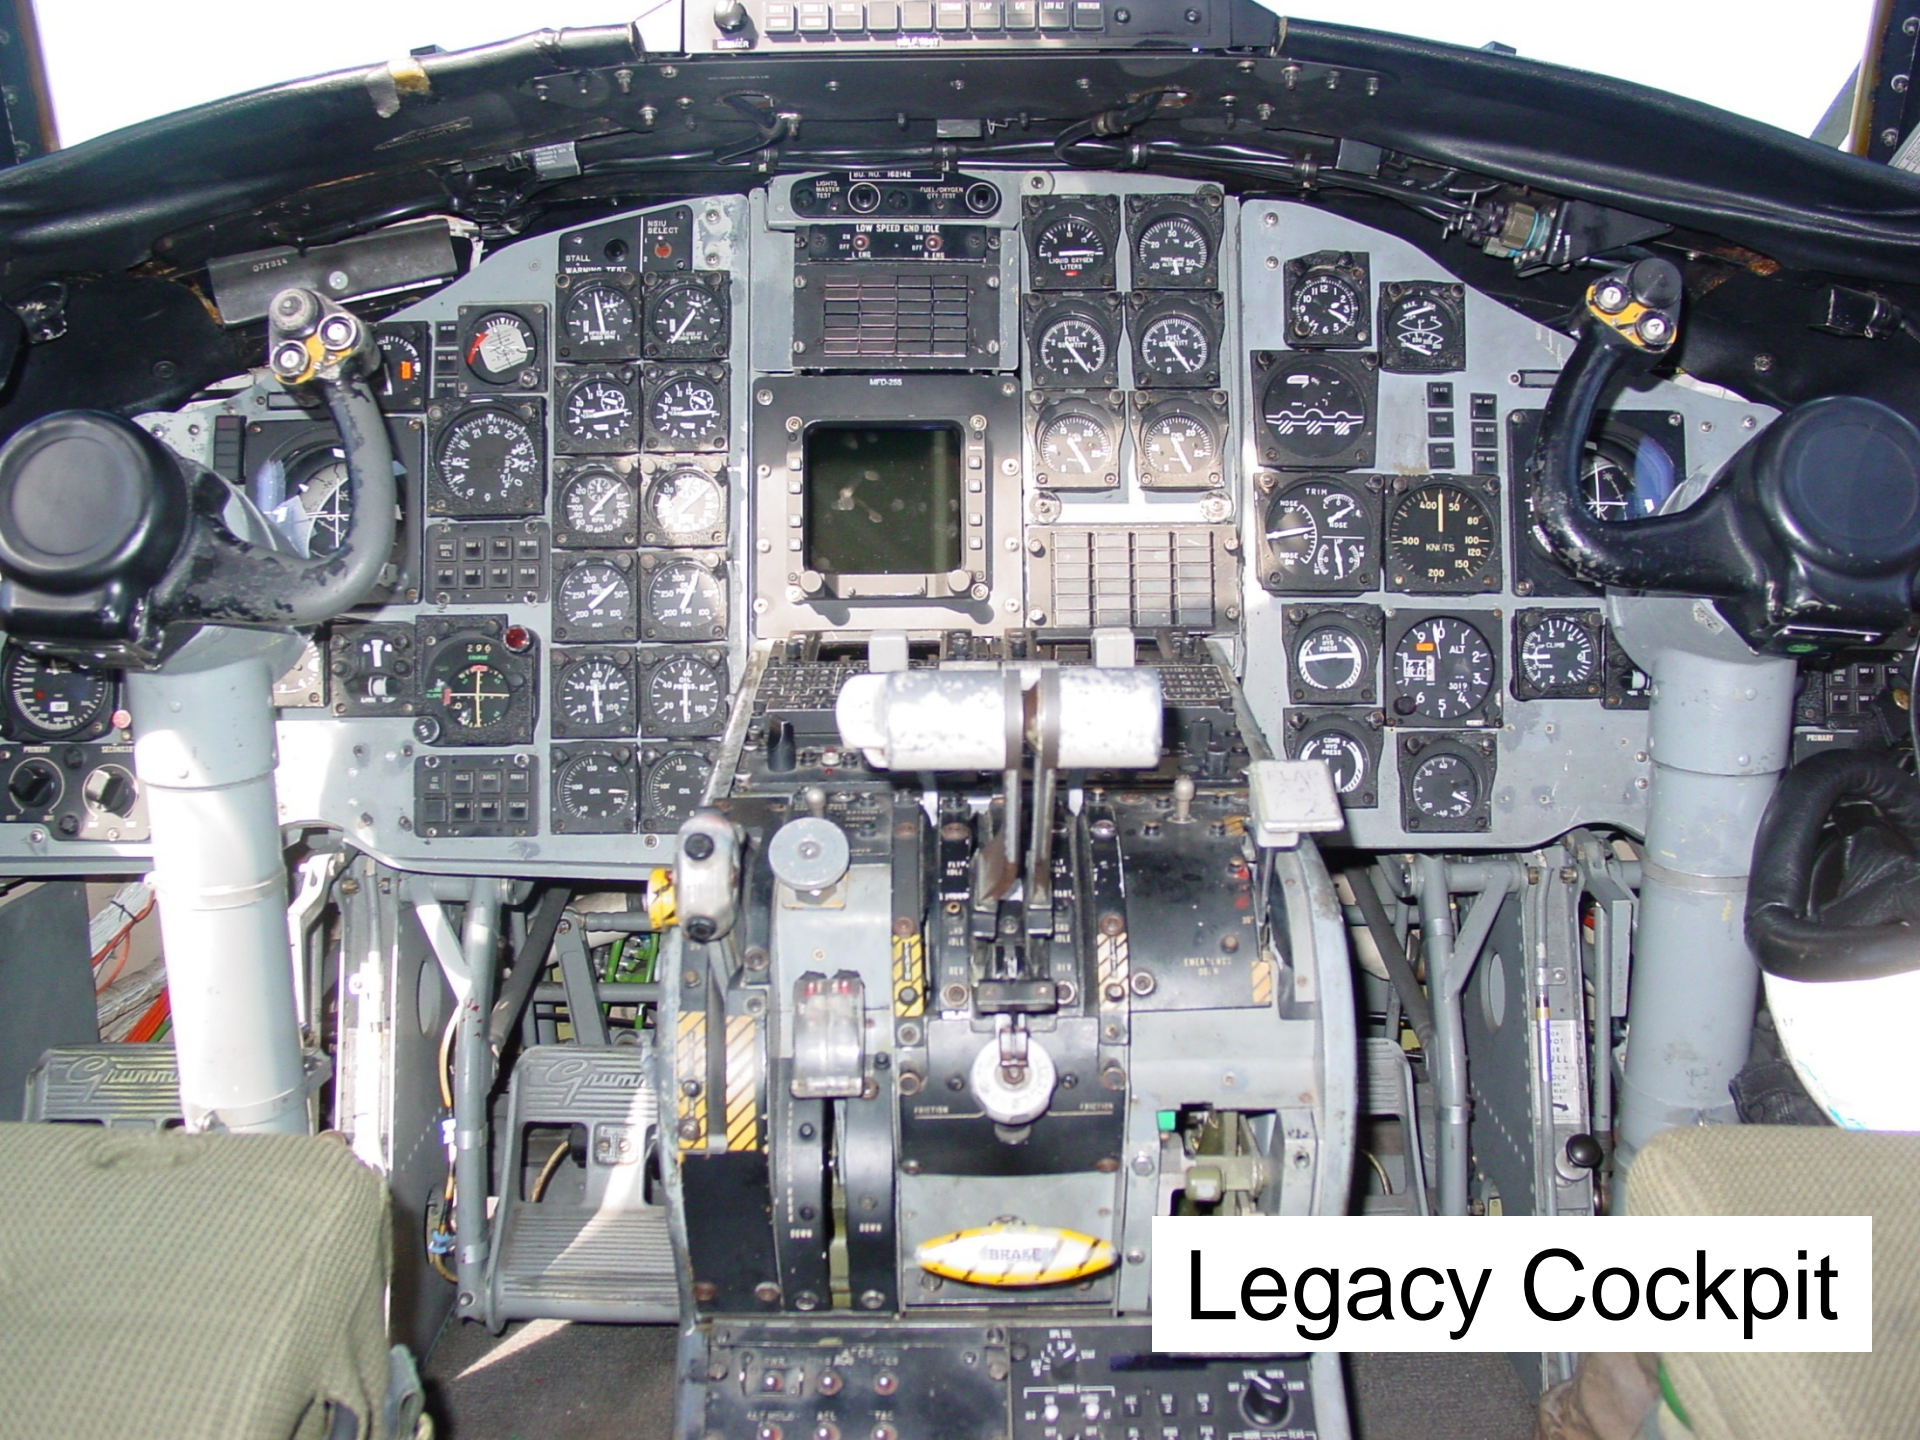
Legacy Cockpit

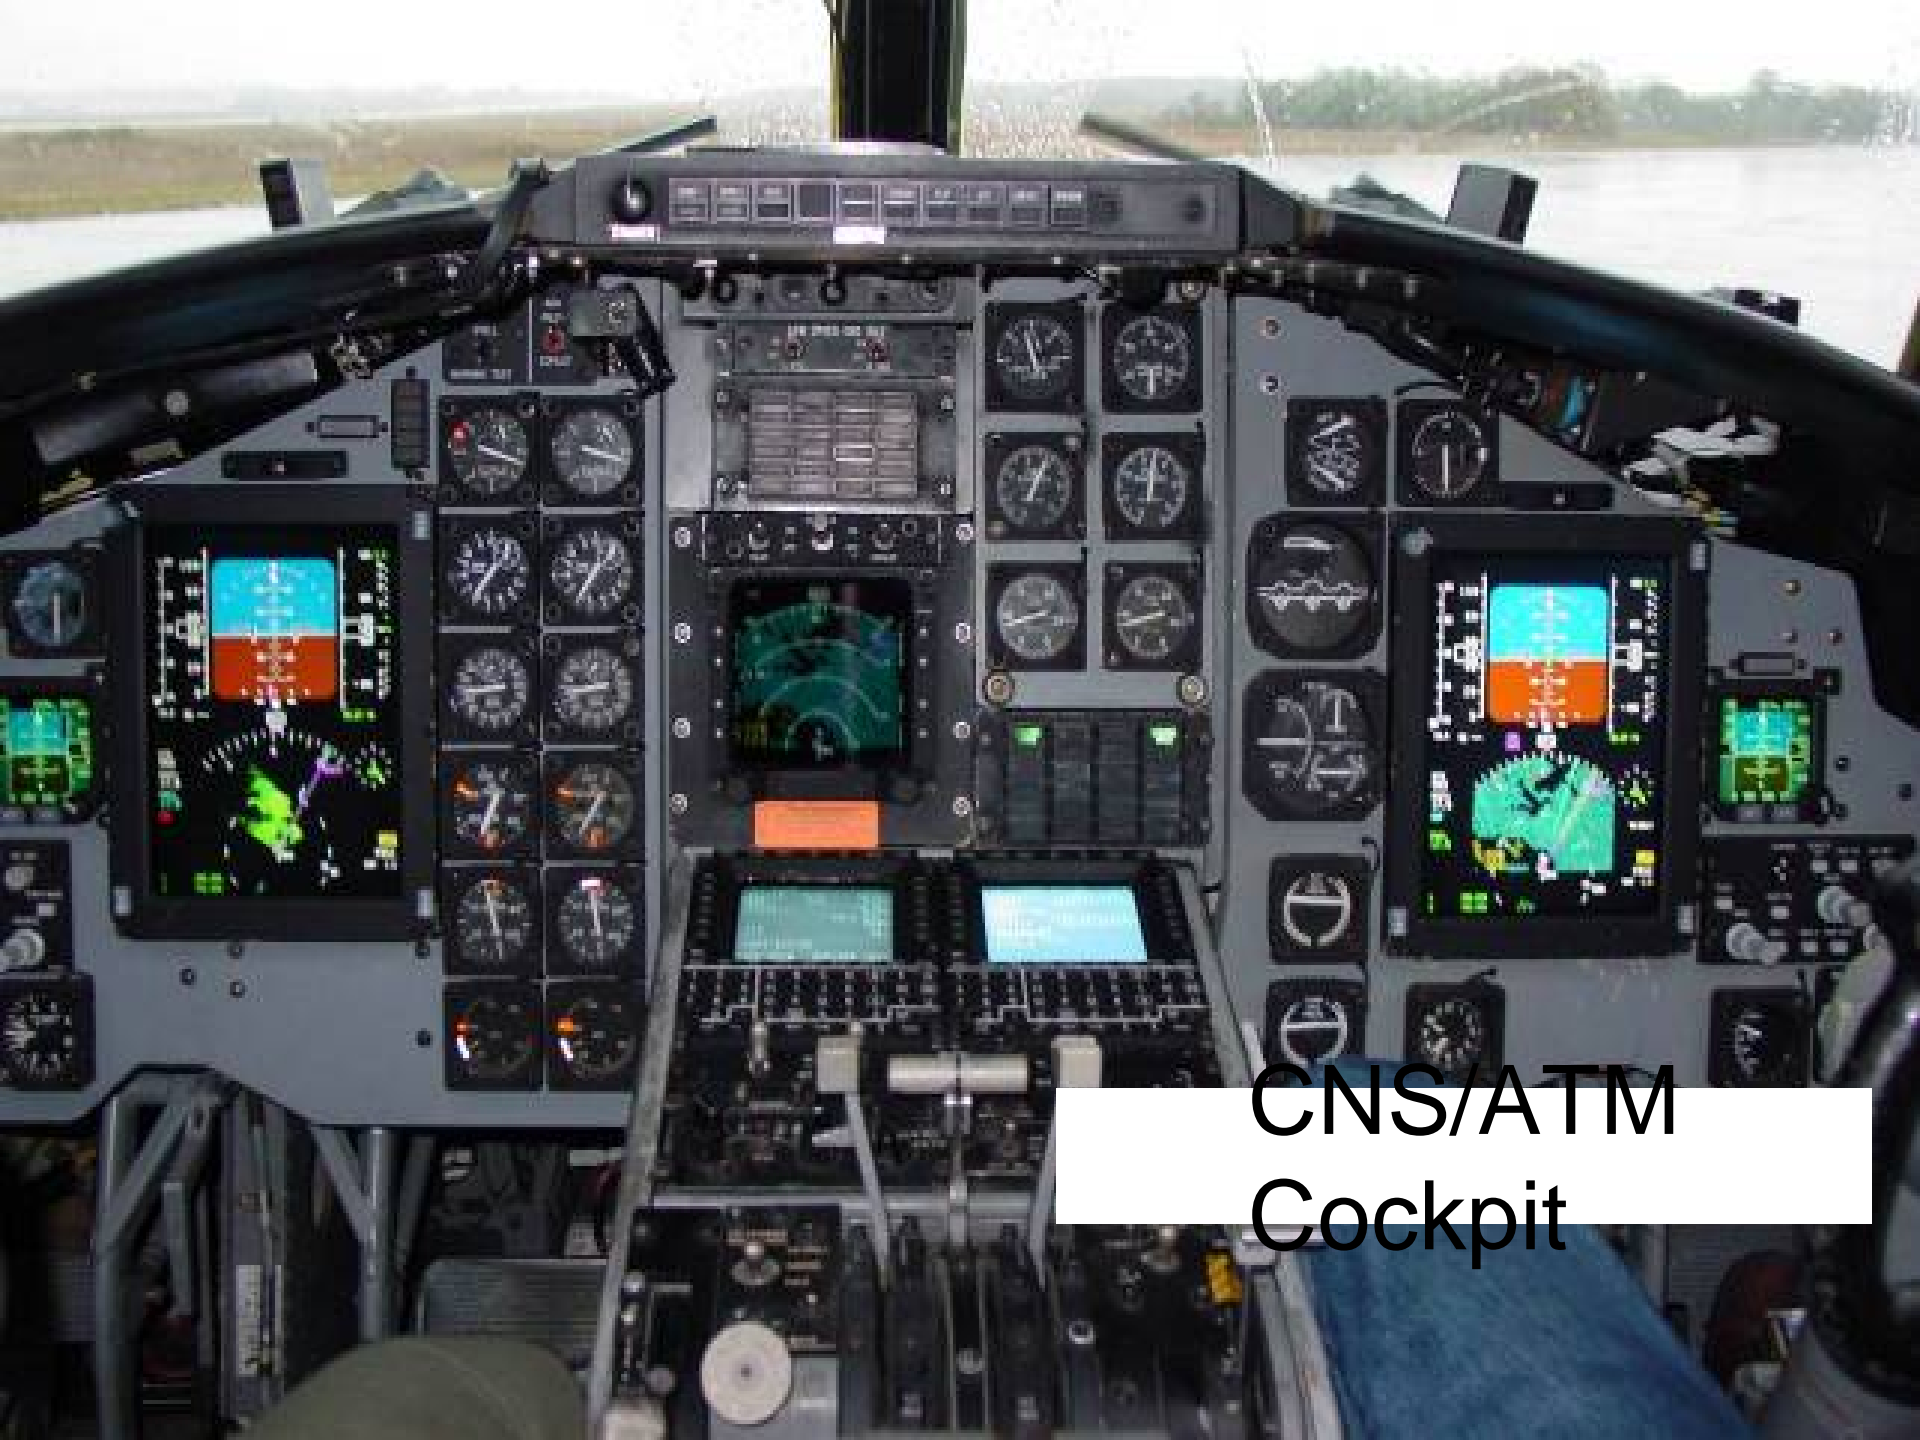
CNS/ATM Cockpit

- New navigation suite
- New transponder
- Upgraded radio
- New Flight Management System (FMS)
- MAJOR cockpit upgrades
 - Glass displays
 - Lighting
 - New backup gyro
- Mod did NOT directly affect: engines, hydraulics, external aircraft mold-line, flight controls*

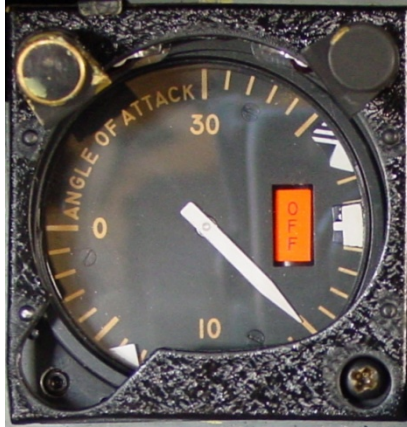
AOA Displays

- For C-2 aircraft, in Day/VMC, reliable AOA gauge is all you really need to land
 - Provides precise airspeed/attitude
 - Provides stall warning
 - With known IHP can estimate ROD
- Legacy AOA system remained in cockpit
 - Not a part of the potentially compromised pitot/static system
 - Requires AOA probe and gauge only

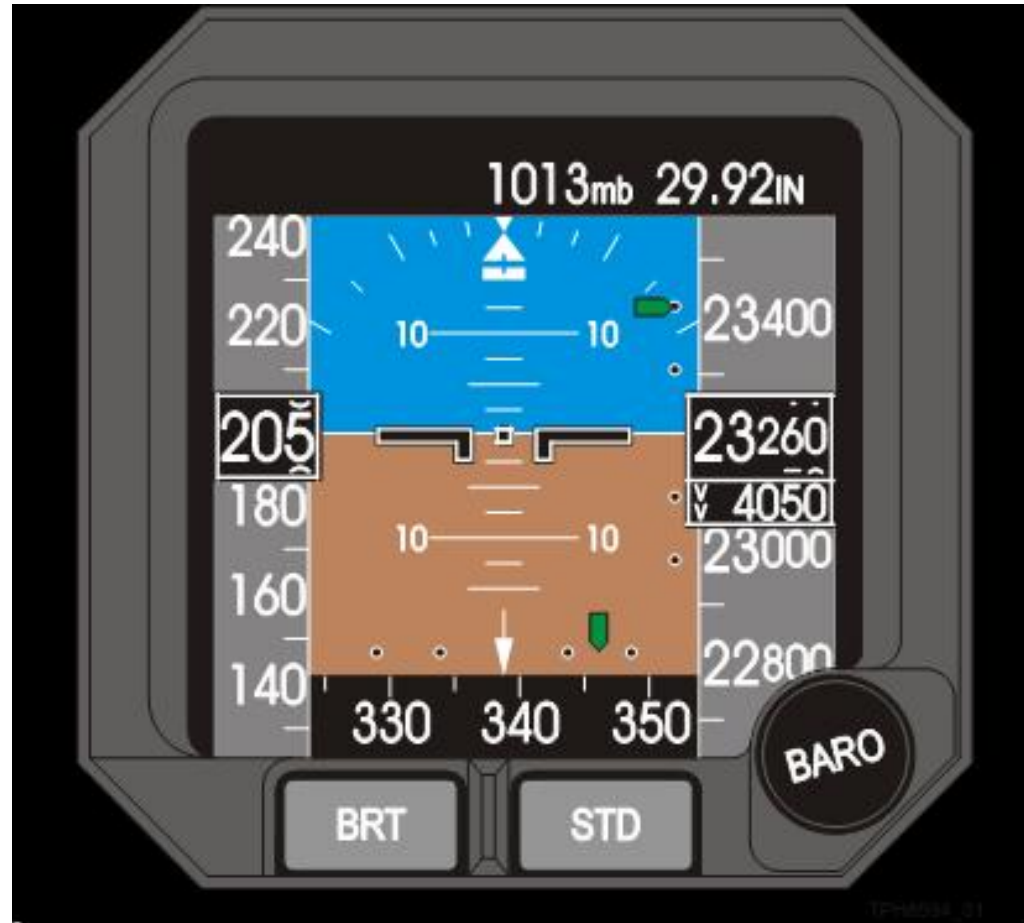
New Emergency Standby
