Late 1940's,
Early 1950's

F.T. Events/Accidents

Note on the structural failure of
Handley Page 88 (E6/48) VX.330

The Handley Page 88 prototype (E6/48) crashed at Stansted airfield on 26/6/51 following structural failure in the air. The pilot was killed.

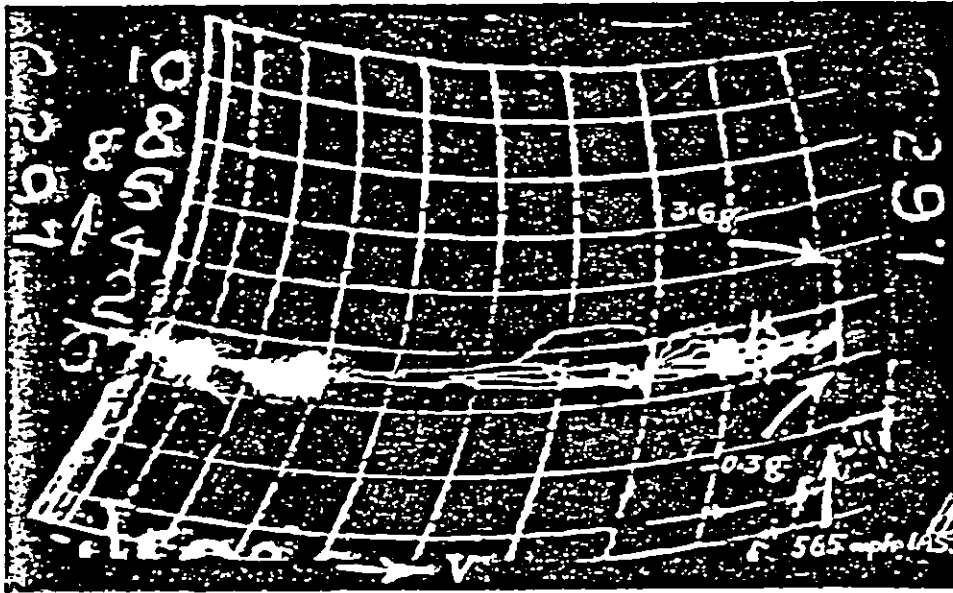
FIG.7. V-G RECORDER SLIDE. 4th AUGUST, 1951

"The only traces which we believe may be of significance occur on the 2 record slides taken on the 4th and 5th August, 1951, copies of which are attached (Figs.7 and 8). It will be seen on both records that there is an acceleration trace at the maximum speed attained. These traces appear to have been caused by a pitching oscillation, possibly due to a gust or inadvertent control stick movement followed by over correction by the pilot. The importance of these traces lies in their similarity to the high speed traces on the accident record.

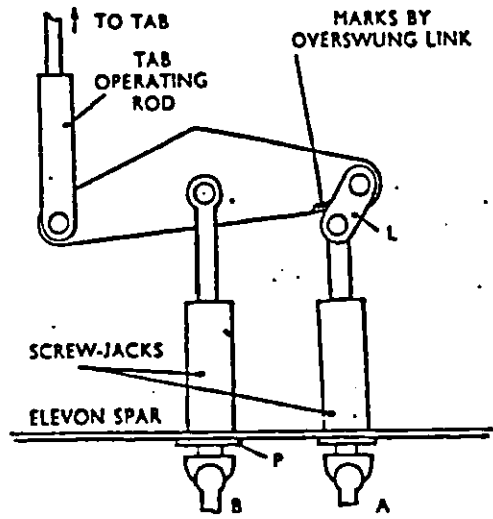
FIG.6. TAB CONTROL CIRCUIT IN THE ELEVON (DIAGRAMMATIC)

3.5 Significant evidence was found in the elevon tab operating mechanism. The tab is moved by a rod which is operated by a balance lever controlled both manually and electrically (for automatic trimming) through screw jacks. The manual operation is for trimming only and is done through jack A (Fig.6) while the automatic electrical operation is initiated by the torque applied to the elevon. If this torque exceeds a specified value (23 lb ft in this instance) a micro-switch is actuated and an electric motor brings jack B into play and moves the tab in order to decrease the elevon torque. Both jacks are mounted side by side on the wing spar and one point of attachment of the jack ram to the balance lever acts as a fulcrum for the lever when the other jack ram is in operation. The connection between the manual operation jack and the balance lever is made by an articulated link so that movement of the balance lever does not tend to force the jacks towards or away from each other. Evidence of excessive movement of the link was found in the form of a smear on the balance lever (Fig.7 and 8). This suggests that the linkage was not sufficiently rigid.
