Canedair ~~CL~~CL44 Modified  
"Guppy" ✓

+++++  
+ DATA REPORT CANADAIR - CL44  
+ EVENTS | PHASES: AIRFRAME FAILURE | AERIAL WORK

## 377MGT-1 Accident

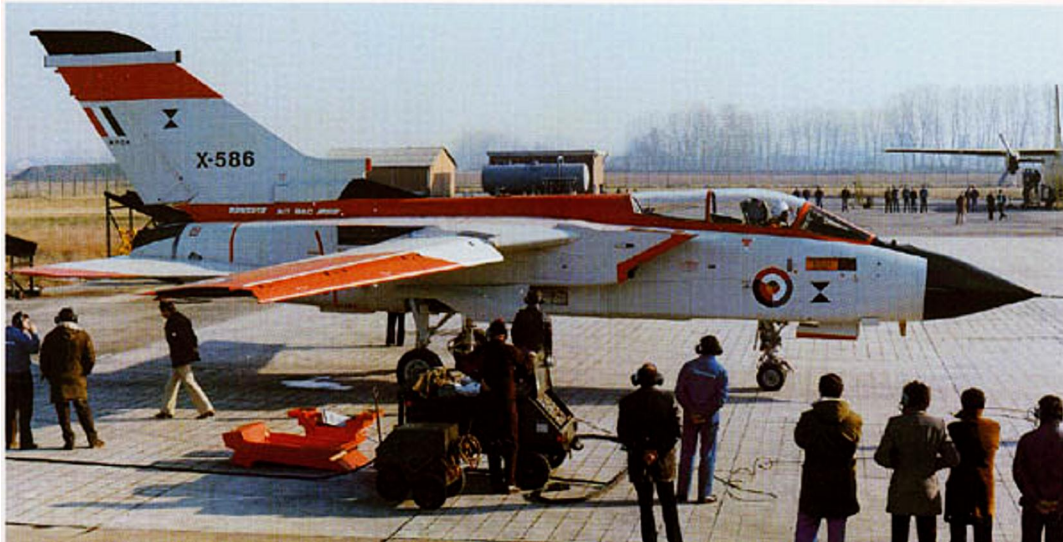
## Prototype P.05 - X586 MM586

- First flight 05.12.1975
- P.05 was due to be used for flutter and airframe load trials but was extensively damaged during a landing accident at Caselle during January 1976. After extensive refurbishment including a new forward section, it rejoined the trials fleet in 1978. It was also used for weapons release trials.
- This was the last prototype to wear the red & white colour scheme.
- Delivered in Panavia color scheme,
- Used for load surveys with stores.
