SJ30-2 SN002 Flight 211 4-26-03

SSAC SJ30-2 Flight 231: Post Flight Briefing

On April 26, 2003 at approximately 1005 CDT, a Sino Swearingen SJ30-2, N138BF, was destroyed when it impacted terrain north of Del Rio, Texas. The certificated airline transport pilot was fatally injured. Visual meteorological conditions prevailed and an instrument flight rules flight plan was filed. The experimental test flight was conducted under 14 CFR Part 91. The accident airplane and the accompanying T-38 chase plane (shown in Figure 1) departed San Antonio International Airport (SAT), San Antonio, Texas, at approximately 0911 to conduct high speed flight flutter testing north of Del Rio, Texas.

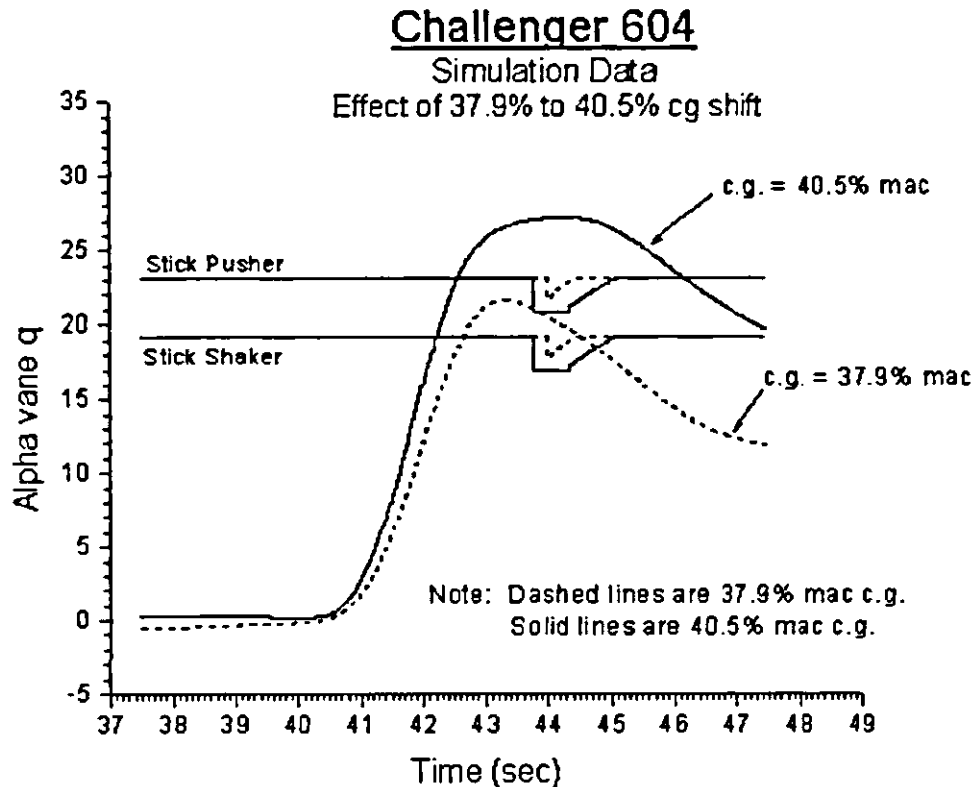
The new SJ30-2 flight flutter test airplane, serial number 004, N404SJ, was equipped with a high speed drag chute before flutter testing resumed. (Airplane serial number 003, N30SJ, was used primarily as a systems validation platform.)

The Safety Board staff conducted c.g. and PFS sensitivity studies in an engineering flight simulator at Bombardier Aerospace facilities in Montreal as part of the accident investigation. The first c.g. study was conducted without pilots and used elevator values derived from the accident flight's FDR. The study indicated that with a c.g. of 37.9 percent MAC (the start of the takeoff roll), the alpha vane AOA did not reach the stick pusher value (for activation). At 40.5 percent MAC (the c.g. after rotation), the alpha vane AOA peaked about 5° beyond stick pusher value (see figure 3). [36]

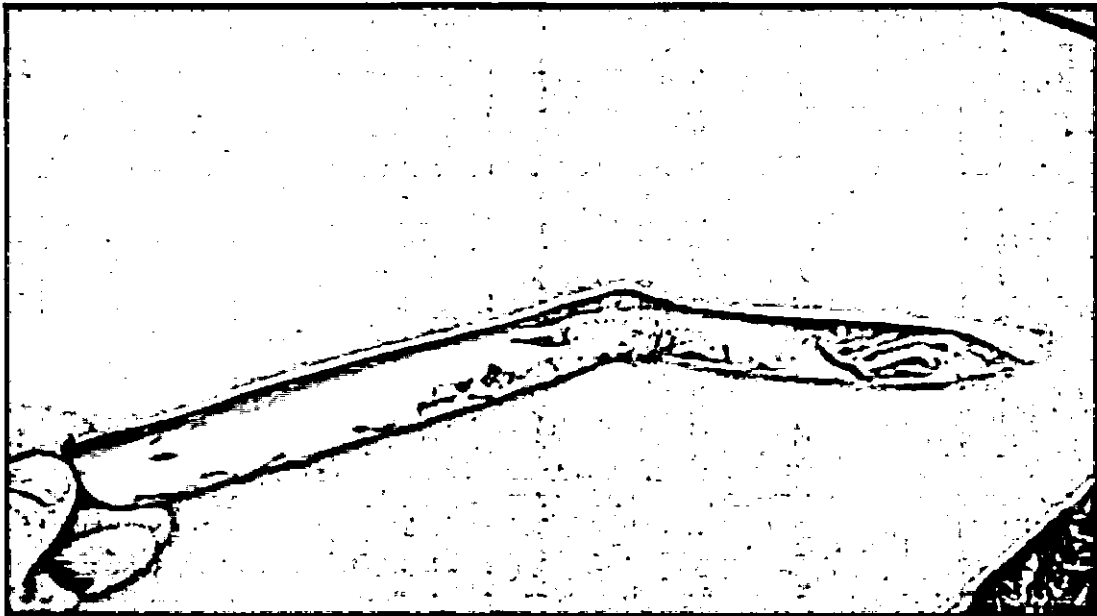
Figure 1-3: Gurney Flap

The gurney flap was found at the wreckage site fully separated from the wing. It was bent about the longitudinal center of the flap. Aeronautical speed tape was found on the flap, but no rivets were noted. Photographs of the gurney flap, as found, are included in Attachment 1 as figures 1-3 and 1-4.

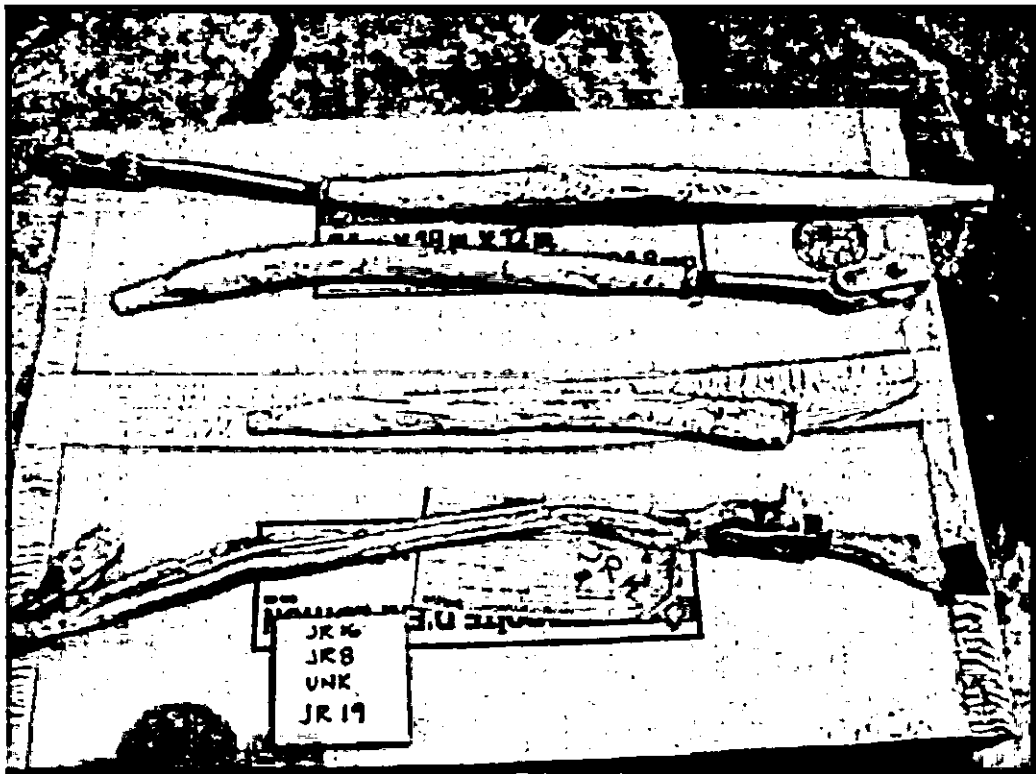
Figure 1-5: Various Recovered Aileron Control Push-Pull Rods

A photograph of several selected aileron push/pull rods is included in Attachment 1 as figure 1-5.

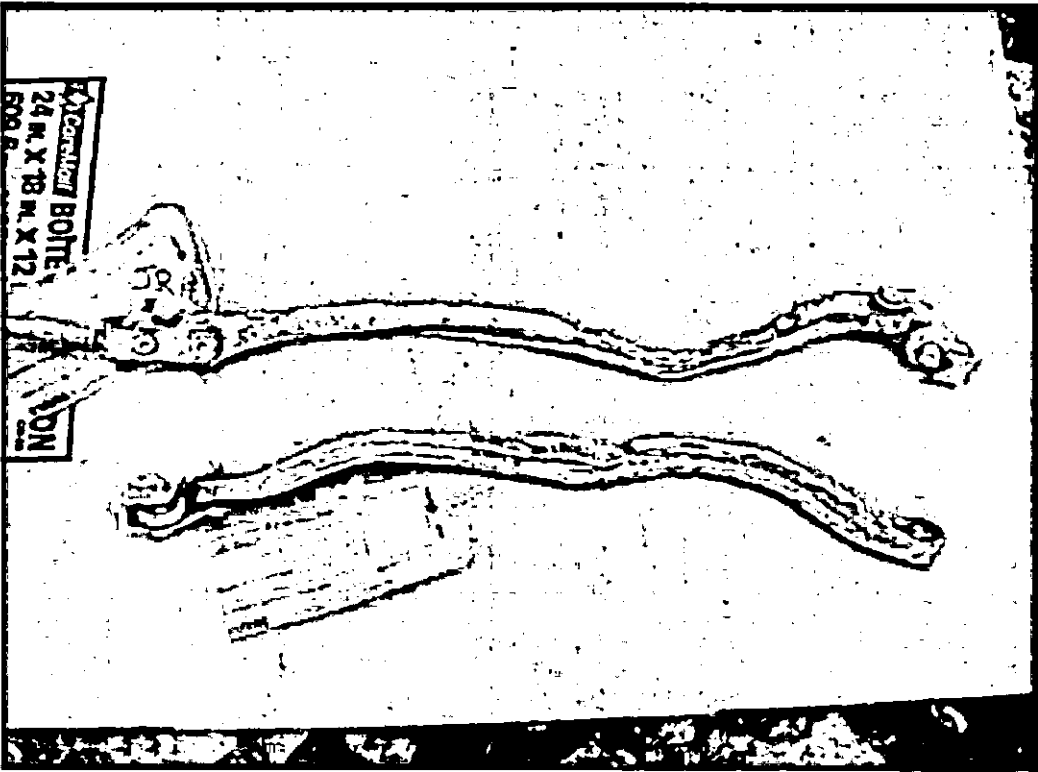
Figure 1-6: Aileron "Dog Bone" Control Rods

Included in the recovered aileron push/pull rods were two "dog-bone" linkages. The airplane has two dog-bone linkages, one in each wing. The linkage is bent in the center of the linkage for clearance inside the wing. One recovered dog-bone linkage's part number was discernable, 30-71017-5, and was bent in the middle of the linkage. The other rod did not have a discernable part number, but had one attachment with castellated nut and cotter pin. A photograph of the recovered dog bone linkages is included in Attachment 1 as figure 1-6.

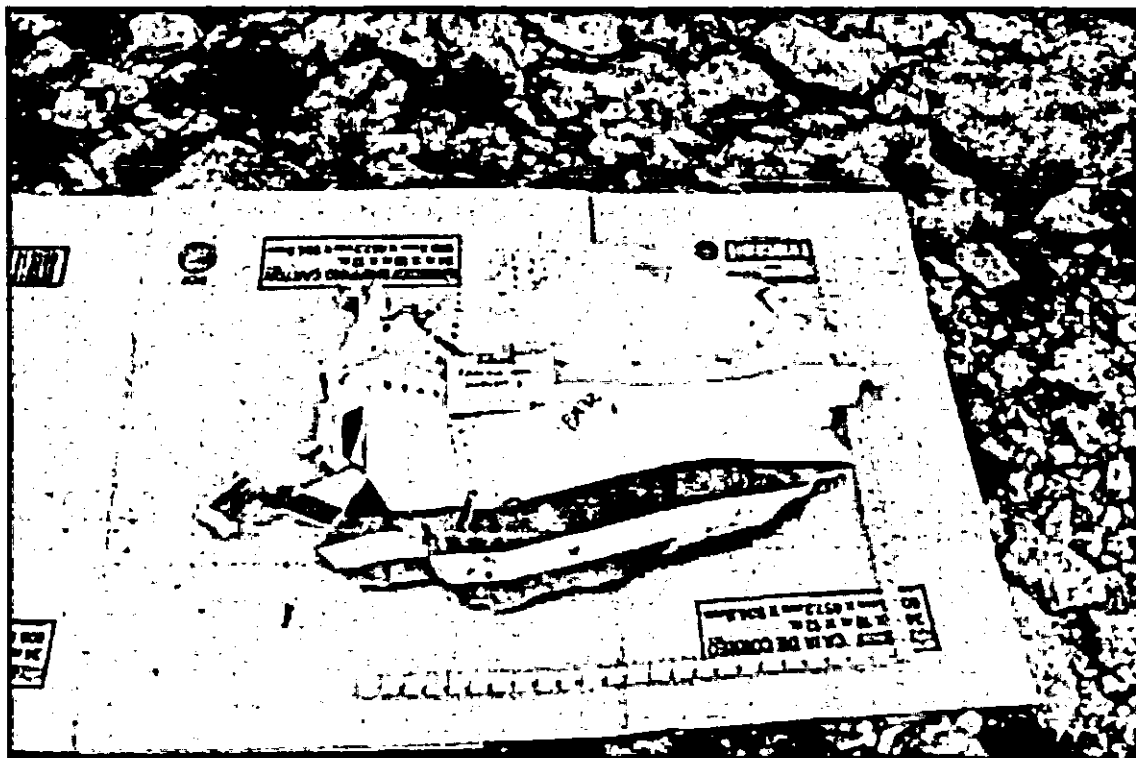
Figure 9

The fuselage structure was largely identifiable. Portions of the fuselage skins, frames and stringers were found throughout the debris field. The largest piece of fuselage structure recovered was a portion of the skin above the wing and measured approximately 2 feet by 2 feet. (see Attachment A Figure 9) Small pieces of the flight test equipment racks (orange in color) were identified throughout the debris field. Several large steel floorboards were identified at the main impact site along with several of the seven aft mounted ballast weights. A reconstruction of the fuselage was not possible due to the severity of the impact damage. (Reference wreckage diagram)

Fuselage Skin

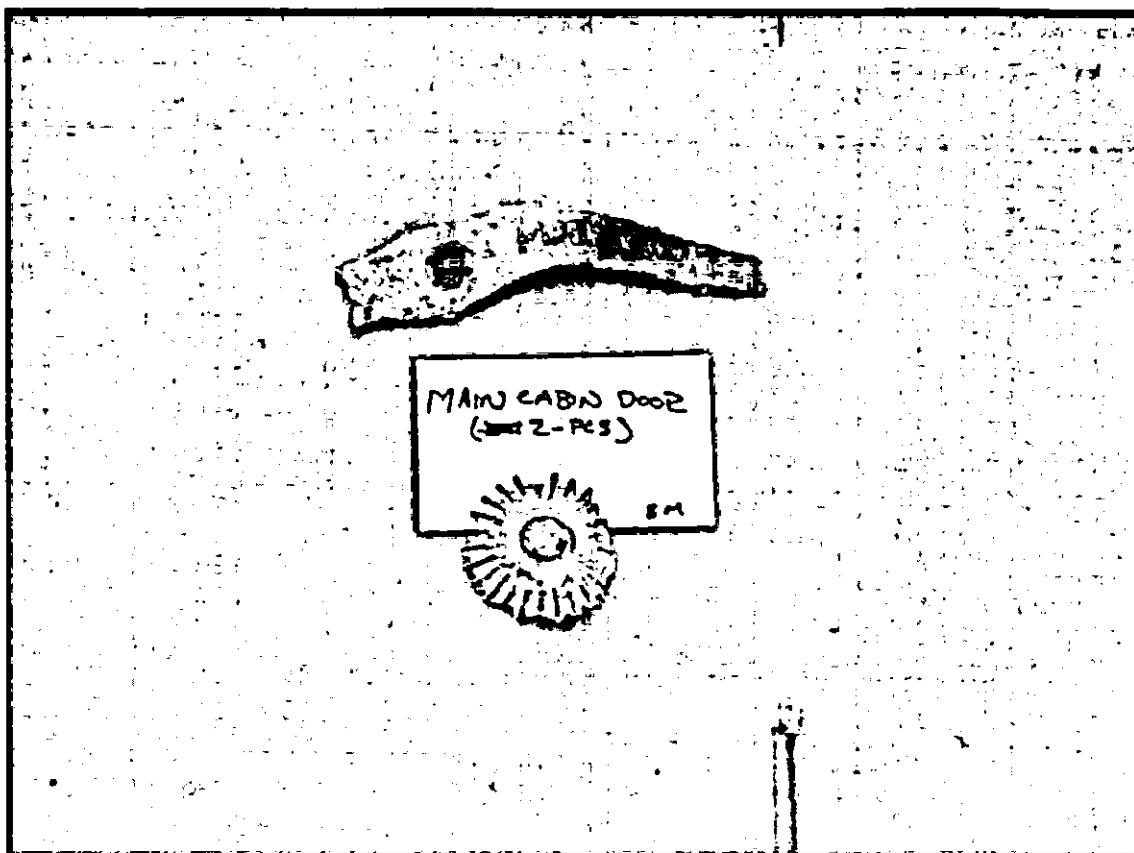
Figure 10

The main cabin door handle and a gear from the internal door mechanism were recovered at the accident site. (see Attachment A Figure 10) Additionally a portion of the emergency exit (overwing) door was identified along with main gear door hinges with attached door structure. The remainder of the main cabin door, emergency exit, baggage, nose and main landing gear doors were unidentifiable amongst the wreckage in the debris field.

Door Handle

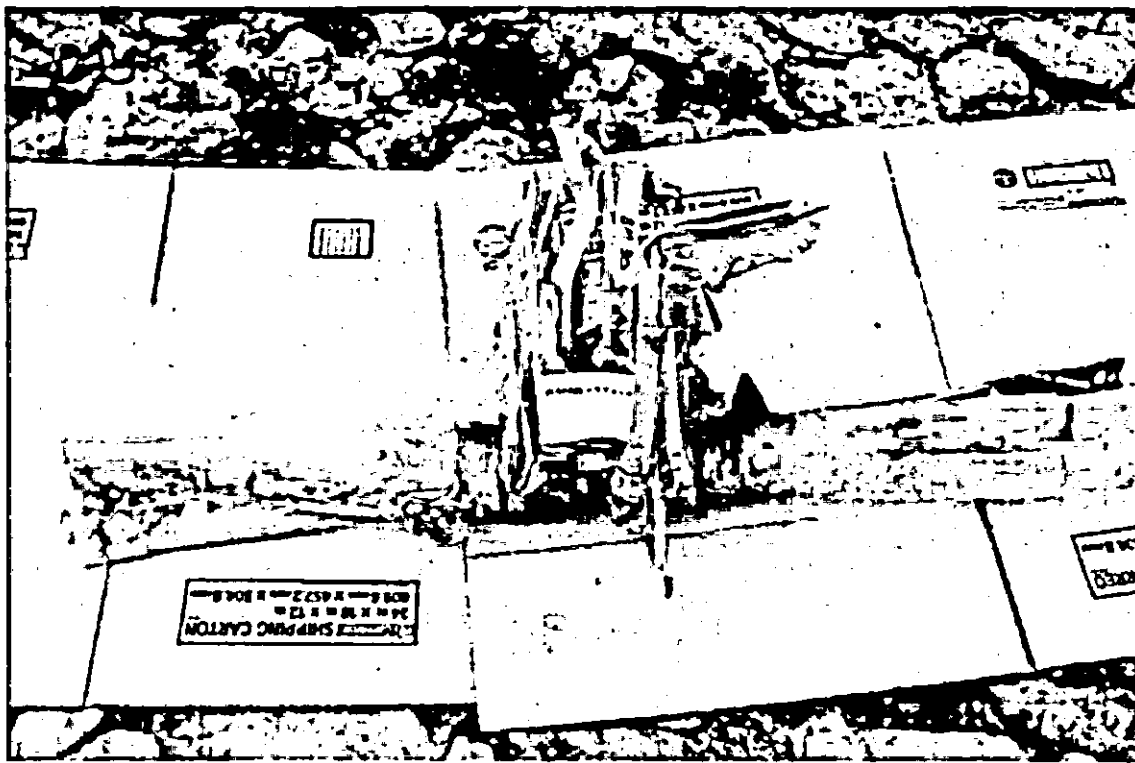
Figure 11

Both the horizontal and vertical stabilizers fractured into numerous pieces on impact. The largest piece identified was the horizontal stabilizer torque tube and control arm structure. (see Attachment A Figure 11) Numerous small pieces of horizontal and vertical stabilizer main box structure (skins, ribs & spars) were identified in the northeast quadrant of the debris field. A reconstruction of the empennage was not possible due to the severity of the impact damage.

Horizontal Stabilizer Torque Tube

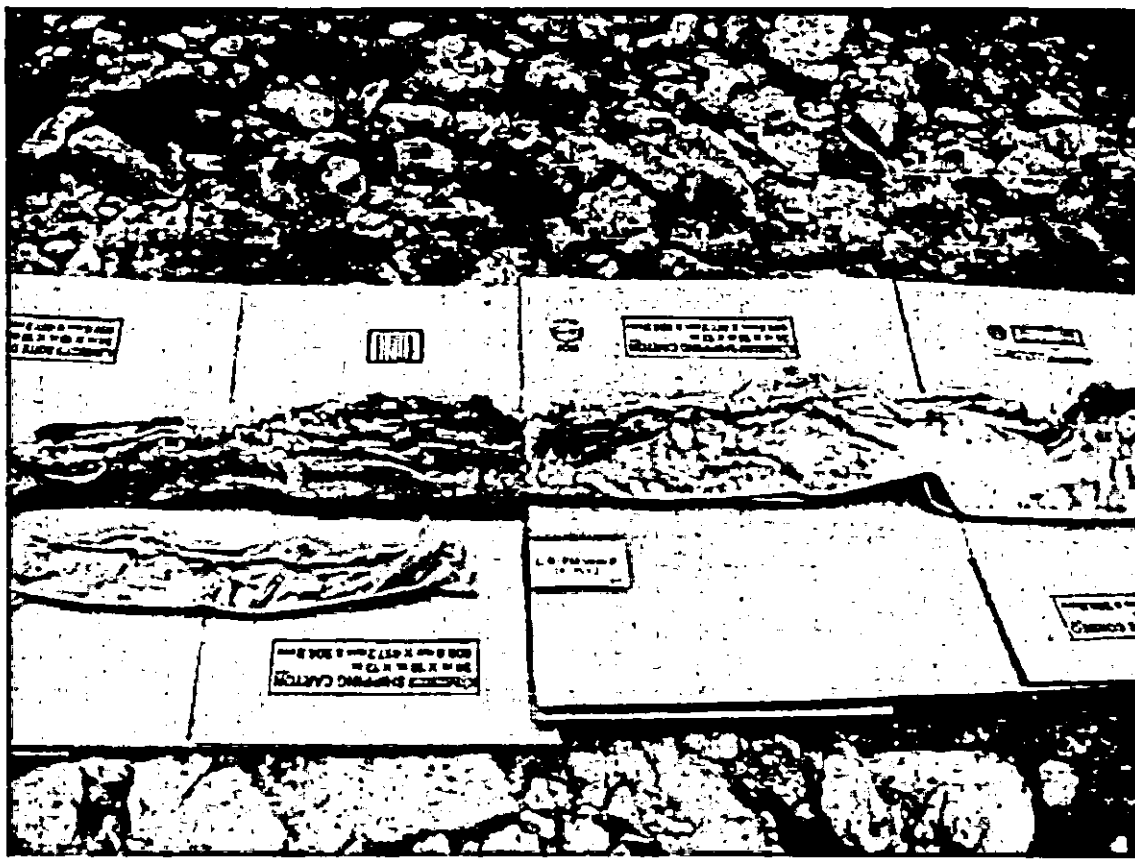
Figure 12

All of the movable control surfaces were located in the immediate debris field and identified at the accident site. The elevator and rudder structure were recovered in the northeast quadrant. Both the left and right flap (flap & flap tracks) and speed brake structure were located in the immediate vicinity of the main impact site along with the ventral rudder leading edge and torque tube. Both the right and left hand ailerons were located on the north side of the main impact site along with the right wing gurney flap. Slat tracks were identified at the main impact site however no slat structure was identified in the debris field. (see Attachment A Figures 12 thru 20)

Left Hand Elevator

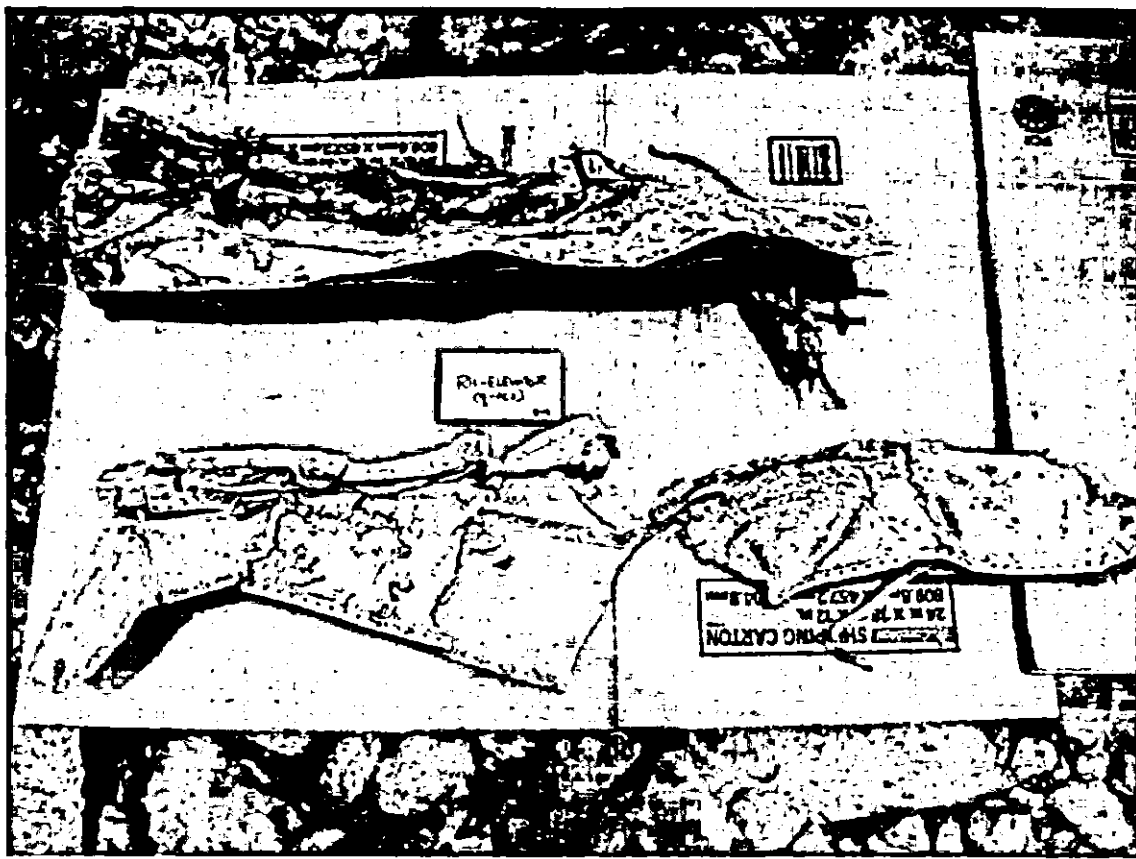
Figure 13

Right Hand Elevator

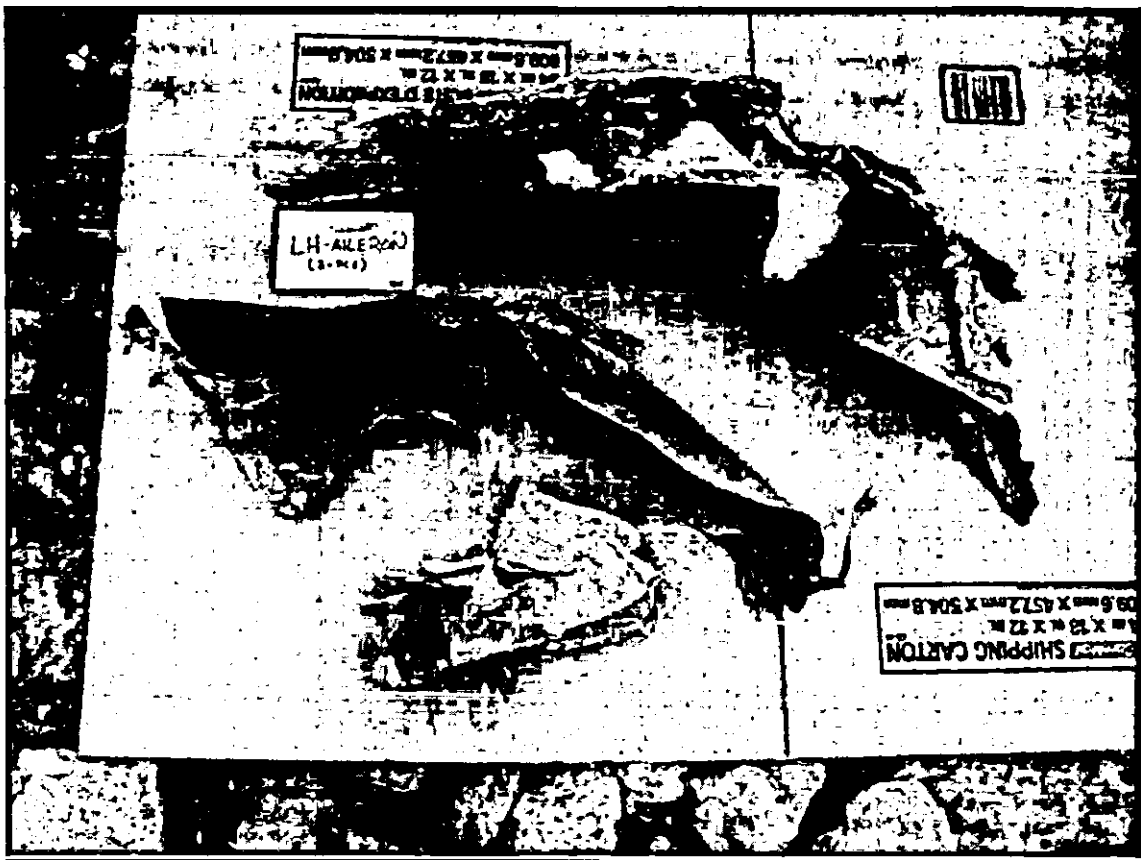
Figure 14

Left Hand Aileron

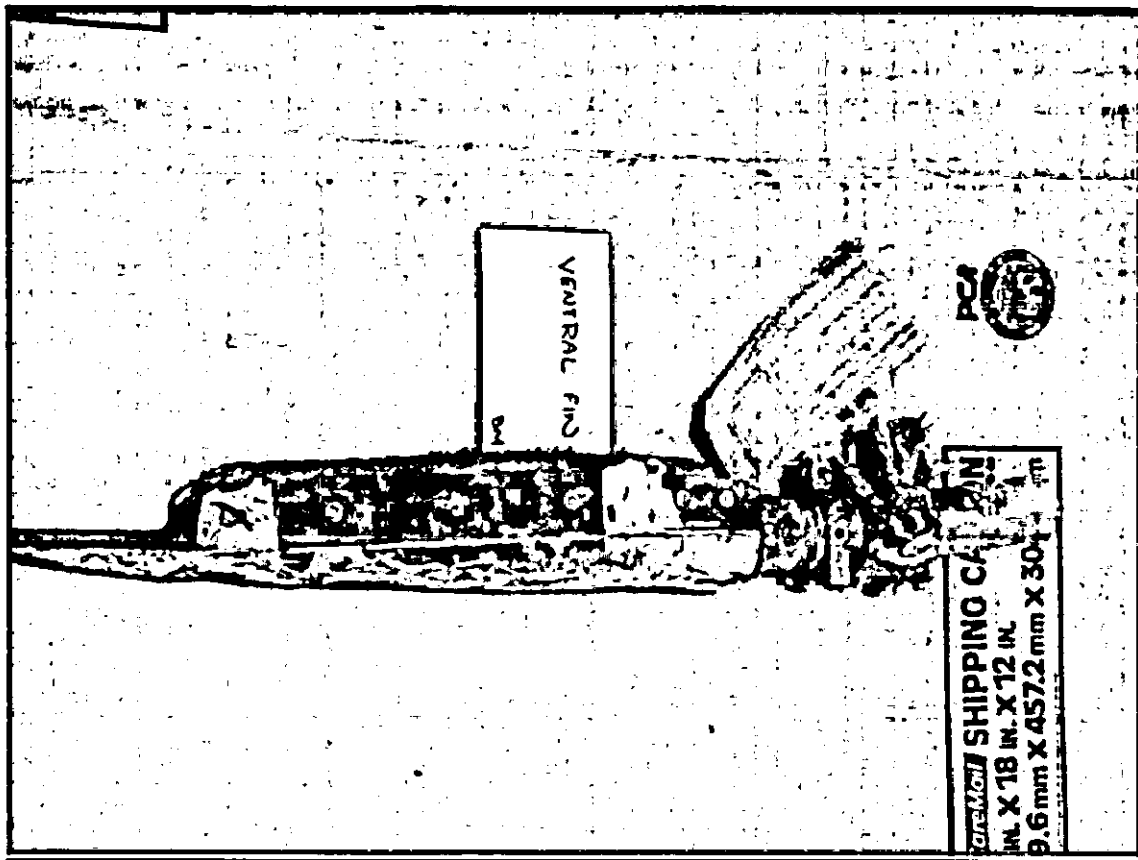
Figure 15

Ventral Rudder Torque Tube

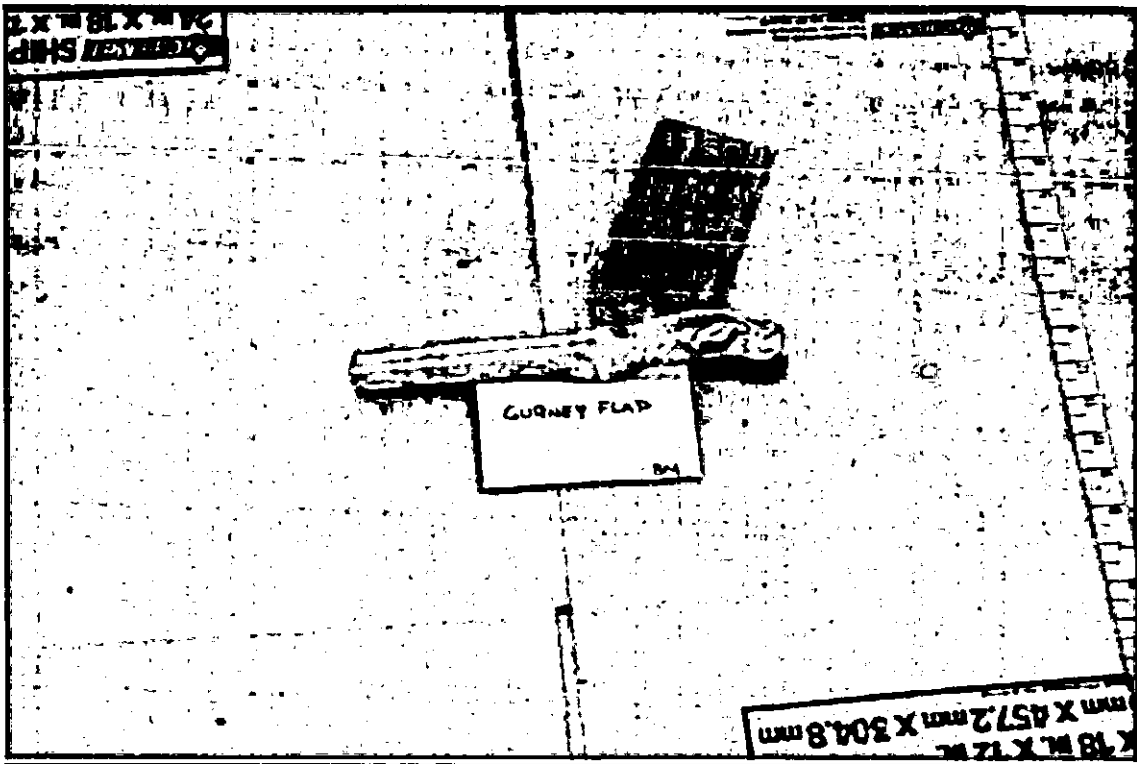
Figure 18

Gourney Flap

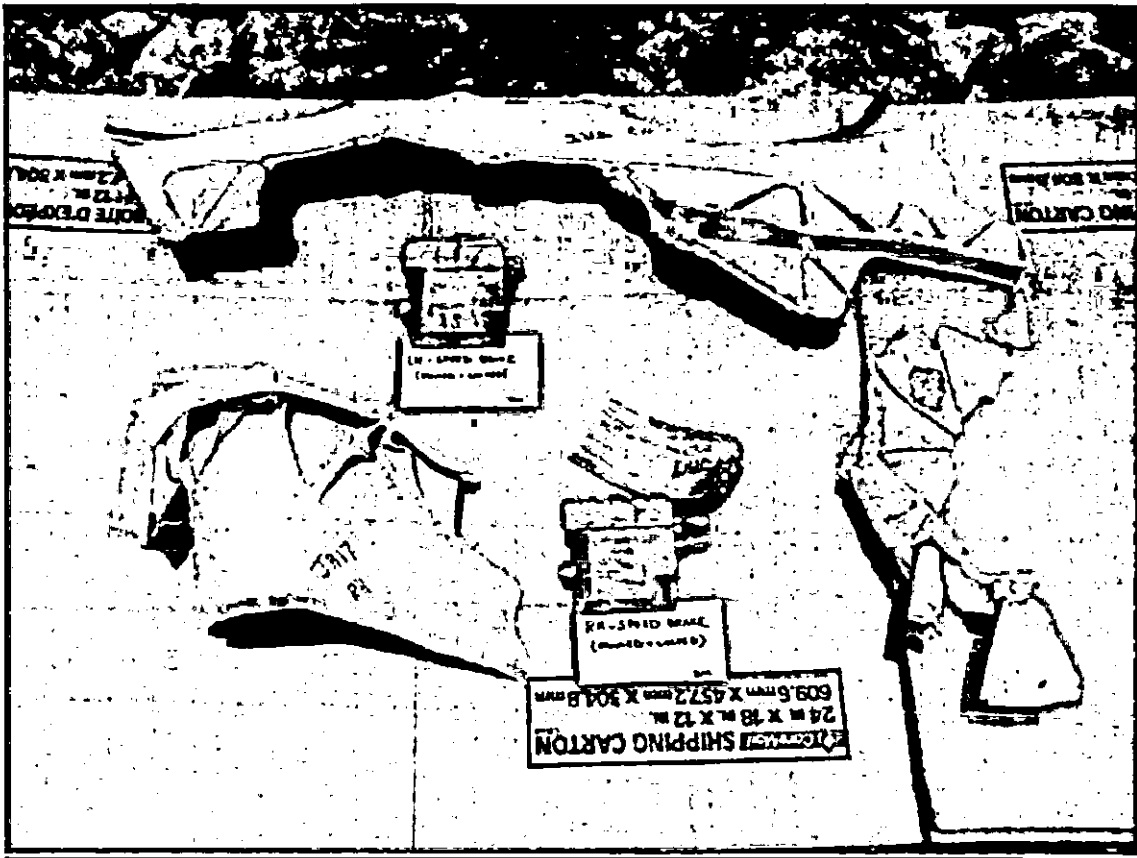
Figure 19

Speed Brakes

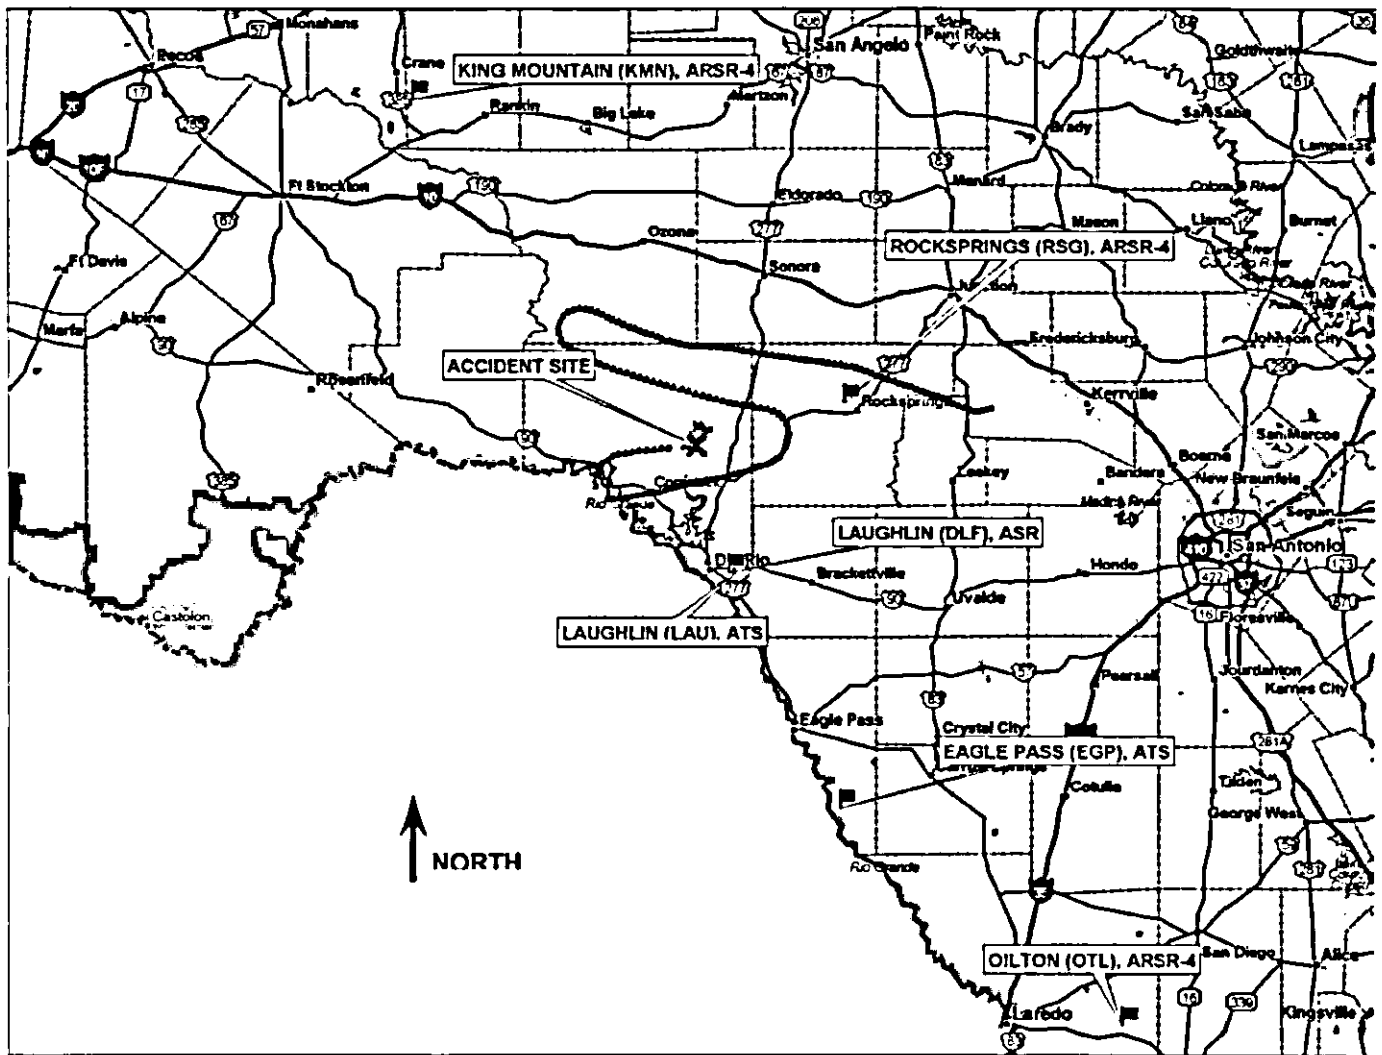
Figure 7: Radar site locations, N138BF ground track based on RSG ARSR-4 data, and the accident site location.

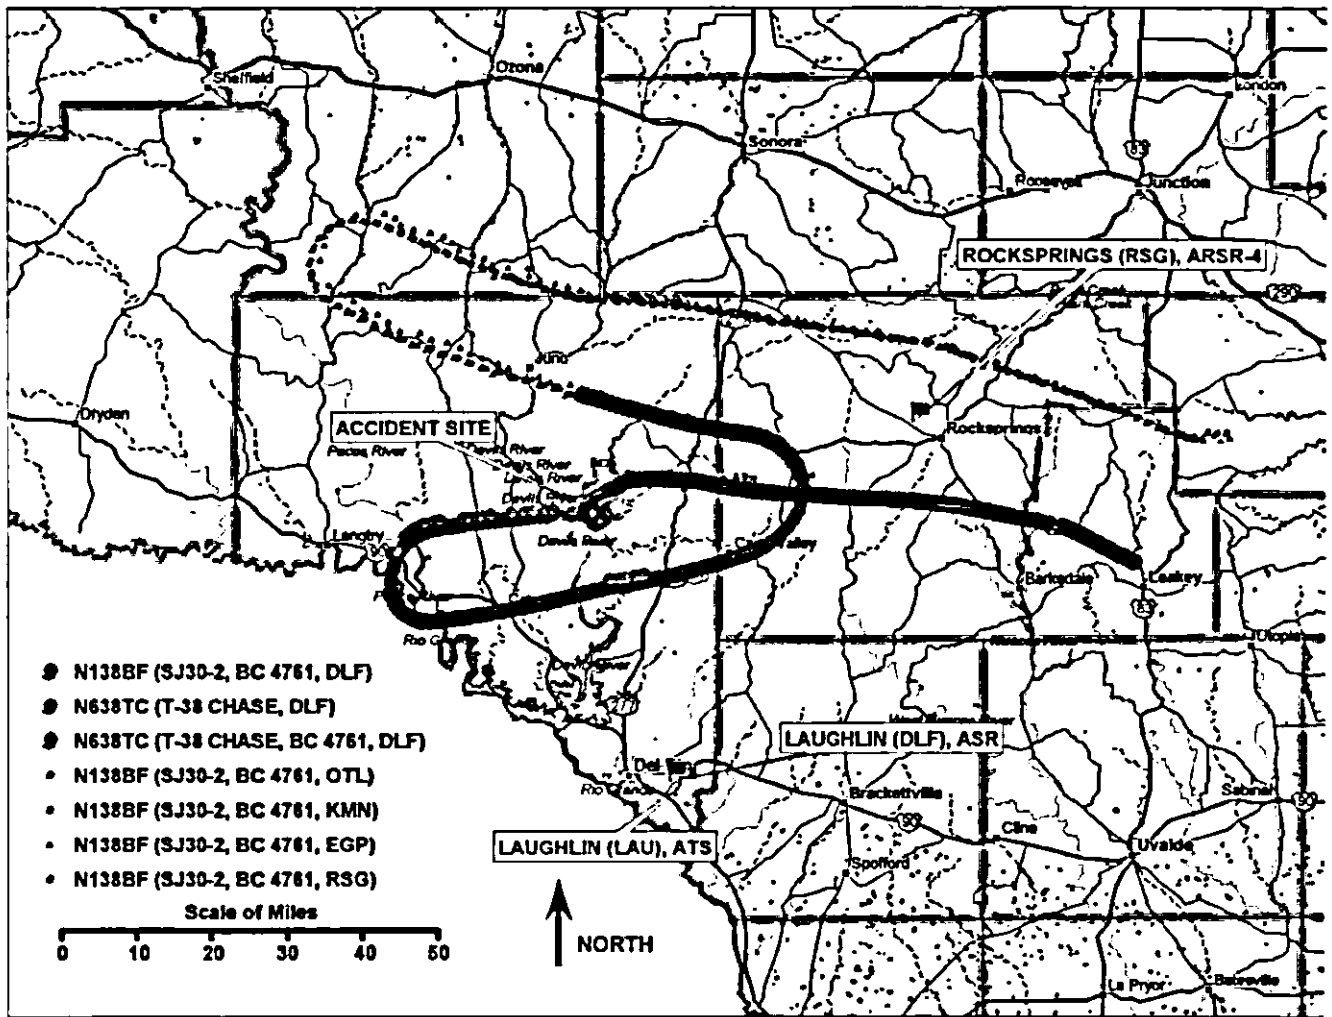
The long range and short range radar data identified in the Vehicle Performance Factual Report were processed to determine aircraft latitude, longitude, altitude, rate of climb, and groundspeed as a function of time. The radar sites, accident site, and the accident and chase aircraft ground track data were superimposed on the map presented in Figure 1. The long range N138BF radar data are depicted by small blue, green, yellow, or red circular symbols, according to radar site source. The short range radar data are illustrated by the large blue, green, and red circular symbols. The data indicate that N138BF was on a course from west to east about 35 miles north of Del Rio, Texas at an altitude of 30,500 feet when the accident occurred.

Figure 1: Partial accident flight ground track, accident site location, and partial chase plane ground track with key identifying aircraft by beacon code, if available, and radar data source.

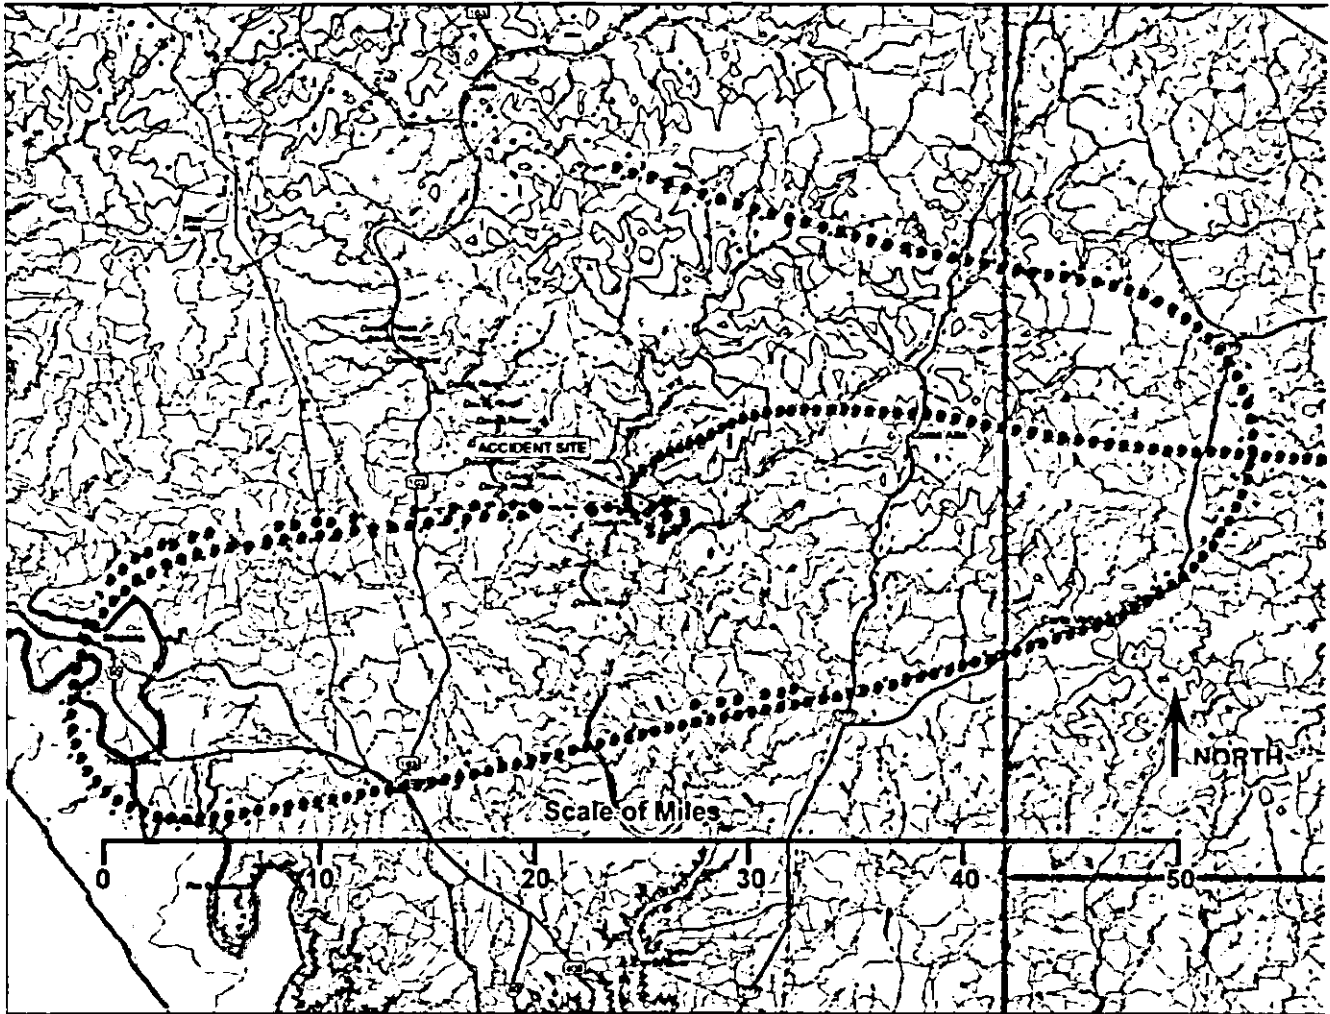
A close up view of the accident site and the short range radar data is presented in Figure 2. The accident aircraft ground track is depicted by the large blue symbols, whereas the large green and red symbols denote the chase plane ground track. According to SSAC, N138BF was squawking beacon code 4761 during the flight test and N638TC was flying chase. As such, N638TC was the second aircraft in a flight of 2 aircraft and was not squawking an independent transponder code.

Subsequent to the accident, N638TC assumed the flight test transponder code and began squawking beacon code 4761. This fact is confirmed by the radar data documented in Figure 2 as the ground track transitions from N138BF squawking 4761 (large blue symbols), to only primary returns near the time of the accident (large green symbols), to N638TC squawking 4761 (large red symbols).

Figure 2: Close up view of DLF short range radar data used for aircraft performance calculations. The accident aircraft ground track is depicted by the large blue symbols. The large green and red symbols depict the chase plane ground track.

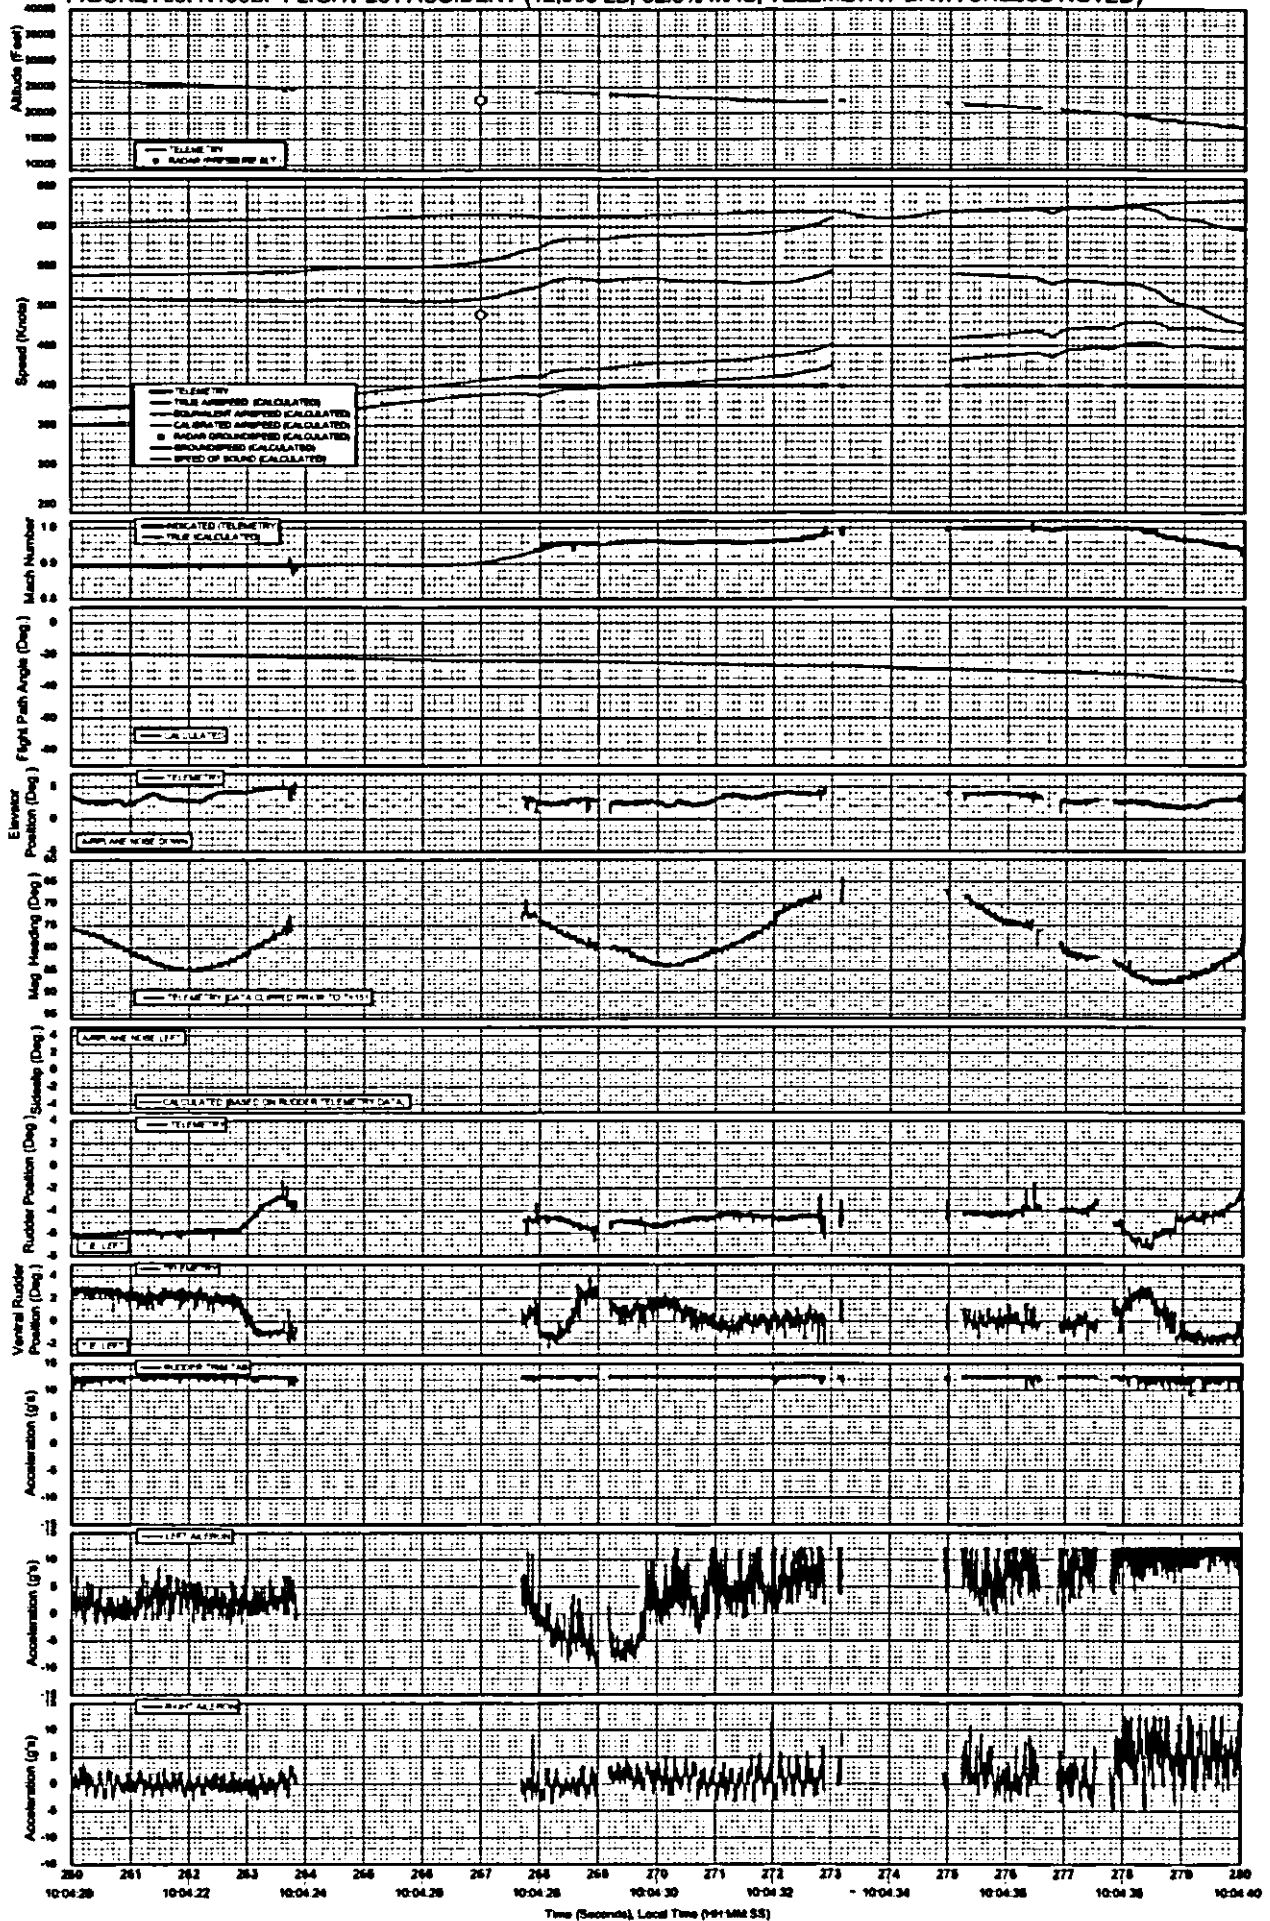
FIGURE A.8: N138BF FLIGHT 231 ACCIDENT (12,060 LB; 32.5% MAC; TELEMETRY DATA UNLESS NOTED)

Flut commands increasing left rudder deflection (2.8 to 4.8 deg TEL)

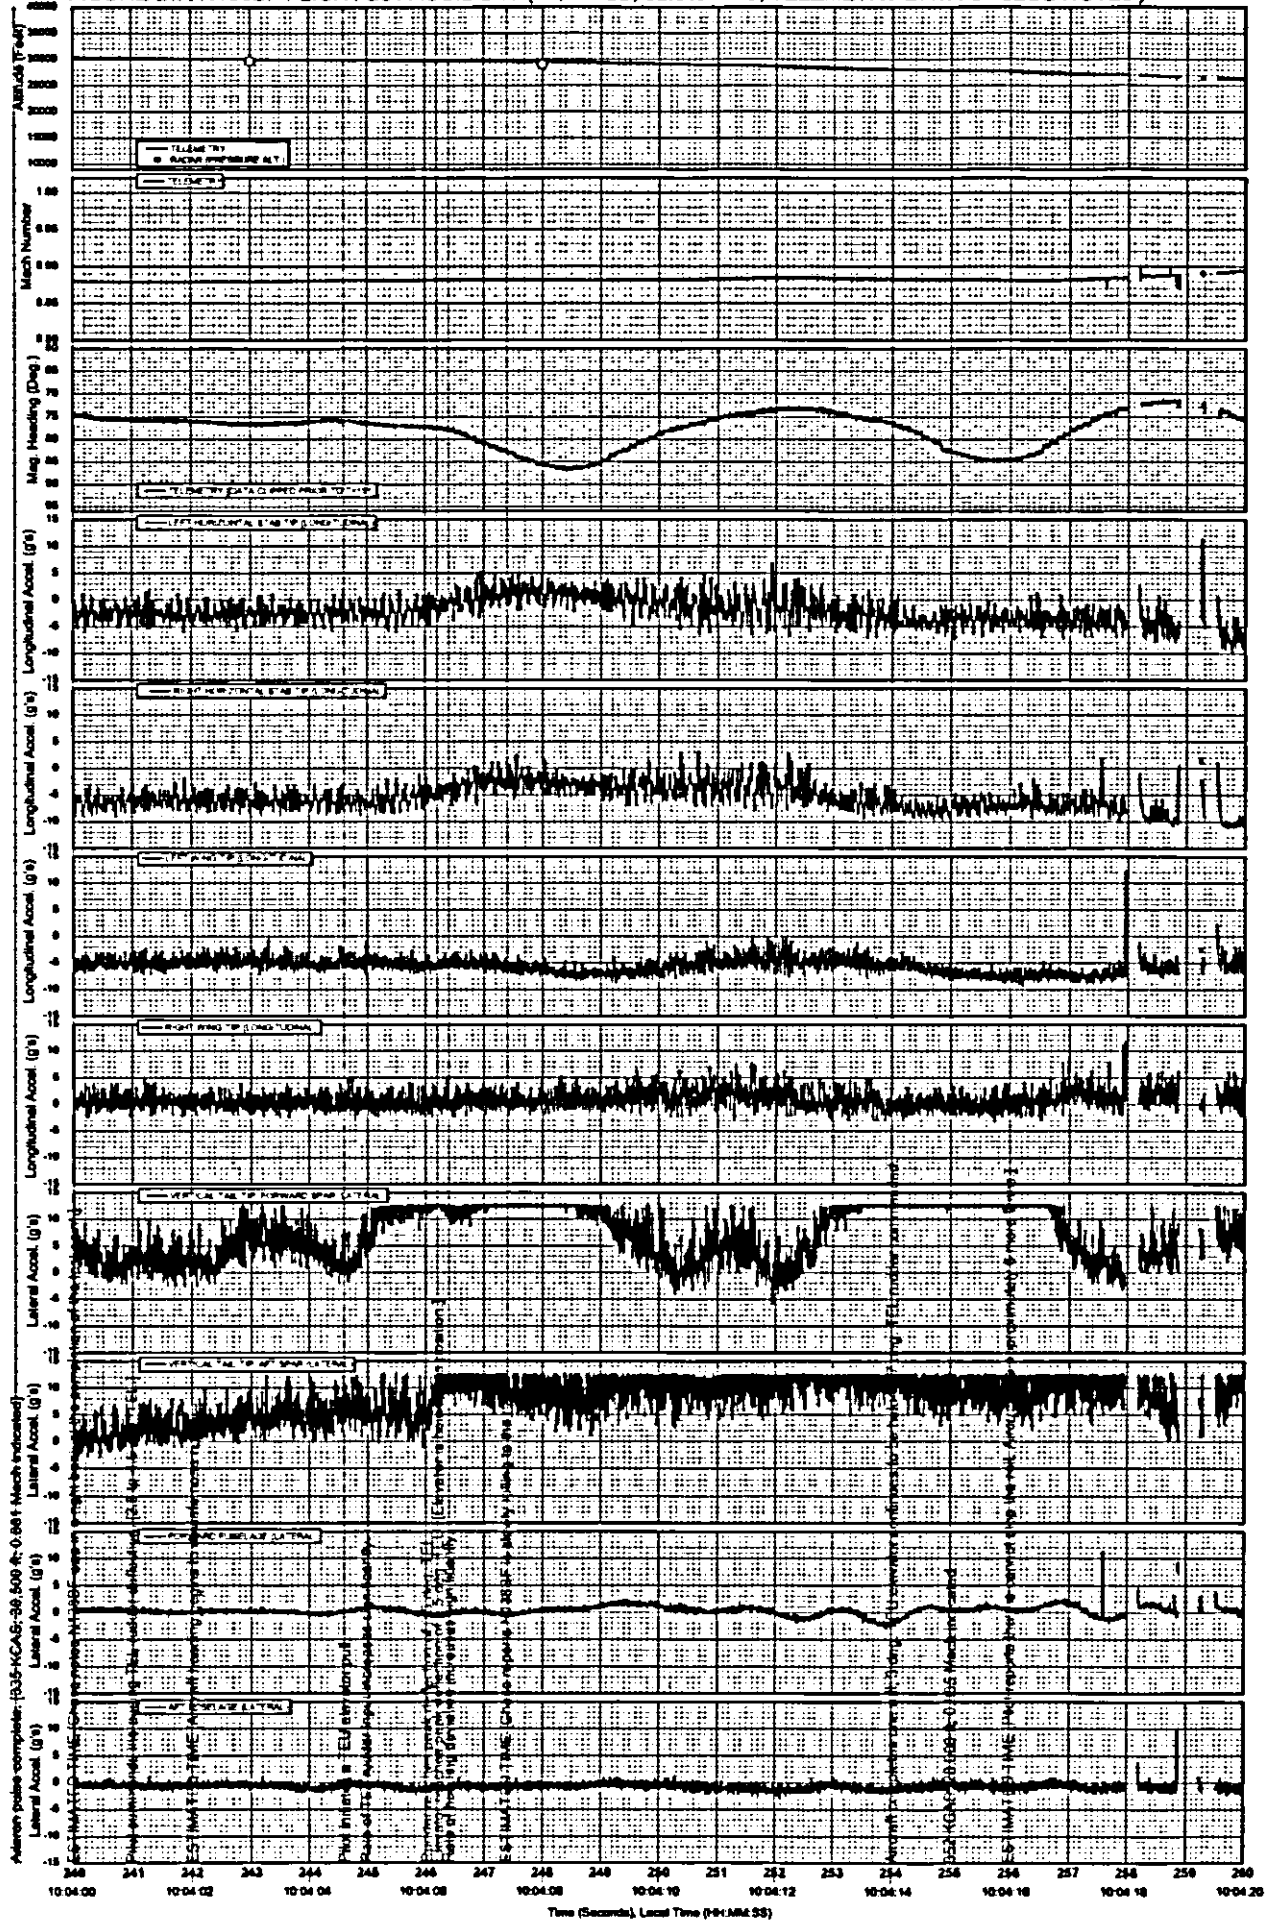
FIGURE B.7: N138BF FLIGHT 231 ACCIDENT (12,060 LB; 32.5% MAC; TELEMETRY DATA UNLESS NOTED)

Pilot comments increasing TEL. rudder deflection. (2.8 to 4.6 deg. TEL.)
