EMBRAER -120 Brasilia Simulated Ice Shapes Incident

Flight Test Safety Workshop
Seattle May/2012

This presentation intends to cover some technical aspects of an EMB-120 Brasilia incident which happened during one of the last test flights of Inter-cycle Ice Evaluation performed in the Prototype EMB-120 s/n 001 (PT-ZBA) at early 01's, and also emphasizes the organization and procedural changes and lessons learned resulting from that incident.

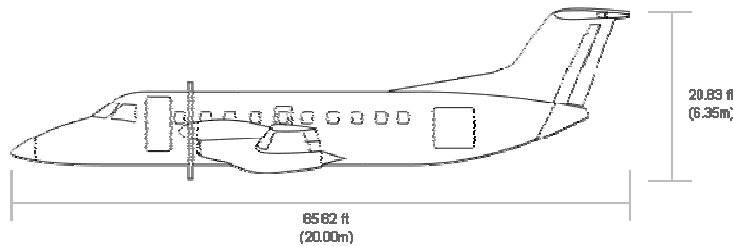
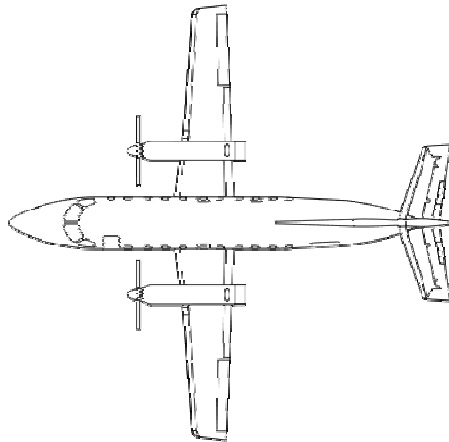
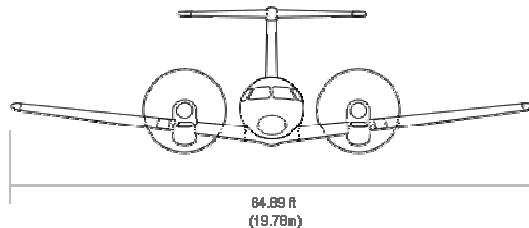
- Ø Embraer was accessing an Inter-Cycle Ice Handling Qualities, required by FAA
- Ø Simulated Ice Shapes installed on Wings, Vertical and Horizontal Stabilizer
- Ø At 16,5Kft, during a Turning Stall (30 deg), Landing configuration (DN/ 45) aircraft departed from the controlled flight
- Ø Extreme pitch down attitude, with no effective pitch control;
- Ø Tail Chute was deployed and PF regained aircraft control at aprox. 8,500 ft;
- Ø Max airspeed was 241 kts, RTB and safe landing at SBSJ

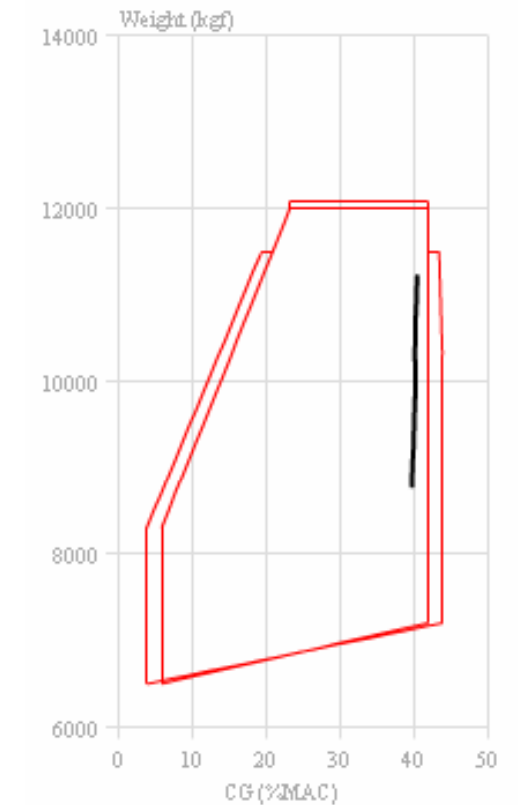
Ø Simulated Ice Shapes (Inter-Cycle Ice) installed on the wings leading edge, Horizontal and Vertical Stabilizers and all unprotected areas

✓ Inter-Cycle Ice = Ice that builds up on the Wings, Horizontal and Vertical Stabilizers leading edge between two consecutive anti-ice Boots cycles (3 minutes)

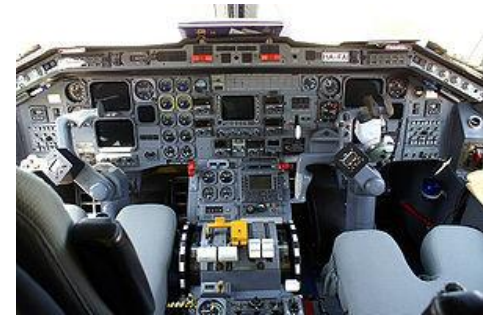
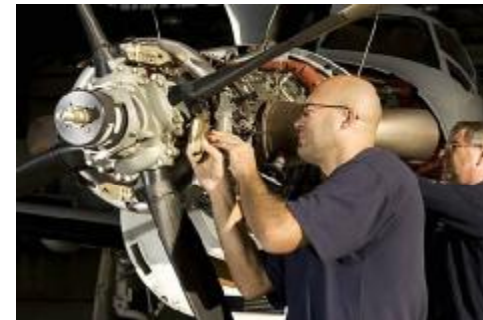
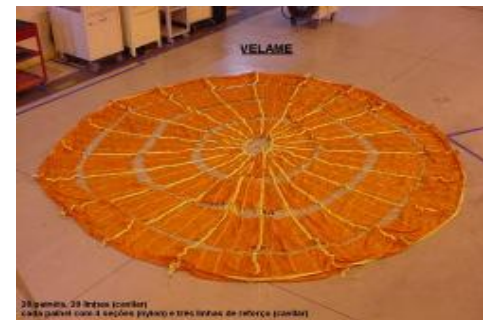
- Ø Prototype not fully representative from series aircraft and difficult to maintain
- Ø Lack of good Configuration Control and Tech Publications
- Ø Aircraft was parked outside Hangar for a long time
- Ø Lack of inspections on the Ice shapes (Horizontal Stabilizer)
- Ø Poor plumb ballast attachment
- Ø No FDR installation, only FTI data

- Ø Complete redesign of all ballast attachment devices
- Ø New Artificial Ice Shapes Adhesives / Resins and Materials are now employed
- Ø For longer Flight Test Campaigns, any “special equipment/device” installed shall have a dedicated appreciation regarding its “expiration time”
- Ø Ongoing Research Project for new Artificial Ice Shapes materials and gluing processes
